Manhole Inspection Report

Date:	10/08/2022	Weather:		Coding:	RZMACP
MH#:	M-804-043	Owner:	NA	Len. Surveyed:	4.4
P.O.#:		Surveyor:	Todd Machine	Rim to Invert:	5.0
Customer:		Cert. #:	P0038859-082022	Wall Material:	Concrete (cast in place)

Street:	256' South of High St. 162' West of L	Project:	Hobart, IN
City:	Hobart, IN	GPS Northing:	2292808.063
Location:	Other	GPS Easting:	2908893.019
Drain Area:	Northeast	GPS Accuracy:	Sub-Meter
Cover Shape:	Circular	Evidence of Surcharge:	No
Cover Size:	24.0	Potential for Runoff:	None
Comments:

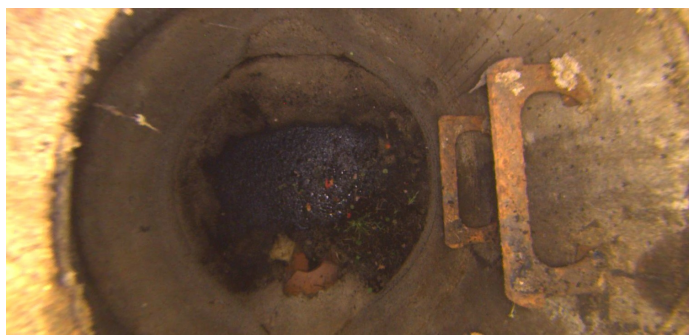
Code: **MGO**
Description: **General Observation**

Distance (ft): **.0**
Structural Grade: **0**
O&M Grade: **0**
Clock Start/From:
Clock To:
1st Value:
2nd Value:
Value Percent:
Step: **NO**
Remarks: **access mh**

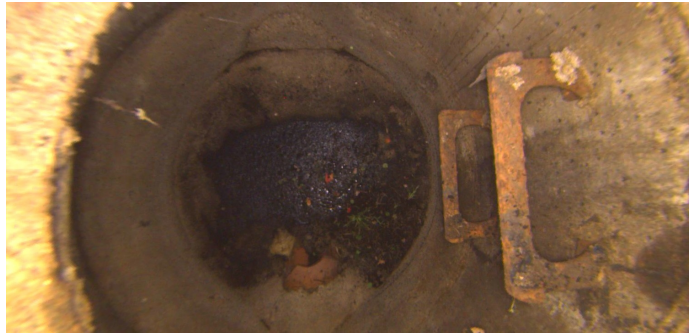
Code: **SRI**
Description: **Surface Roughness Increased**

Distance (ft): **.0**
Structural Grade: **1**
O&M Grade: **0**
Clock Start/From: **12**
Clock To: **12**
1st Value:
2nd Value:
Value Percent:
Step: **NO**
Remarks:

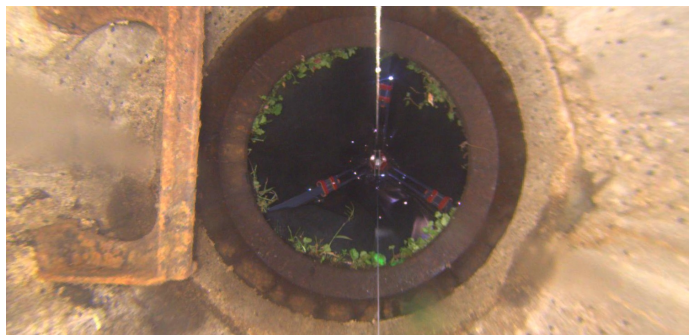
Code: **MGO**
Description: **General Observation**

Distance (ft): **2.3**
Structural Grade: **0**
O&M Grade: **0**
Clock Start/From:
Clock To:
1st Value:
2nd Value:
Value Percent:
Step: **NO**
Remarks: **underside of frame**
