# Manhole Inspection Report

Date:	<b>05/15/2018</b>	Weather:		Coding:	<b>RZMACP</b>
MH#:	<b>M-804-044</b>	Owner:	<b>NA</b>	Len. Surveyed:	<b>5.1</b>
P.O.#:		Surveyor:	<b>Jen Costello</b>	Rim to Invert:	<b>5.0</b>
Customer:		Cert. #:	<b>U-907-5518</b>	Wall Material:	<b>Concrete (reinforced)</b>

Street:	<b>168' South of High St. 163' West of L</b>	Project:	<b>Hobart, IN</b>
City:	<b>Hobart, IN</b>	GPS Northing:	<b>2908893.21</b>
Location:		GPS Easting:	<b>2908893.21</b>
Drain Area:	<b>Northeast</b>	GPS Accuracy:	<b>Sub-Meter</b>
Cover Shape:	<b>Circular</b>	Evidence of Surcharge:	<b>No</b>
Cover Size:	<b>22.5</b>	Potential for Runoff:	<b>None</b>
Comments:

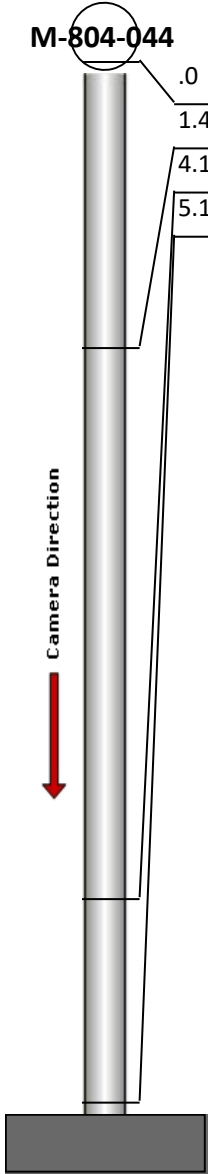
M-804-044				
	.0	MGP	General Photo	10	NA
	1.4	MGO	General Observation	26	NA
	4.1	DSF	Deposits Settled Fine	45	M 2
	5.1	MGO	General Observation	58	NA

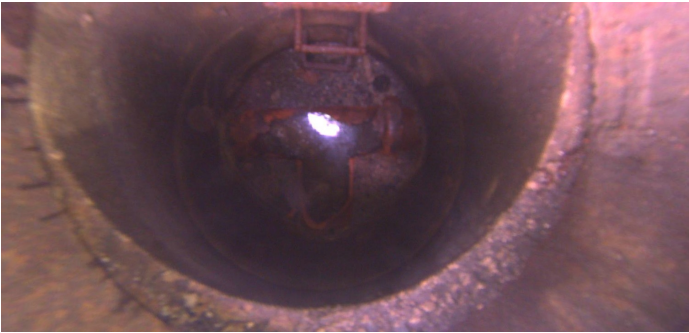
Code: **MGP**  
 Description: **General Photo**

Distance (ft): **.0**  
 Structural Grade: **0**  
 O&M Grade: **0**  
 Clock Start/From:  
 Clock To:  
 1st Value:  
 2nd Value:  
 Value Percent:  
 Step: **NO**  
 Remarks: **ACCESS MH**

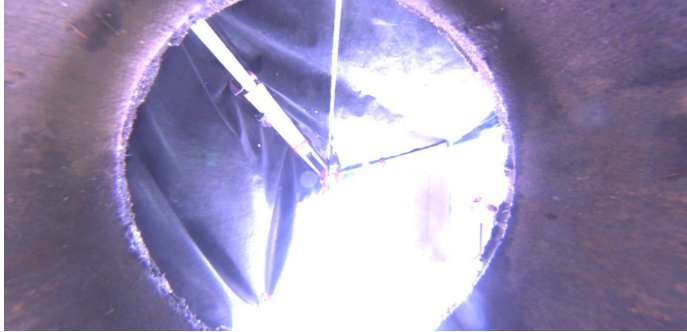
Code:	<b>MGO</b>
Description:	<b>General Observation</b>
Distance (ft):	<b>1.4</b>
Structural Grade:	<b>0</b>
O&M Grade:	<b>0</b>
Clock Start/From:	
Clock To:	
1st Value:	
2nd Value:	
Value Percent:	
Step:	<b>NO</b>
Remarks:	<b>UNDERSIDE OF FRAME</b>

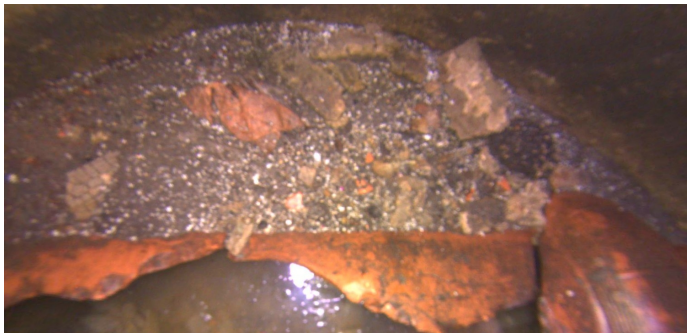
Code:	<b>DSF</b>
Description:	<b>Deposits Settled Fine</b>
Distance (ft):	<b>4.1</b>
Structural Grade:	<b>0</b>
O&M Grade:	<b>2</b>
Clock Start/From:	<b>9</b>
Clock To:	<b>3</b>
1st Value:	
2nd Value:	
Value Percent:	<b>5.000</b>
Step:	<b>NO</b>
Remarks:

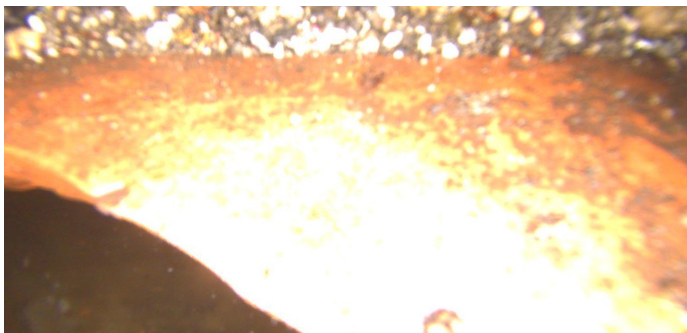
Code:	<b>MGO</b>
Description:	<b>General Observation</b>
Distance (ft):	<b>5.1</b>
Structural Grade:	<b>0</b>
O&M Grade:	<b>0</b>
Clock Start/From:	
Clock To:	
1st Value:	
2nd Value:	
Value Percent:	
Step:	<b>NO</b>
Remarks:	<b>END SURVEY</b>
