Manhole Inspection Report

Date:	05/15/2018	Weather:		Coding:	RZMACP
MH#:	M-804-047	Owner:	NA	Len. Surveyed:	7.7
P.O.#:		Surveyor:	Jen Costello	Rim to Invert:	7.7
Customer:		Cert. #:	U-907-5518	Wall Material:	Concrete (reinforced)

Street:	Ohio St. 177' North of Hickey St.	Project:	Hobart, IN
City:	Hobart, IN	GPS Northing:	2908411.035
Location:		GPS Easting:	2908411.035
Drain Area:	Northeast	GPS Accuracy:	Sub-Meter
Cover Shape:	Circular	Evidence of Surcharge:	No
Cover Size:	22.5	Potential for Runoff:	None
Comments:

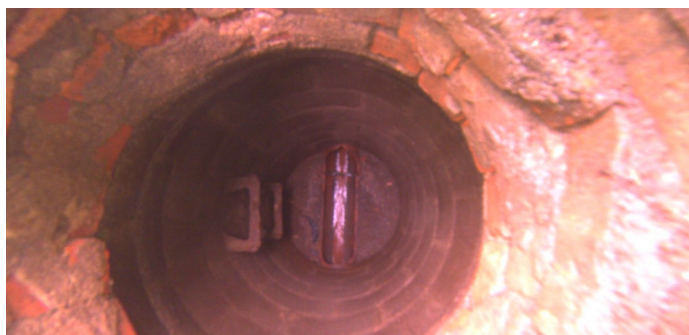
Code: **MGP**
Description: **General Photo**

Distance (ft): **.0**
Structural Grade: **0**
O&M Grade: **0**
Clock Start/From:
Clock To:
1st Value:
2nd Value:
Value Percent:
Step: **NO**
Remarks: **ACCESS MH**

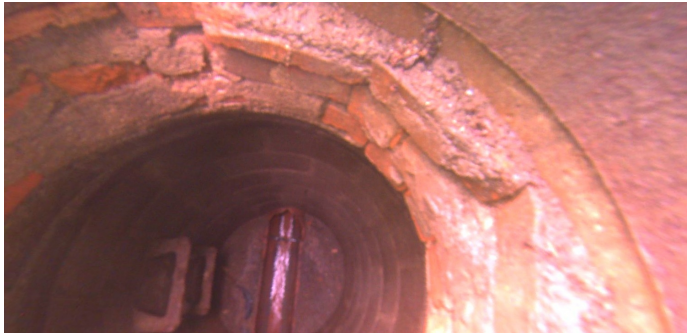
Code: **DB**
Description: **Displaced Brick**

Distance (ft): **.0**
Structural Grade: **3**
O&M Grade: **0**
Clock Start/From: **12**
Clock To: **2**
1st Value:
2nd Value:
Value Percent:
Step: **NO**
Remarks:

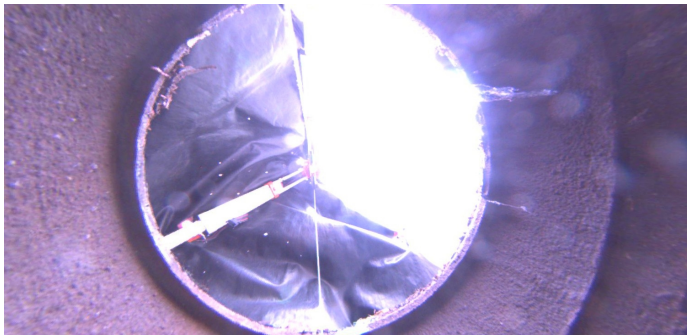
Code: **MGO**
Description: **General Observation**

Distance (ft): **1.1**
Structural Grade: **0**
O&M Grade: **0**
Clock Start/From:
Clock To:
1st Value:
2nd Value:
Value Percent:
Step: **NO**
Remarks: **UNDERSIDE OF FRAME**

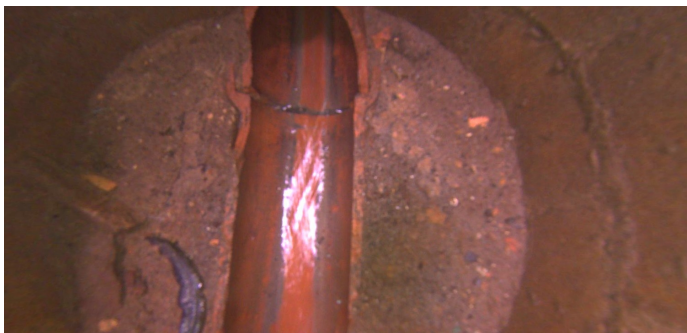
Code: **DSF**
Description: **Deposits Settled Fine**

Distance (ft): **5.6**
Structural Grade: **0**
O&M Grade: **2**
Clock Start/From: **12**
Clock To: **12**
1st Value:
2nd Value:
Value Percent: **5.000**
Step: **NO**
Remarks:

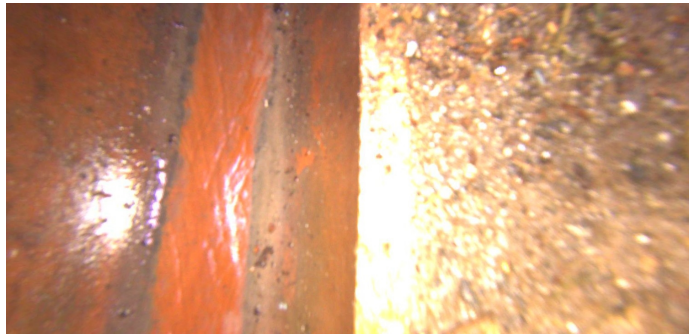
Code: **MGO**
Description: **General Observation**

Distance (ft): **7.4**
Structural Grade: **0**
O&M Grade: **0**
Clock Start/From:
Clock To:
1st Value:
2nd Value:
Value Percent:
Step: **NO**
Remarks: **END SURVEY**

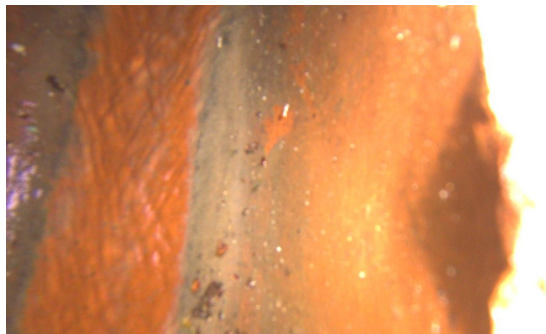
Code: **MGO**
Description: **General Observation**

Distance (ft): **7.7**
Structural Grade: **0**
O&M Grade: **0**
Clock Start/From:
Clock To:
1st Value:
2nd Value:
Value Percent:
Step: **NO**
Remarks: **END SURVEY**
