Manhole Inspection Report

Date:	05/15/2018	Weather:		Coding:	RZMACP
MH#:	M-804-048	Owner:	NA	Len. Surveyed:	7.5
P.O.#:		Surveyor:	Jen Costello	Rim to Invert:	8.3
Customer:		Cert. #:	U-907-5518	Wall Material:	Concrete (reinforced)

Street:	Ohio St. 454' North of Hickey St.	Project:	Hobart, IN
City:	Hobart, IN	GPS Northing:	2908402.332
Location:		GPS Easting:	2908402.332
Drain Area:	Northeast	GPS Accuracy:	Sub-Meter
Cover Shape:	Circular	Evidence of Surcharge:	No
Cover Size:	22.5	Potential for Runoff:	None
Comments:

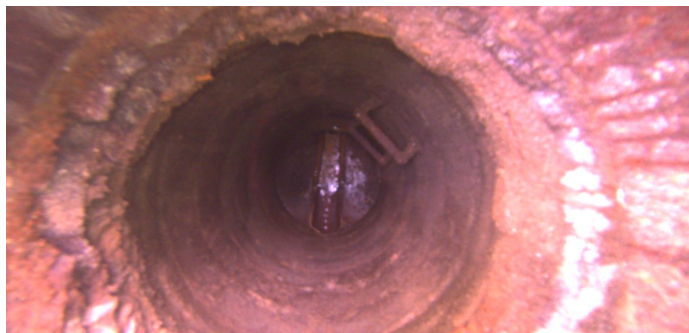
Code: **MGP**
Description: **General Photo**

Distance (ft): **.0**
Structural Grade: **0**
O&M Grade: **0**
Clock Start/From:
Clock To:
1st Value:
2nd Value:
Value Percent:
Step: **NO**
Remarks: **ACCESS MH**

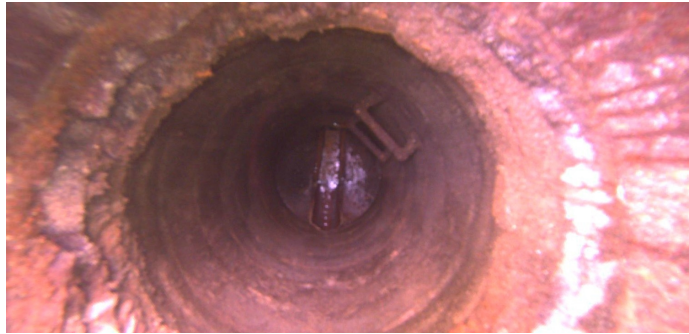
Code:	DAE
Description:	Deposits Attached Encrustation
Distance (ft):	.0
Structural Grade:	0
O&M Grade:	2
Clock Start/From:	12
Clock To:	12
1st Value:	
2nd Value:	
Value Percent:	5.000
Step:	NO
Remarks:

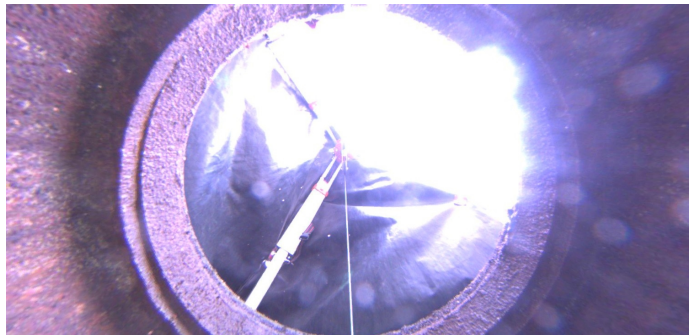
Code:	MGO
Description:	General Observation
Distance (ft):	1.5
Structural Grade:	0
O&M Grade:	0
Clock Start/From:	
Clock To:	
1st Value:	
2nd Value:	
Value Percent:	
Step:	NO
Remarks:	UNDERSIDE OF FRAME

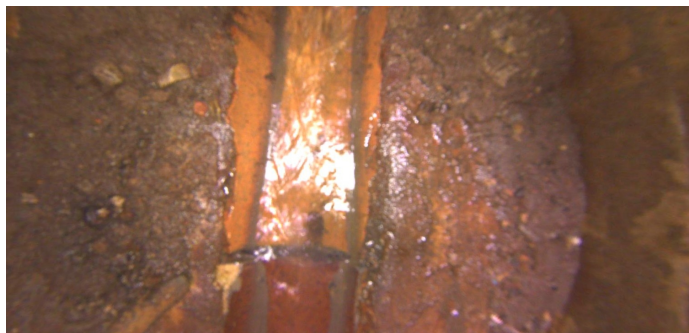
Code:	DSF
Description:	Deposits Settled Fine
Distance (ft):	6.9
Structural Grade:	0
O&M Grade:	2
Clock Start/From:	12
Clock To:	12
1st Value:	
2nd Value:	
Value Percent:	5.000
Step:	NO
Remarks:

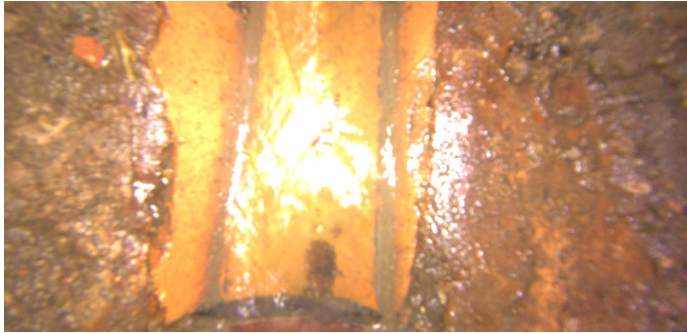
Code: **MGO**
Description: **General Observation**

Distance (ft): **7.5**
Structural Grade: **0**
O&M Grade: **0**
Clock Start/From:
Clock To:
1st Value:
2nd Value:
Value Percent:
Step: **NO**
Remarks: **END SURVEY**
