# Manhole Inspection Report

Date:	05/15/2018	Weather:		Coding:	RZMACP
MH#:	M-804-050	Owner:	NA	Len. Surveyed:	5.9
P.O.#:		Surveyor:	Jen Costello	Rim to Invert:	6.3
Customer:		Cert. #:	U-907-5518	Wall Material:	Concrete (reinforced)

Street:	Ohio St. 336' South of High St.	Project:	Hobart, IN
City:	Hobart, IN	GPS Northing:	2908396.573
Location:		GPS Easting:	2908396.573
Drain Area:	Northeast	GPS Accuracy:	Sub-Meter
Cover Shape:	Circular	Evidence of Surcharge:	No
Cover Size:	22.5	Potential for Runoff:	None
Comments:

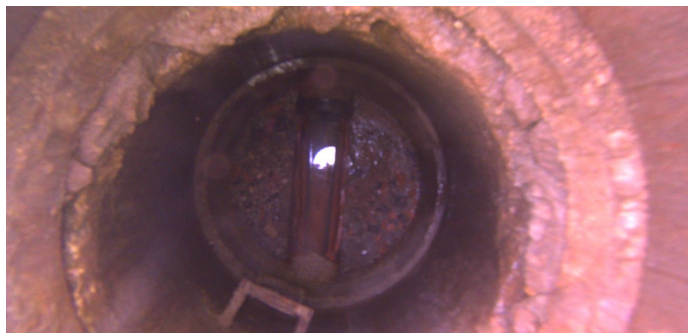
Code: **MGP**  
Description: **General Photo**

Distance (ft): **.0**  
Structural Grade: **0**  
O&M Grade: **0**  
Clock Start/From:  
Clock To:  
1st Value:  
2nd Value:  
Value Percent:  
Step: **NO**  
Remarks: **ACCESS MH**

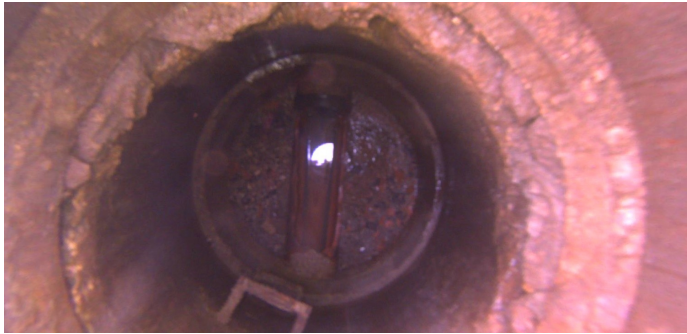
Code: **B**  
Description: **Broken**

Distance (ft): **.0**  
Structural Grade: **5**  
O&M Grade: **0**  
Clock Start/From: **12**  
Clock To: **12**  
1st Value:  
2nd Value:  
Value Percent:  
Step: **NO**  
Remarks:

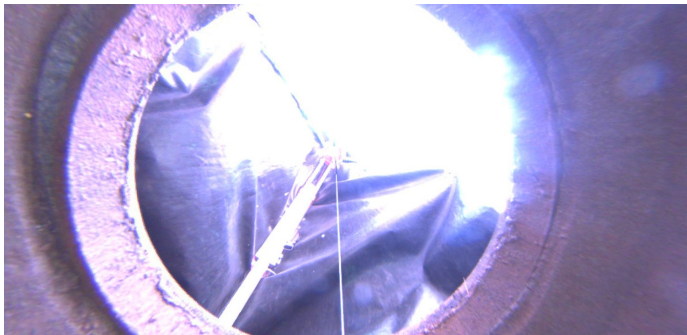
Code: **MGO**  
Description: **General Observation**

Distance (ft): **1.1**  
Structural Grade: **0**  
O&M Grade: **0**  
Clock Start/From:  
Clock To:  
1st Value:  
2nd Value:  
Value Percent:  
Step: **NO**  
Remarks: **UNDERSIDE OF FRAME**

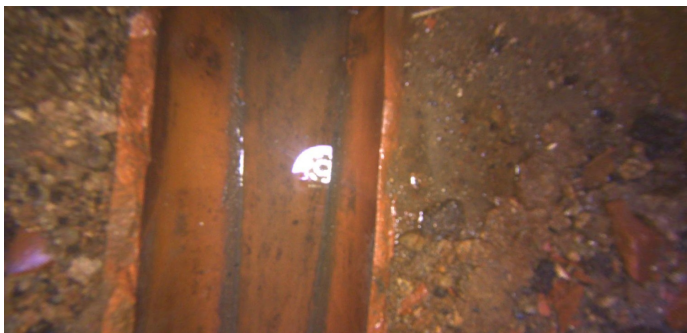
Code: **DSGV**  
Description: **Deposits Settled Gravel**

Distance (ft): **5.0**  
Structural Grade: **0**  
O&M Grade: **2**  
Clock Start/From: **12**  
Clock To: **12**  
1st Value:  
2nd Value:  
Value Percent: **5.000**  
Step: **NO**  
Remarks:

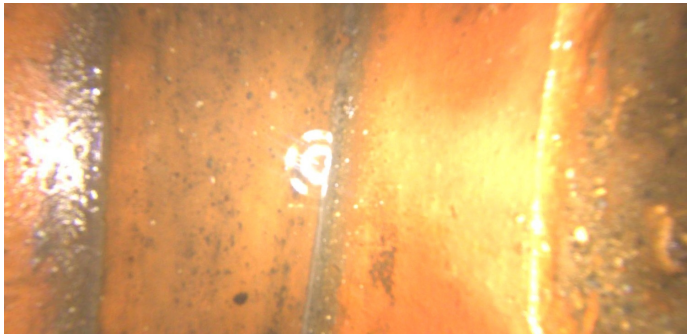
Code:	<b>MGO</b>
Description:	<b>General Observation</b>
Distance (ft):	<b>5.9</b>
Structural Grade:	<b>0</b>
O&M Grade:	<b>0</b>
Clock Start/From:	
Clock To:	
1st Value:	
2nd Value:	
Value Percent:	
Step:	<b>NO</b>
Remarks:	<b>END SURVEY</b>
