Manhole Inspection Report

Date:	05/16/2018	Weather:		Coding:	RZMACP
MH#:	M-804-053	Owner:	NA	Len. Surveyed:	8.5
P.O.#:		Surveyor:	Jen Costello	Rim to Invert:	9.3
Customer:		Cert. #:	U-907-5518	Wall Material:	Concrete (reinforced)

Street:	Kelly St. 381' North of Hickey St.	Project:	Hobart, IN
City:	Hobart, IN	GPS Northing:	2907748.131
Location:		GPS Easting:	2907748.131
Drain Area:	Northeast	GPS Accuracy:	Sub-Meter
Cover Shape:	Circular	Evidence of Surcharge:	No
Cover Size:	22.5	Potential for Runoff:	None
Comments:

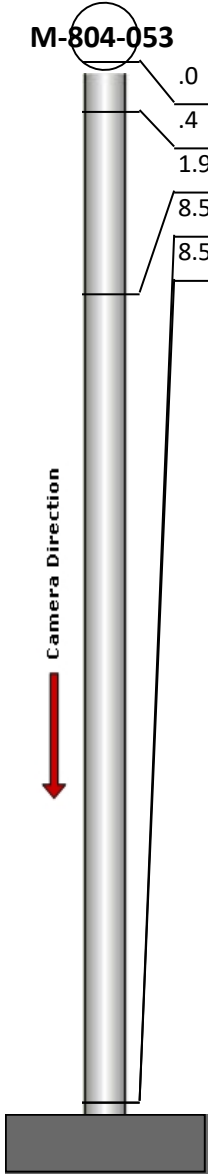
<p>M-804-053</p> <p>Camera Direction</p>	.0	MGP	General Photo	10	NA
	.4	DB	Displaced Brick	22	S 3
	1.9	MGO	General Observation	39	NA
	8.5	MGO	General Observation	66	NA
	8.5	DSF	Deposits Settled Fine	77	M 2

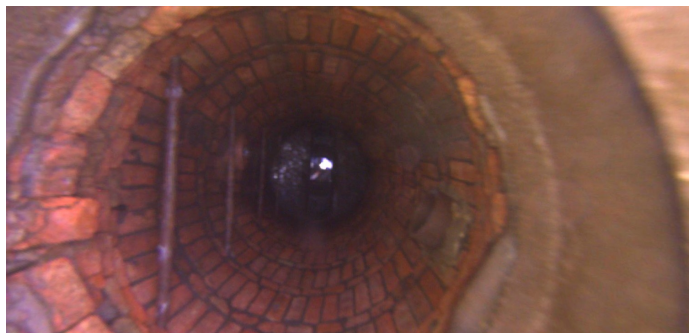
Code: **MGP**
Description: **General Photo**

Distance (ft): **.0**
Structural Grade: **0**
O&M Grade: **0**
Clock Start/From:
Clock To:
1st Value:
2nd Value:
Value Percent:
Step: **NO**
Remarks: **ACCESS MH**

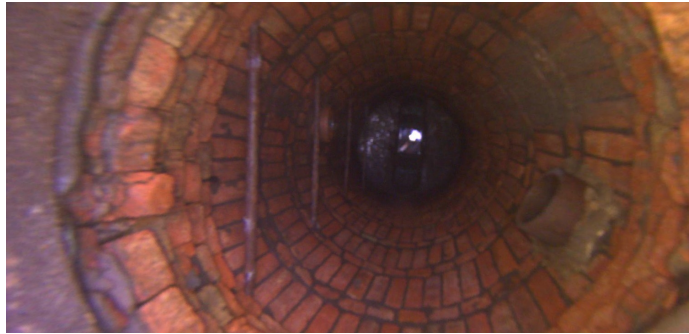
Code: **DB**
Description: **Displaced Brick**

Distance (ft): **.4**
Structural Grade: **3**
O&M Grade: **0**
Clock Start/From: **9**
Clock To:
1st Value:
2nd Value:
Value Percent:
Step: **NO**
Remarks:

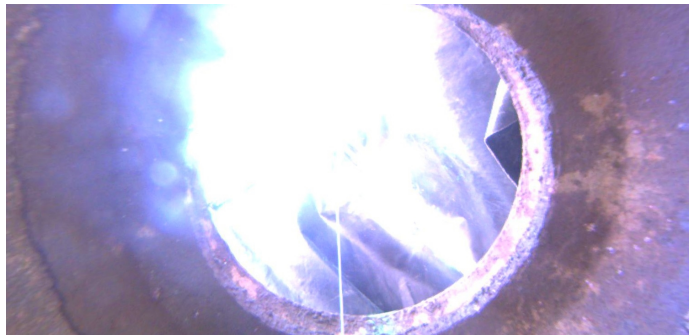
Code: **MGO**
Description: **General Observation**

Distance (ft): **1.9**
Structural Grade: **0**
O&M Grade: **0**
Clock Start/From:
Clock To:
1st Value:
2nd Value:
Value Percent:
Step: **NO**
Remarks: **UNDERSIDE OF FRAME**

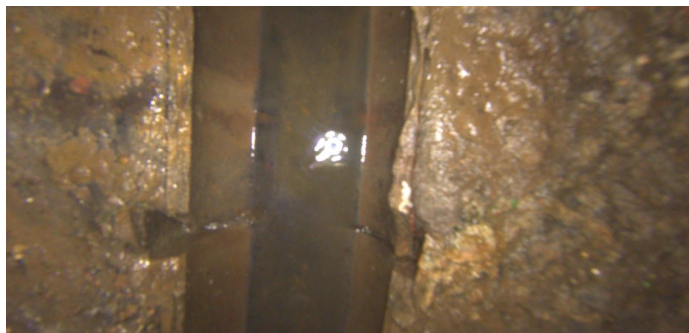
Code: **MGO**
Description: **General Observation**

Distance (ft): **8.5**
Structural Grade: **0**
O&M Grade: **0**
Clock Start/From:
Clock To:
1st Value:
2nd Value:
Value Percent:
Step: **NO**
Remarks: **END SURVEY**

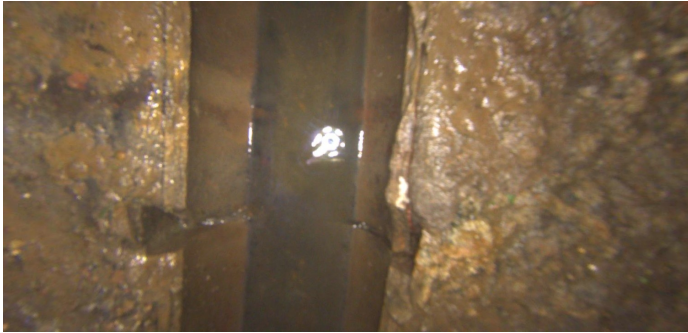
Code:	DSF
Description:	Deposits Settled Fine
Distance (ft):	8.5
Structural Grade:	0
O&M Grade:	2
Clock Start/From:	12
Clock To:	12
1st Value:	
2nd Value:	
Value Percent:	5.000
Step:	NO
Remarks:
