Manhole Inspection Report

O&M Index:	2.00	O&M Quick:	2100	O&M Rating:	2.00
Structural Index:	1.00	Structural Quick:	1100	Structural Rating:	1.00
Overall Index:	1.50	Overall Quick:	2111	Overall Rating:	3.00

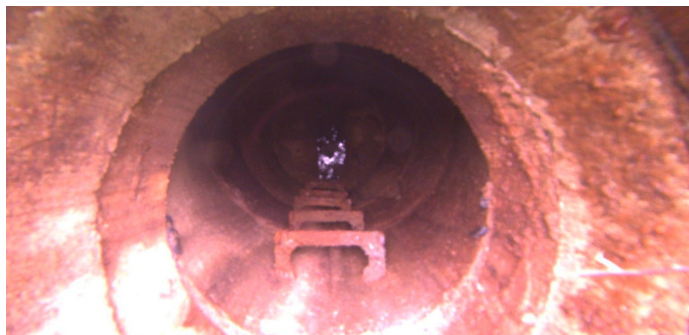
Code: **MGO**
Description: **General Observation**

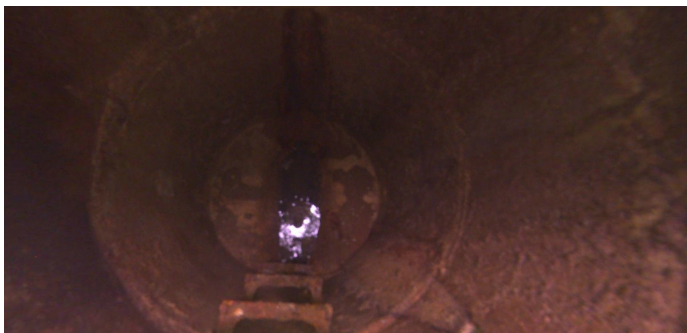
Code:	IS
Description:	Infil Stain
Distance (ft):	3.3
Structural Grade:	0
O&M Grade:	0
Clock Start/From:	4
Clock To:	
1st Value:	
2nd Value:	
Value Percent:	
Step:	NO
Remarks:

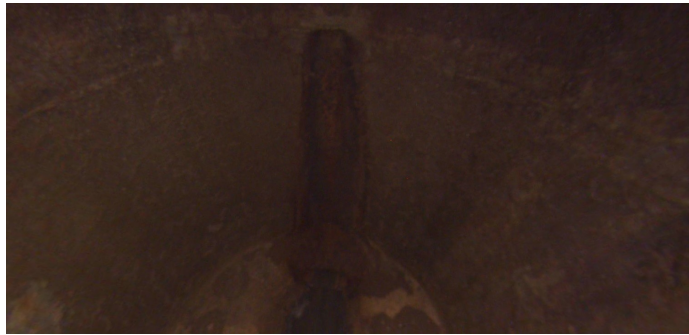
Code: **IW**
Description: **Infil Weeper**
