Manhole Inspection Report

Date:	10/08/2022	Weather:		Coding:	RZMACP
MH#:	M-804-070	Owner:	NA	Len. Surveyed:	6.8
P.O.#:		Surveyor:	Jen Costello	Rim to Invert:	7.7
Customer:		Cert. #:	U-907-5518	Wall Material:	Brick

Street:	Liberty St. 661' North of Hickey St.	Project:	Hobart, IN
City:	Hobart, IN	GPS Northing:	2292391.498
Location:	Other	GPS Easting:	2909062.128
Drain Area:	Northeast	GPS Accuracy:	Sub-Meter
Cover Shape:	Circular	Evidence of Surcharge:	Yes
Cover Size:	24.0	Potential for Runoff:	None
Comments:

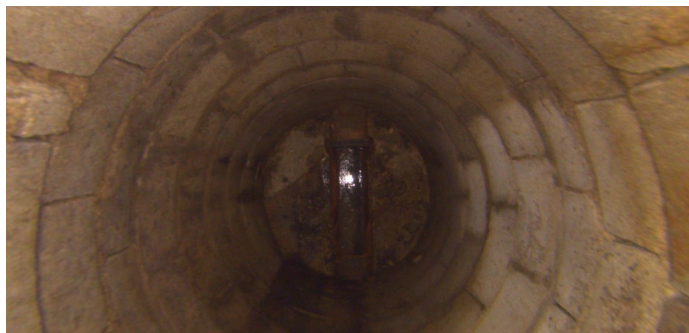
Code: **MGO**
Description: **General Observation**

Distance (ft): **.0**
Structural Grade: **0**
O&M Grade: **0**
Clock Start/From:
Clock To:
1st Value:
2nd Value:
Value Percent:
Step: **NO**
Remarks: **access mh**

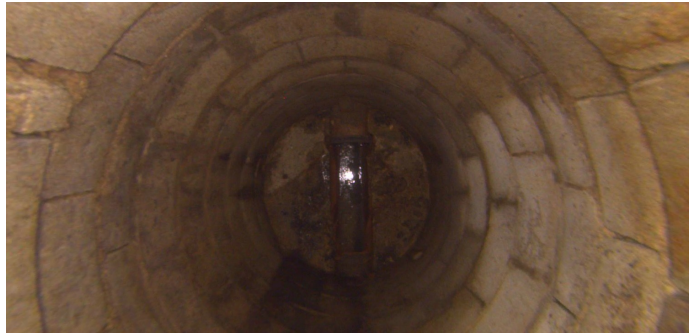
Code: **SAV**
 Description: **Surface Aggregate Visible**

Distance (ft): **.0**
 Structural Grade: **3**
 O&M Grade: **0**
 Clock Start/From: **12**
 Clock To: **12**
 1st Value:
 2nd Value:
 Value Percent:
 Step: **NO**
 Remarks:

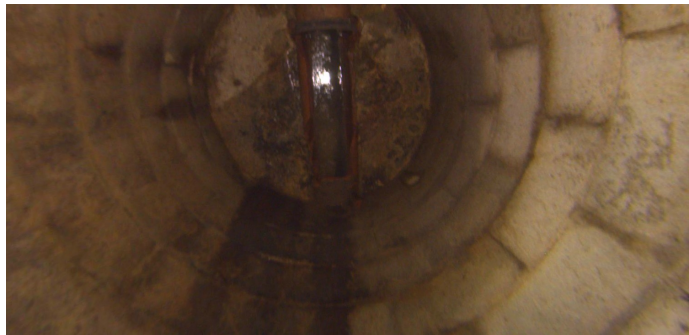
Code: **IW**
 Description: **Infil Weeper**

Distance (ft): **1.6**
 Structural Grade: **0**
 O&M Grade: **2**
 Clock Start/From: **6**
 Clock To: **9**
 1st Value:
 2nd Value:
 Value Percent:
 Step: **NO**
 Remarks:

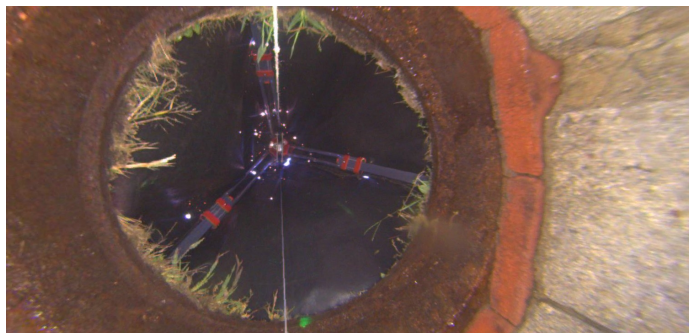
Code: **MGO**
 Description: **General Observation**

Distance (ft): **1.6**
 Structural Grade: **0**
 O&M Grade: **0**
 Clock Start/From:
 Clock To:
 1st Value:
 2nd Value:
 Value Percent:
 Step: **NO**
 Remarks: **underside of frame**

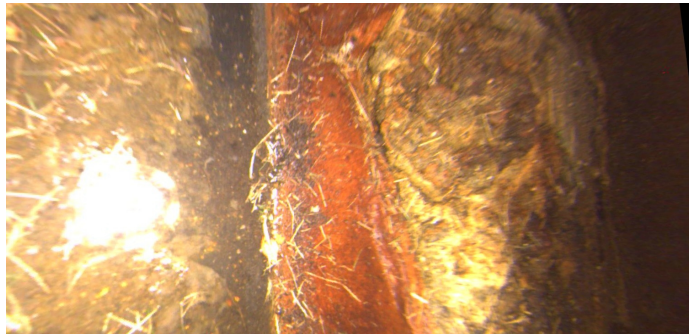
Code: **DSF**
Description: **Deposits Settled Fine**

Distance (ft): **6.3**
Structural Grade: **0**
O&M Grade: **2**
Clock Start/From: **12**
Clock To: **12**
1st Value:
2nd Value:
Value Percent: **5.000**
Step: **NO**
Remarks:

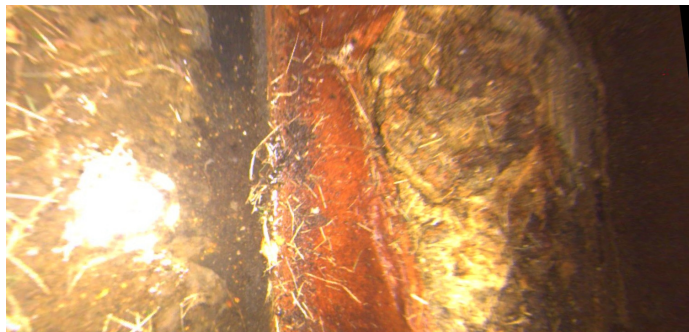
Code: **DB**
Description: **Displaced Brick**

Distance (ft): **6.3**
Structural Grade: **3**
O&M Grade: **0**
Clock Start/From: **2**
Clock To: **3**
1st Value:
2nd Value:
Value Percent:
Step: **NO**
Remarks:

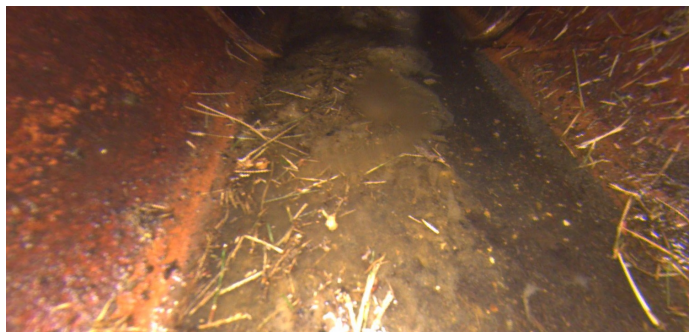
Code: **SAV**
Description: **Surface Aggregate Visible**

Distance (ft): **6.8**
Structural Grade: **3**
O&M Grade: **0**
Clock Start/From: **12**
Clock To: **12**
1st Value:
2nd Value:
Value Percent:
Step: **NO**
Remarks:

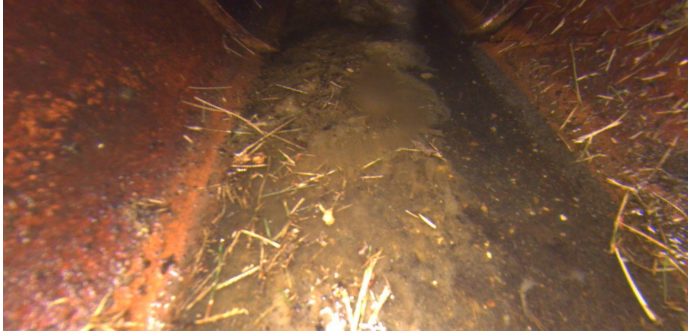
Code:	MGO
Description:	General Observation
Distance (ft):	6.8
Structural Grade:	0
O&M Grade:	0
Clock Start/From:	
Clock To:	
1st Value:	
2nd Value:	
Value Percent:	
Step:	NO
Remarks:	end of survey
