# Manhole Inspection Report

Date:	<b>03/28/2018</b>	Weather:		Coding:	<b>RZMACP</b>
MH#:	<b>M-804-072</b>	Owner:	<b>NA</b>	Len. Surveyed:	<b>3.1</b>
P.O.#:		Surveyor:	<b>John Kuglmaier</b>	Rim to Invert:	<b>3.9</b>
Customer:		Cert. #:	<b>U-1215-07002349</b>	Wall Material:	<b>Concrete (reinforced)</b>

Street:	<b>High St. 140' West of Indiana St.</b>	Project:	<b>Hobart, IN</b>
City:	<b>Hobart, IN</b>	GPS Northing:	<b>0.0</b>
Location:		GPS Easting:	<b>0.0</b>
Drain Area:	<b>Northeast</b>	GPS Accuracy:	<b>Nearest Meter</b>
Cover Shape:	<b>Circular</b>	Evidence of Surcharge:	<b>No</b>
Cover Size:	<b>23.0</b>	Potential for Runoff:	<b>None</b>
Comments:

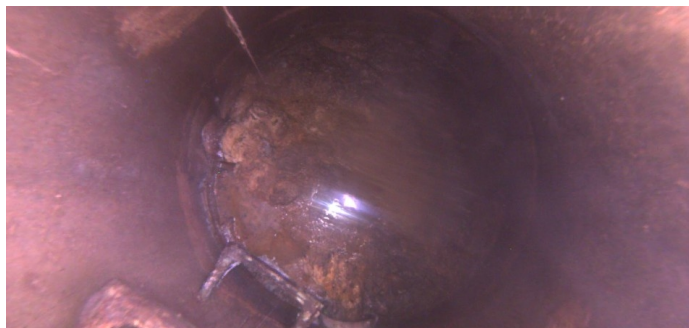
Code: **MGP**  
Description: **General Photo**

Distance (ft): **.0**  
Structural Grade: **0**  
O&M Grade: **0**  
Clock Start/From:  
Clock To:  
1st Value:  
2nd Value:  
Value Percent:  
Step: **NO**  
Remarks:

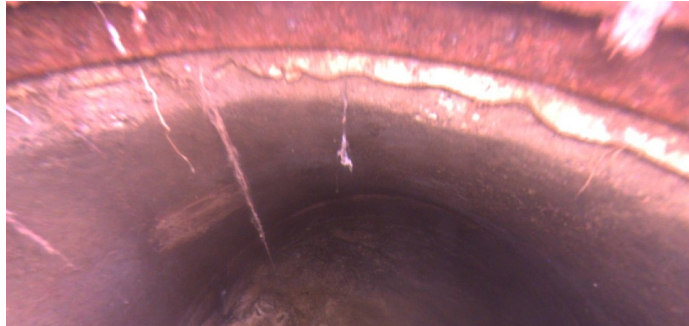
Code: **RFJ**  
Description: **Roots Fine Joint**

Distance (ft): **.0**  
Structural Grade: **0**  
O&M Grade: **1**  
Clock Start/From: **10**  
Clock To: **2**  
1st Value:  
2nd Value:  
Value Percent:  
Step: **NO**  
Remarks:

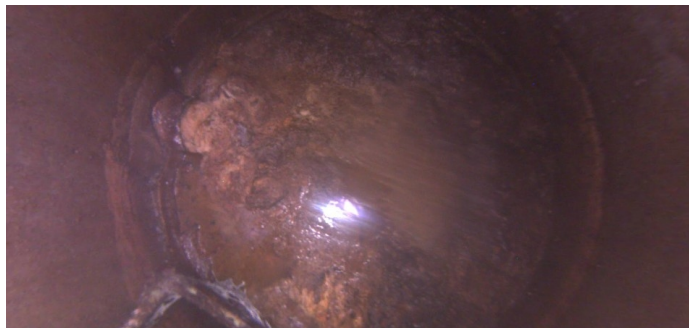
Code: **DAZ**  
Description: **Deposits Attached Other**

Distance (ft): **1.0**  
Structural Grade: **0**  
O&M Grade: **2**  
Clock Start/From: **12**  
Clock To: **12**  
1st Value:  
2nd Value:  
Value Percent: **10.000**  
Step: **NO**  
Remarks: **Mixed materials**

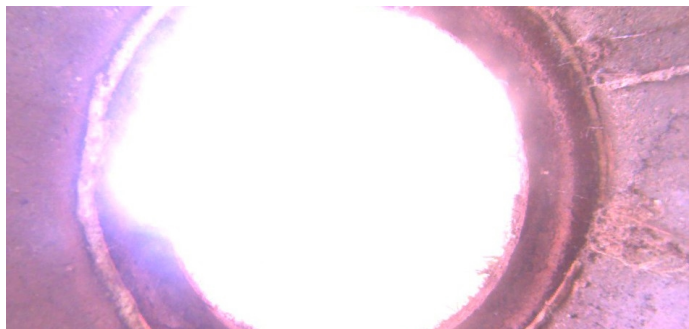
Code: **MGP**  
Description: **General Photo**

Distance (ft): **1.4**  
Structural Grade: **0**  
O&M Grade: **0**  
Clock Start/From:  
Clock To:  
1st Value:  
2nd Value:  
Value Percent:  
Step: **NO**  
Remarks:

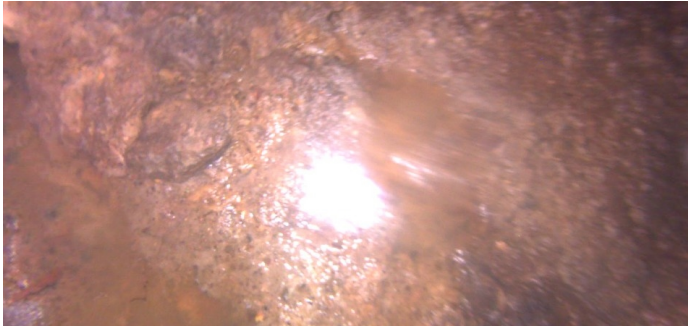
Code:	<b>MGO</b>
Description:	<b>General Observation</b>
Distance (ft):	<b>2.5</b>
Structural Grade:	<b>0</b>
O&M Grade:	<b>0</b>
Clock Start/From:	
Clock To:	
1st Value:	
2nd Value:	
Value Percent:	
Step:	<b>NO</b>
Remarks:	<b>Ins. Comp.</b>
