Manhole Inspection Report

Date:	05/09/2018	Weather:		Coding:	RZMACP
MH#:	M-805-005	Owner:	NA	Len. Surveyed:	15.1
P.O.#:		Surveyor:	Jen Costello	Rim to Invert:	16.5
Customer:		Cert. #:	U-907-5518	Wall Material:	Concrete (reinforced)

Street:	5th St. 164' East of Lawrence St.	Project:	Hobart, IN
City:	Hobart, IN	GPS Northing:	2909611.245
Location:		GPS Easting:	2909611.245
Drain Area:	Southeast	GPS Accuracy:	Sub-Meter
Cover Shape:	Circular	Evidence of Surcharge:	No
Cover Size:	22.5	Potential for Runoff:	None
Comments:

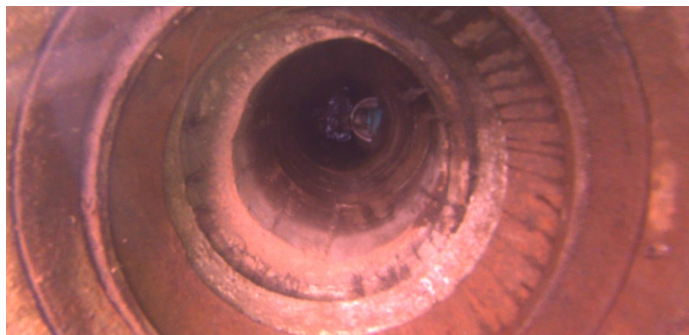
Code: **MGP**
Description: **General Photo**

Distance (ft): **.0**
Structural Grade: **0**
O&M Grade: **0**
Clock Start/From:
Clock To:
1st Value:
2nd Value:
Value Percent:
Step: **NO**
Remarks: **ACCESS MH**

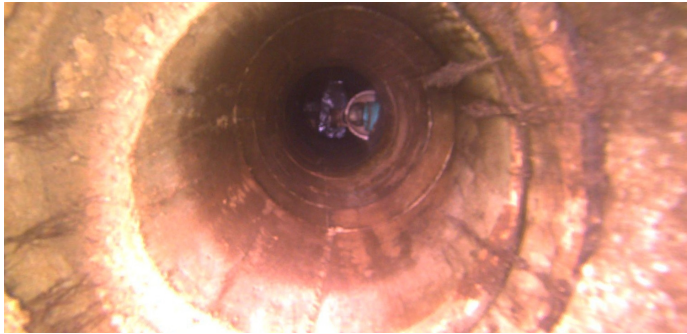
Code: **RFJ**
Description: **Roots Fine Joint**

Distance (ft): **1.0**
Structural Grade: **0**
O&M Grade: **1**
Clock Start/From: **12**
Clock To: **12**
1st Value:
2nd Value:
Value Percent:
Step: **NO**
Remarks:

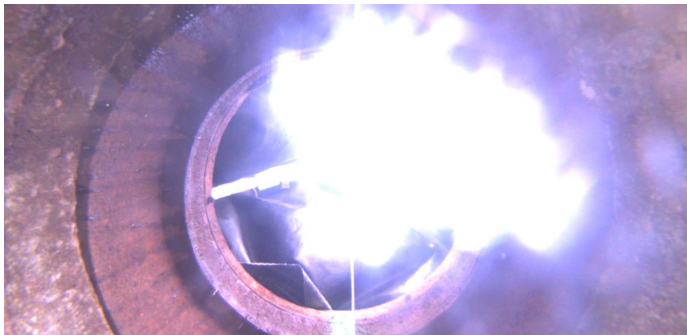
Code: **MGO**
Description: **General Observation**

Distance (ft): **2.7**
Structural Grade: **0**
O&M Grade: **0**
Clock Start/From:
Clock To:
1st Value:
2nd Value:
Value Percent:
Step: **NO**
Remarks: **UNDERSIDE OF FRAME**

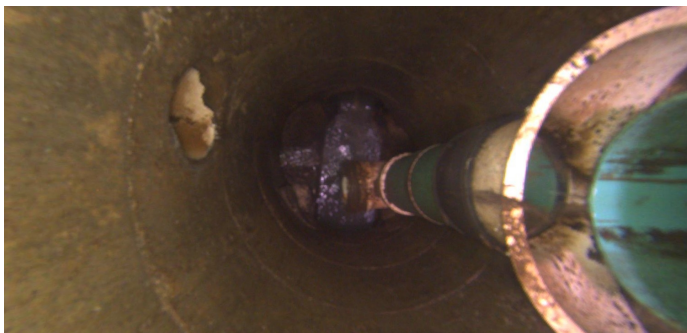
Code: **OBP**
Description: **Obstacle External Pipe or Cable**

Distance (ft): **10.1**
Structural Grade: **0**
O&M Grade: **2**
Clock Start/From: **3**
Clock To: **4**
1st Value:
2nd Value:
Value Percent: **10.000**
Step: **NO**
Remarks:

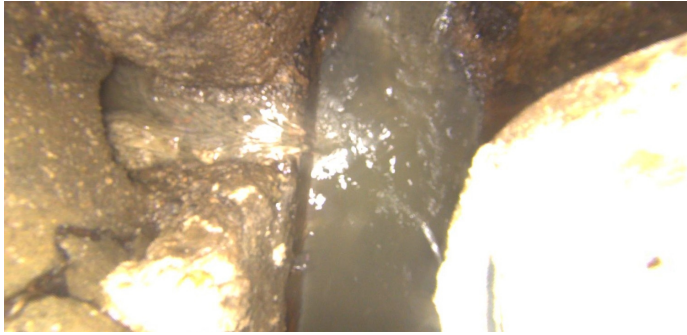
Code: **MGO**
Description: **General Observation**

Distance (ft): **15.1**
Structural Grade: **0**
O&M Grade: **0**
Clock Start/From:
Clock To:
1st Value:
2nd Value:
Value Percent:
Step: **NO**
Remarks: **END SURVEY**
