Manhole Inspection Report

Date:	05/09/2018	Weather:		Coding:	RZMACP
MH#:	M-805-006	Owner:	NA	Len. Surveyed:	9.4
P.O.#:		Surveyor:	Jen Costello	Rim to Invert:	7.9
Customer:		Cert. #:	U-907-5518	Wall Material:	Concrete (reinforced)

Street:	201' North of 5th St. East of Lawrenc	Project:	Hobart, IN
City:	Hobart, IN	GPS Northing:	2909611.803
Location:		GPS Easting:	2909611.803
Drain Area:	Southeast	GPS Accuracy:	Sub-Meter
Cover Shape:	Circular	Evidence of Surcharge:	No
Cover Size:	22.5	Potential for Runoff:	None
Comments:

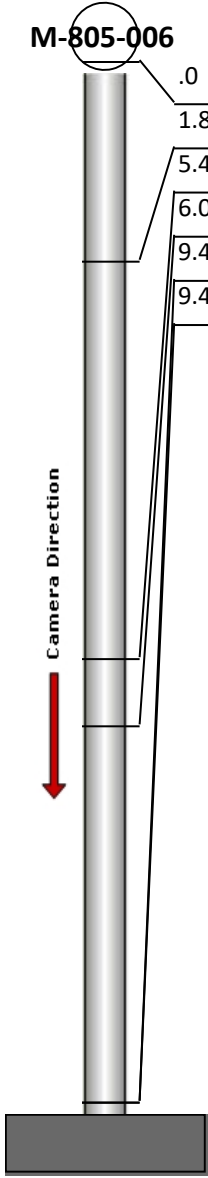
.0	MGP	General Photo	10	NA
	1.8	MGO	General Observation	27	NA
	5.4	CL	Crack Longitudinal	49	S 2
	6.0	IS	Infil Stain	61	NA
	9.4	DSGV	Deposits Settled Gravel	80	M 2
	9.4	MGO	General Observation	91	NA

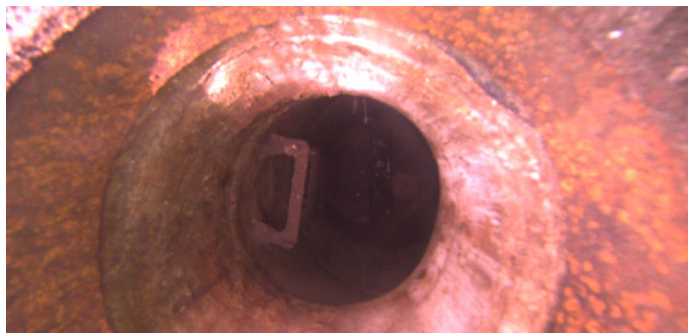
Code: **MGP**
Description: **General Photo**

Distance (ft): **.0**
Structural Grade: **0**
O&M Grade: **0**
Clock Start/From:
Clock To:
1st Value:
2nd Value:
Value Percent:
Step: **NO**
Remarks: **ACCESS MH**

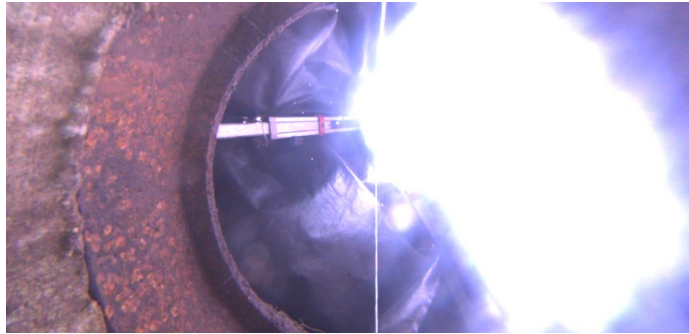
Code:	MGO
Description:	General Observation
Distance (ft):	1.8
Structural Grade:	0
O&M Grade:	0
Clock Start/From:	
Clock To:	
1st Value:	
2nd Value:	
Value Percent:	
Step:	NO
Remarks:	UNDERSIDE OF FRAME

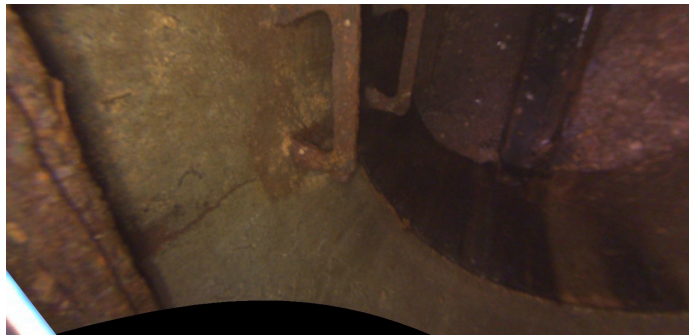
Code:	CL
Description:	Crack Longitudinal
Distance (ft):	5.4
Structural Grade:	2
O&M Grade:	0
Clock Start/From:	8
Clock To:	
1st Value:	
2nd Value:	
Value Percent:	
Step:	NO
Remarks:

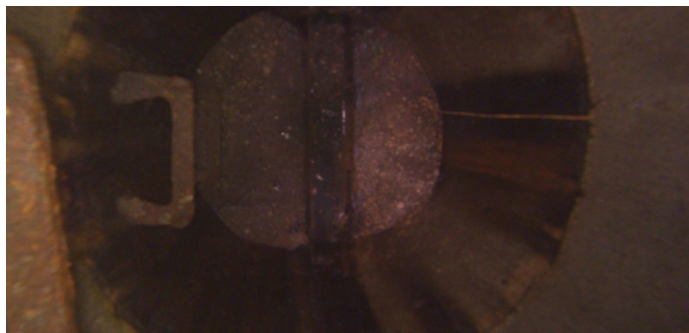
Code:	IS
Description:	Infil Stain
Distance (ft):	6.0
Structural Grade:	0
O&M Grade:	0
Clock Start/From:	12
Clock To:	12
1st Value:	
2nd Value:	
Value Percent:	
Step:	NO
Remarks:

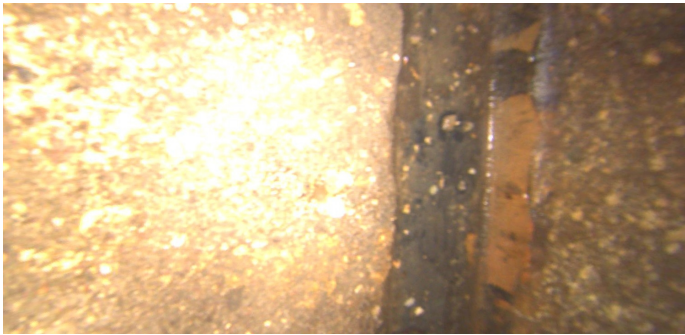
Code:	DSGV
Description:	Deposits Settled Gravel

Distance (ft):	9.4
Structural Grade:	0
O&M Grade:	2
Clock Start/From:	12
Clock To:	12
1st Value:	
2nd Value:	
Value Percent:	5.000
Step:	NO
Remarks:

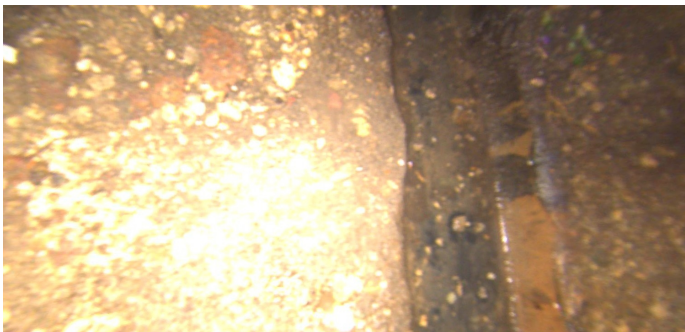
Code:	MGO
Description:	General Observation

Distance (ft):	9.4
Structural Grade:	0
O&M Grade:	0
Clock Start/From:	
Clock To:	
1st Value:	
2nd Value:	
Value Percent:	
Step:	NO
Remarks:	END SURVEY
