Manhole Inspection Report

Date:	05/09/2018	Weather:		Coding:	RZMACP
MH#:	M-805-007	Owner:	NA	Len. Surveyed:	7.7
P.O.#:		Surveyor:	Jen Costello	Rim to Invert:	7.9
Customer:		Cert. #:	U-907-5518	Wall Material:	Concrete (reinforced)

Street:	371' North of 5th St. East of Lawrenc	Project:	Hobart, IN
City:	Hobart, IN	GPS Northing:	2909610.76
Location:		GPS Easting:	2909610.76
Drain Area:	Southeast	GPS Accuracy:	Sub-Meter
Cover Shape:	Circular	Evidence of Surcharge:	No
Cover Size:	22.5	Potential for Runoff:	None
Comments:

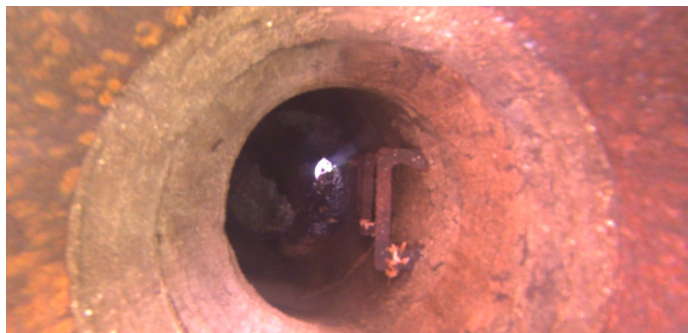
Code: **MGP**
Description: **General Photo**

Distance (ft): **.0**
Structural Grade: **0**
O&M Grade: **0**
Clock Start/From:
Clock To:
1st Value:
2nd Value:
Value Percent:
Step: **NO**
Remarks: **ACCESS MH**

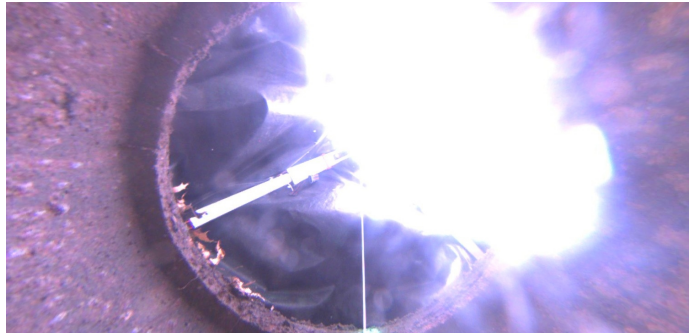
Code:	MGO
Description:	General Observation
Distance (ft):	1.4
Structural Grade:	0
O&M Grade:	0
Clock Start/From:	
Clock To:	
1st Value:	
2nd Value:	
Value Percent:	
Step:	NO
Remarks:	UNDERSIDE OF FRAME

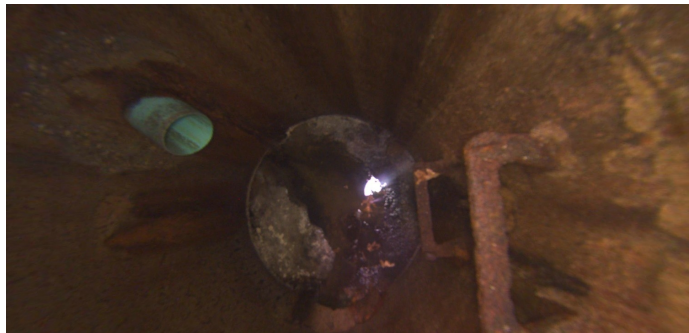
Code:	IW
Description:	Infil Weeper
Distance (ft):	4.3
Structural Grade:	0
O&M Grade:	2
Clock Start/From:	12
Clock To:	12
1st Value:	
2nd Value:	
Value Percent:	
Step:	NO
Remarks:

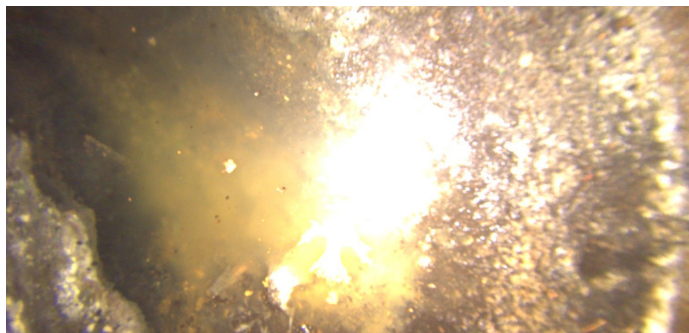
Code:	MGO
Description:	General Observation
Distance (ft):	7.7
Structural Grade:	0
O&M Grade:	0
Clock Start/From:	
Clock To:	
1st Value:	
2nd Value:	
Value Percent:	
Step:	NO
Remarks:	END SURVEY
