Manhole Inspection Report

Date:	05/09/2018	Weather:		Coding:	RZMACP
MH#:	M-805-014	Owner:	NA	Len. Surveyed:	9.2
P.O.#:		Surveyor:	Jen Costello	Rim to Invert:	9.4
Customer:		Cert. #:	U-907-5518	Wall Material:	Concrete (reinforced)

Street:	162' North of 5th St. East of Liberty	Project:	Hobart, IN
City:	Hobart, IN	GPS Northing:	2908946.097
Location:		GPS Easting:	2908946.097
Drain Area:	Southeast	GPS Accuracy:	Sub-Meter
Cover Shape:	Circular	Evidence of Surcharge:	No
Cover Size:	22.5	Potential for Runoff:	None
Comments:

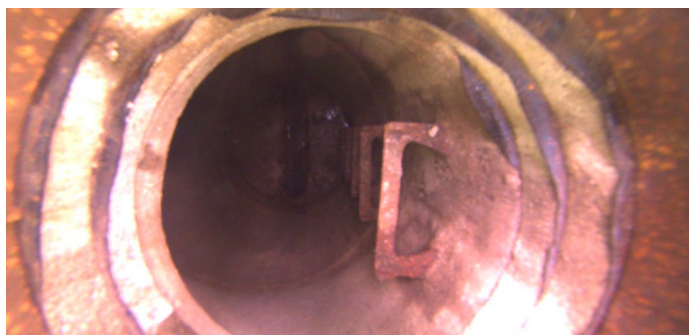
Code: **MGO**
Description: **General Observation**

Distance (ft): **.0**
Structural Grade: **0**
O&M Grade: **0**
Clock Start/From:
Clock To:
1st Value:
2nd Value:
Value Percent:
Step: **NO**
Remarks: **ACCESS MH**

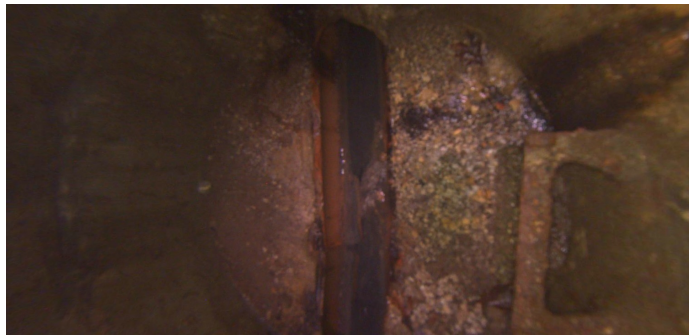
Code:	IW
Description:	Infil Weeper
Distance (ft):	6.9
Structural Grade:	0
O&M Grade:	2
Clock Start/From:	2
Clock To:	
1st Value:	
2nd Value:	
Value Percent:	
Step:	NO
Remarks:
