# Manhole Inspection Report

Date:	05/09/2018	Weather:		Coding:	RZMACP
MH#:	M-805-017	Owner:	NA	Len. Surveyed:	8.0
P.O.#:		Surveyor:	Jen Costello	Rim to Invert:	8.6
Customer:		Cert. #:	U-907-5518	Wall Material:	Concrete (reinforced)

Street:	224' South of 5th St. East of Joliet St.	Project:	Hobart, IN
City:	Hobart, IN	GPS Northing:	2908632.389
Location:		GPS Easting:	2908632.389
Drain Area:	Southeast	GPS Accuracy:	Sub-Meter
Cover Shape:	Circular	Evidence of Surcharge:	No
Cover Size:	22.5	Potential for Runoff:	None
Comments:

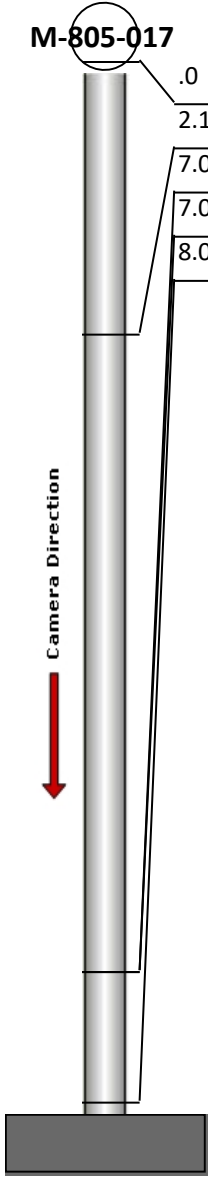
.0	MGP	General Photo	10	NA
	2.1	MGO	General Observation	28	NA
	7.0	IW	Infil Weeper	51	M 2
	7.0	DSF	Deposits Settled Fine	62	M 2
	8.0	MGO	General Observation	75	NA

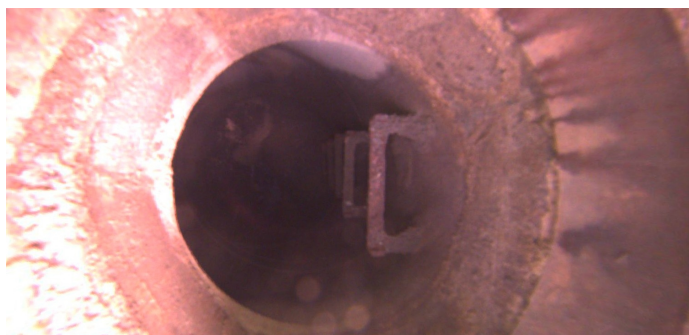
Code: **MGP**  
Description: **General Photo**

Distance (ft): **.0**  
Structural Grade: **0**  
O&M Grade: **0**  
Clock Start/From:  
Clock To:  
1st Value:  
2nd Value:  
Value Percent:  
Step: **NO**  
Remarks: **access MH**

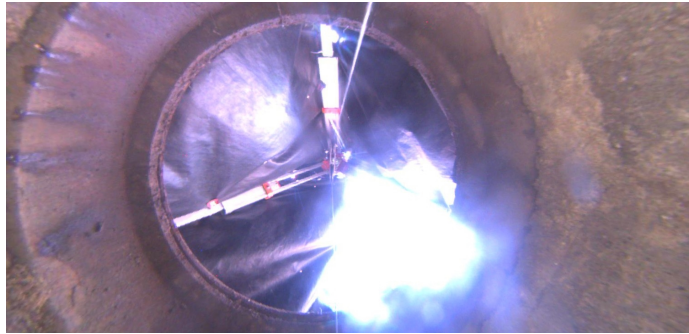
Code: **MGO**  
Description: **General Observation**

Distance (ft): **2.1**  
Structural Grade: **0**  
O&M Grade: **0**  
Clock Start/From:  
Clock To:  
1st Value:  
2nd Value:  
Value Percent:  
Step: **NO**  
Remarks: **UNDERSIDE OF FRAME**

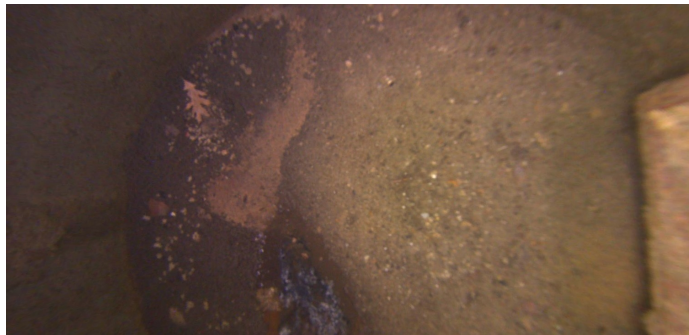
Code: **IW**  
Description: **Infil Weeper**

Distance (ft): **7.0**  
Structural Grade: **0**  
O&M Grade: **2**  
Clock Start/From: **9**  
Clock To:  
1st Value:  
2nd Value:  
Value Percent:  
Step: **NO**  
Remarks:

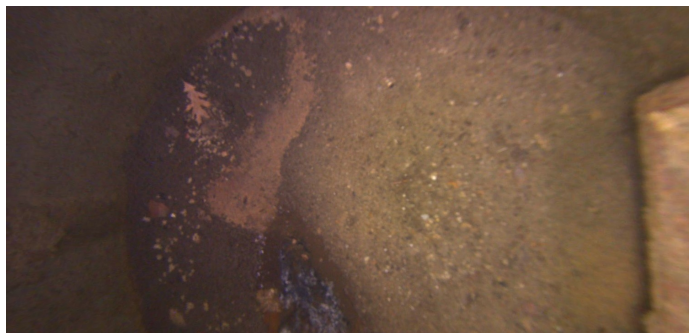
Code: **DSF**  
Description: **Deposits Settled Fine**

Distance (ft): **7.0**  
Structural Grade: **0**  
O&M Grade: **2**  
Clock Start/From: **7**  
Clock To: **12**  
1st Value:  
2nd Value:  
Value Percent: **5.000**  
Step: **NO**  
Remarks:

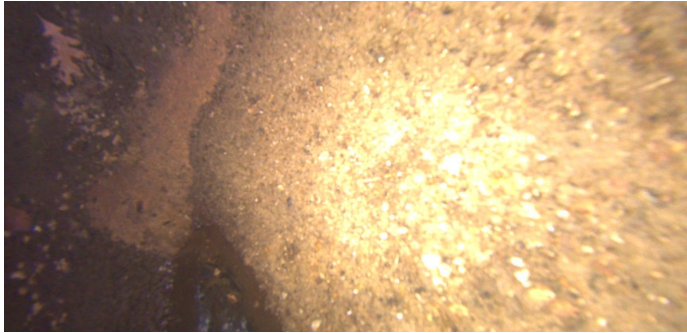
Code:	<b>MGO</b>
Description:	<b>General Observation</b>
Distance (ft):	<b>8.0</b>
Structural Grade:	<b>0</b>
O&M Grade:	<b>0</b>
Clock Start/From:	
Clock To:	
1st Value:	
2nd Value:	
Value Percent:	
Step:	<b>NO</b>
Remarks:	<b>END SURVEY</b>
