# Manhole Inspection Report

Date:	05/09/2018	Weather:		Coding:	RZMACP
MH#:	M-805-018	Owner:	NA	Len. Surveyed:	17.2
P.O.#:		Surveyor:	Jen Costello	Rim to Invert:	17.8
Customer:		Cert. #:	U-907-5518	Wall Material:	Concrete (reinforced)

Street:	5th St. 161' East of Joliet St.	Project:	Hobart, IN
City:	Hobart, IN	GPS Northing:	2908623.193
Location:		GPS Easting:	2908623.193
Drain Area:	Southeast	GPS Accuracy:	Sub-Meter
Cover Shape:	Circular	Evidence of Surcharge:	No
Cover Size:	22.5	Potential for Runoff:	None
Comments:

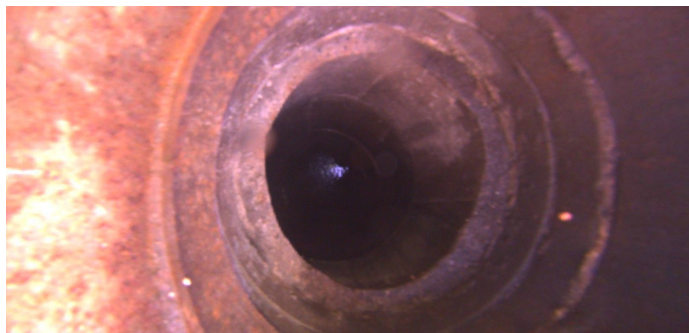
Code: **MGP**  
Description: **General Photo**

Distance (ft): **.0**  
Structural Grade: **0**  
O&M Grade: **0**  
Clock Start/From:  
Clock To:  
1st Value:  
2nd Value:  
Value Percent:  
Step: **NO**  
Remarks: **ACCESS MH**

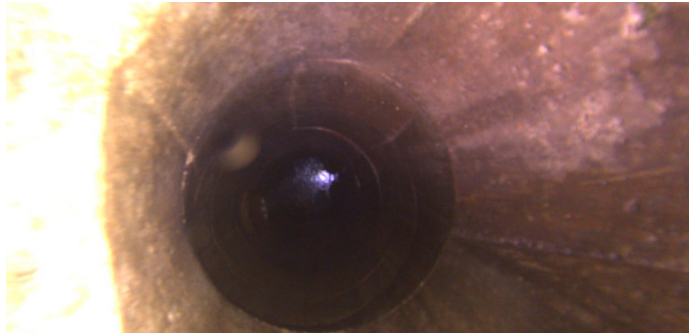
Code:	<b>SAV</b>
Description:	<b>Surface Aggregate Visible</b>
Distance (ft):	<b>1.5</b>
Structural Grade:	<b>3</b>
O&M Grade:	<b>0</b>
Clock Start/From:	<b>12</b>
Clock To:	<b>12</b>
1st Value:	
2nd Value:	
Value Percent:	
Step:	<b>NO</b>
Remarks:

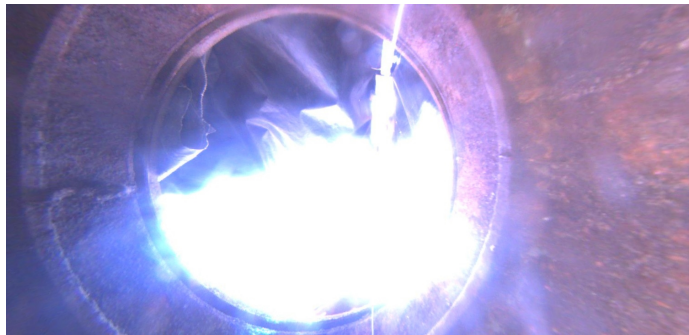
Code:	<b>MGO</b>
Description:	<b>General Observation</b>
Distance (ft):	<b>1.5</b>
Structural Grade:	<b>0</b>
O&M Grade:	<b>0</b>
Clock Start/From:	
Clock To:	
1st Value:	
2nd Value:	
Value Percent:	
Step:	<b>NO</b>
Remarks:	<b>UNDERSIDE OF FRAME</b>

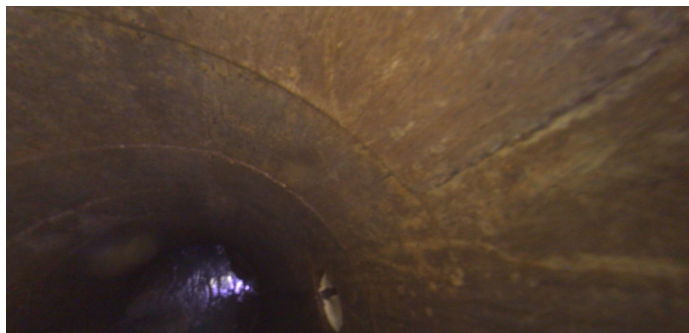
Code:	<b>FL</b>
Description:	<b>Fracture Longitudinal</b>
Distance (ft):	<b>7.5</b>
Structural Grade:	<b>3</b>
O&M Grade:	<b>0</b>
Clock Start/From:	<b>2</b>
Clock To:	
1st Value:	
2nd Value:	
Value Percent:	
Step:	<b>NO</b>
Remarks:

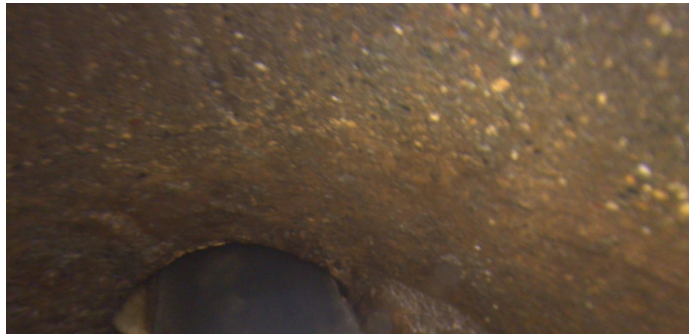
Code:	<b>SAV</b>
Description:	<b>Surface Aggregate Visible</b>
Distance (ft):	<b>15.6</b>
Structural Grade:	<b>3</b>
O&M Grade:	<b>0</b>
Clock Start/From:	<b>12</b>
Clock To:	<b>12</b>
1st Value:	
2nd Value:	
Value Percent:	
Step:	<b>NO</b>
Remarks:

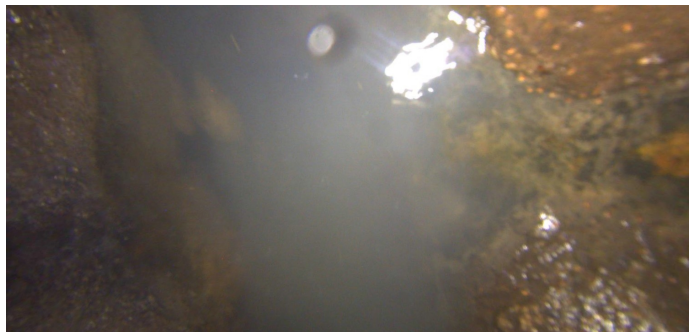
Code:	<b>MGO</b>
Description:	<b>General Observation</b>
Distance (ft):	<b>17.2</b>
Structural Grade:	<b>0</b>
O&M Grade:	<b>0</b>
Clock Start/From:	
Clock To:	
1st Value:	
2nd Value:	
Value Percent:	
Step:	<b>NO</b>
Remarks:	<b>END SURVEY</b>
