Manhole Inspection Report

Date:	09/30/2022	Weather:		Coding:	RZMACP
MH#:	M-805-020	Owner:	NA	Len. Surveyed:	8.5
P.O.#:		Surveyor:	Jen Costello	Rim to Invert:	9.8
Customer:		Cert. #:	U-907-5518	Wall Material:	Concrete (cast in place)

Street:	345' North of 5th St. East of Joliet St.	Project:	Hobart, IN
City:	Hobart, IN	GPS Northing:	2288800.776
Location:	Alley	GPS Easting:	2908620.183
Drain Area:	Southeast	GPS Accuracy:	Sub-Meter
Cover Shape:	Circular	Evidence of Surcharge:	No
Cover Size:	24.0	Potential for Runoff:	None
Comments:

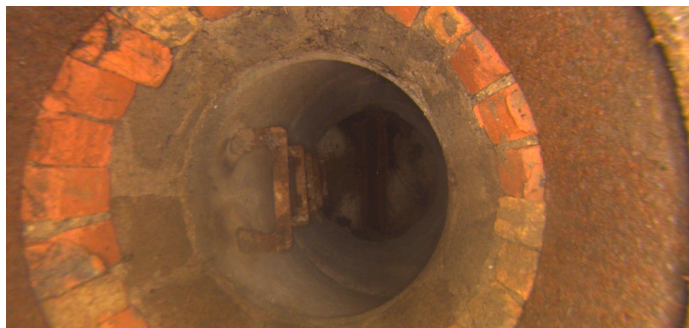
Code: **MGO**
Description: **General Observation**

Distance (ft): **.0**
Structural Grade: **0**
O&M Grade: **0**
Clock Start/From:
Clock To:
1st Value:
2nd Value:
Value Percent:
Step: **NO**
Remarks: **access mh**

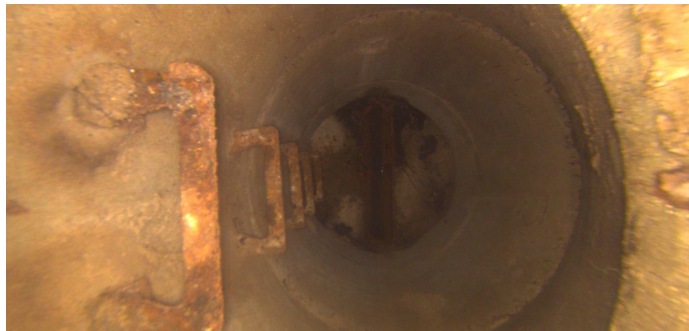
Code: **SRI**
Description: **Surface Roughness Increased**

Distance (ft): **1.5**
Structural Grade: **1**
O&M Grade: **0**
Clock Start/From: **12**
Clock To: **12**
1st Value:
2nd Value:
Value Percent:
Step: **NO**
Remarks:

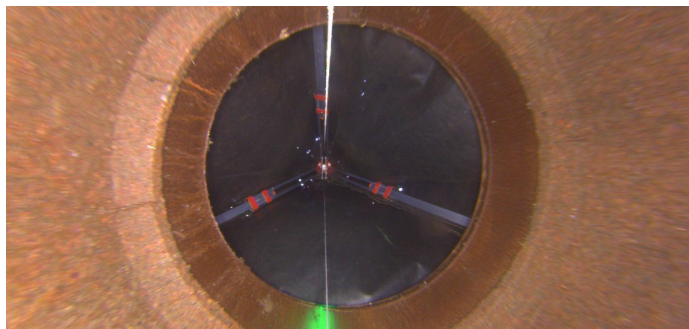
Code: **MGO**
Description: **General Observation**

Distance (ft): **1.5**
Structural Grade: **0**
O&M Grade: **0**
Clock Start/From:
Clock To:
1st Value:
2nd Value:
Value Percent:
Step: **NO**
Remarks: **underside of frame**

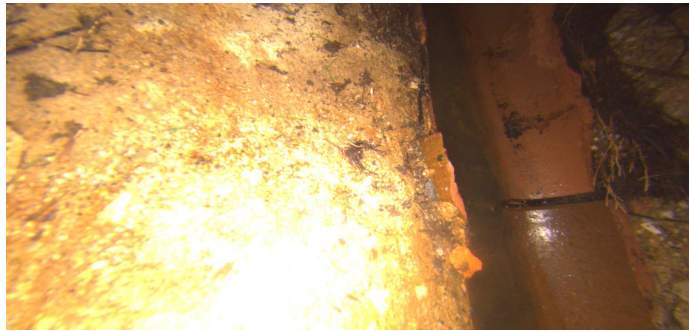
Code: **SAV**
Description: **Surface Aggregate Visible**

Distance (ft): **8.5**
Structural Grade: **3**
O&M Grade: **0**
Clock Start/From: **12**
Clock To: **12**
1st Value:
2nd Value:
Value Percent:
Step: **NO**
Remarks:

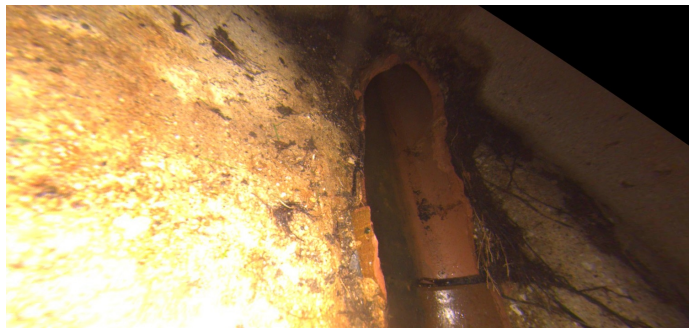
Code: **RFB**
Description: **Roots Fine Barrel**

Distance (ft): **8.5**
Structural Grade: **0**
O&M Grade: **2**
Clock Start/From: **12**
Clock To: **3**
1st Value:
2nd Value:
Value Percent:
Step: **NO**
Remarks:

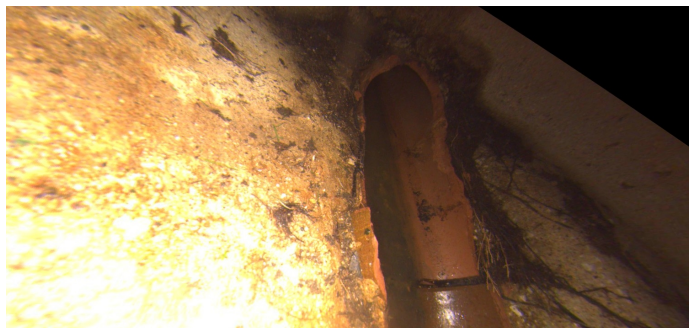
Code: **SRI**
Description: **Surface Roughness Increased**

Distance (ft): **8.5**
Structural Grade: **1**
O&M Grade: **0**
Clock Start/From: **12**
Clock To: **12**
1st Value:
2nd Value:
Value Percent:
Step: **NO**
Remarks:

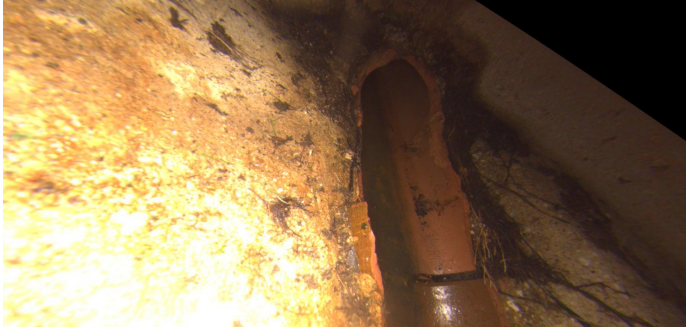
Code:	MGO
Description:	General Observation
Distance (ft):	8.5
Structural Grade:	0
O&M Grade:	0
Clock Start/From:	
Clock To:	
1st Value:	
2nd Value:	
Value Percent:	
Step:	NO
Remarks:	end of survey
