Date:	05/10/2018	Weather:		Coding:	RZMACP
MH#:	M-805-022	Owner:	NA	Len. Surveyed:	7.4
P.O.#:		Surveyor:	Jen Costello	Rim to Invert:	8.1
Customer:		Cert. #:	U-907-5518	Wall Material:	Concrete (reinforced)
Street:	84' North of 4th St	. East of Ohio St.	Project:	Hobart, IN	
City:	NA		GPS Northing:	2908304.337	
Location:			GPS Easting:	2908304.337	
Drain Area:	Southeast		GPS Accuracy:	Sub-Meter	
Cover Shape:	Circular		Evidence of Surcharge:	No	
Cover Size: Comments:	22.5		Potential for Runoff:	None	
O&M Index:	2.00	O&M Quick:	2100	O&M Rating:	2.00
Structural Index:	0.00	Structural Qu	iick: 0000	Structural Rating:	0.00
Overall Index:	2.00	Overall Quick	<: 2100	Overall Rating:	2.00

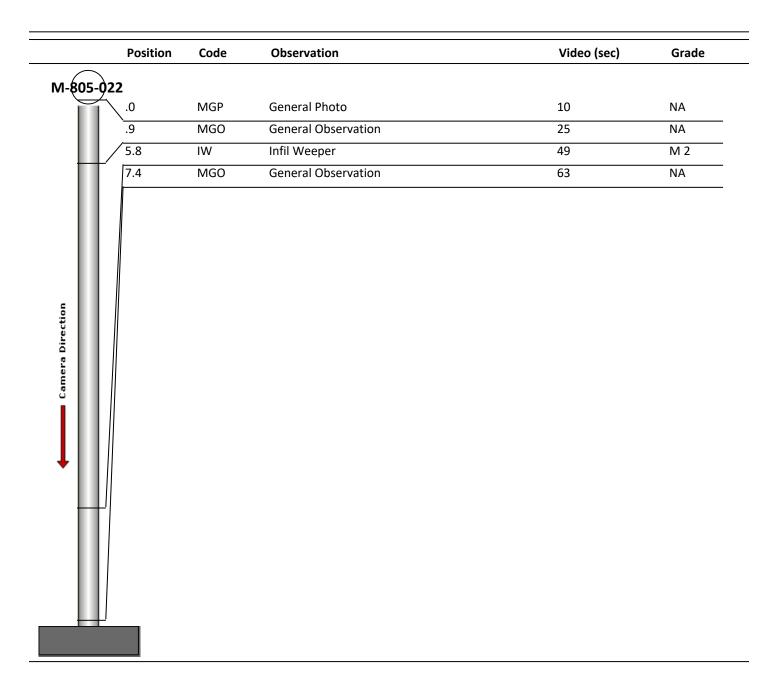
MGP	
General Photo	
_	
.0	
0	
0	
NO	
access mh

Code: Description:	MGO General Observation
Distance (ft):	.9
Distance (It).	.5
Structural Grade:	0
O&M Grade:	0
Clock Start/From:	
Clock To:	
1st Value:	
2nd Value:

underside of frame

IW Infil Weeper
5.8
0
2
9
NO
