Manhole Inspection Report

Date:	04/29/2018	Weather:		Coding:	RZMACP
MH#:	M-805-030	Owner:	NA	Len. Surveyed:	15.1
P.O.#:		Surveyor:	Jen Costello	Rim to Invert:	15.5
Customer:		Cert. #:	U-907-5518	Wall Material:	Brick

Street:	Intersection of Indiana St. and 6th St	Project:	Hobart, IN
City:	Hobart, IN	GPS Northing:	41.52909851
Location:		GPS Easting:	-87.24740601
Drain Area:	Southeast	GPS Accuracy:	Nearest Meter
Cover Shape:	Circular	Evidence of Surcharge:	No
Cover Size:	22.5	Potential for Runoff:	None
Comments:

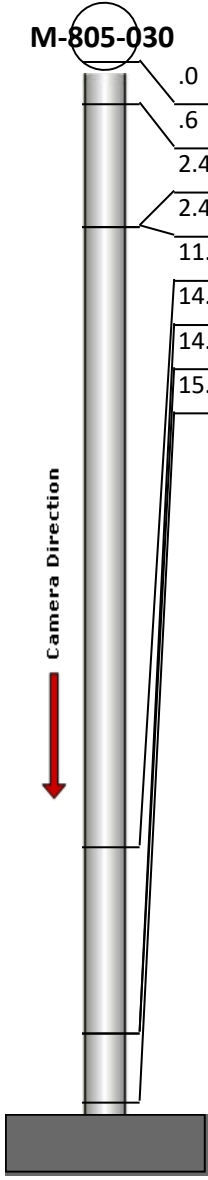
.0	MGO	General Observation	10	NA
	.6	FM	Fracture Multiple	23	S 4
	2.4	SRV	Surface Reinforcement Visible	38	S 5
	2.4	MGO	General Observation	51	NA
	11.4	SAV	Surface Aggregate Visible	83	S 3
	14.1	IW	Infil Weeper	100	M 2
	14.1	DAE	Deposits Attached Encrustation	111	M 2
	15.1	MGO	General Observation	125	NA

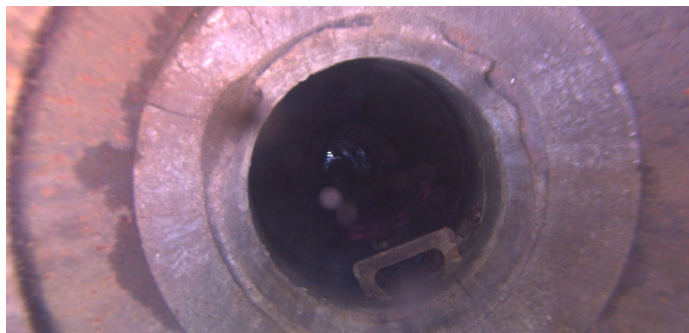
Code: **MGO**
Description: **General Observation**

Distance (ft): **.0**
Structural Grade: **0**
O&M Grade: **0**
Clock Start/From:
Clock To:
1st Value:
2nd Value:
Value Percent:
Step: **NO**
Remarks: **access MH**

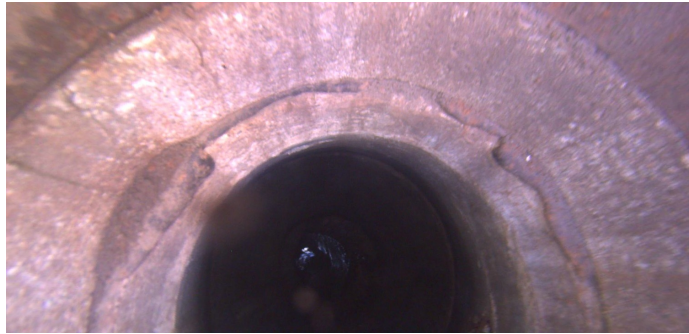
Code: **FM**
Description: **Fracture Multiple**

Distance (ft): **.6**
Structural Grade: **4**
O&M Grade: **0**
Clock Start/From: **10**
Clock To: **2**
1st Value:
2nd Value:
Value Percent:
Step: **NO**
Remarks:

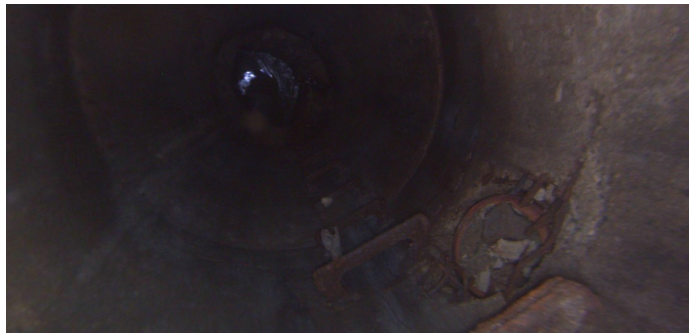
Code: **SRV**
Description: **Surface Reinforcement Visible**

Distance (ft): **2.4**
Structural Grade: **5**
O&M Grade: **0**
Clock Start/From: **4**
Clock To: **5**
1st Value:
2nd Value:
Value Percent:
Step: **NO**
Remarks:

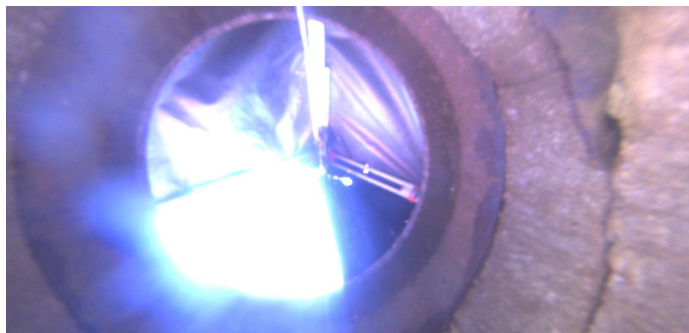
Code: **MGO**
Description: **General Observation**

Distance (ft): **2.4**
Structural Grade: **0**
O&M Grade: **0**
Clock Start/From:
Clock To:
1st Value:
2nd Value:
Value Percent:
Step: **NO**
Remarks: **UNDERSIDE OF FRAME**

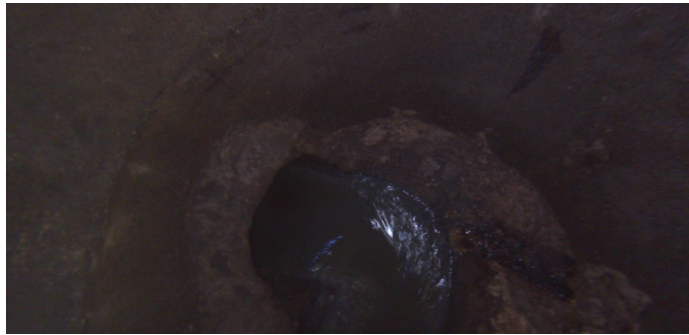
Code: **SAV**
Description: **Surface Aggregate Visible**

Distance (ft): **11.4**
Structural Grade: **3**
O&M Grade: **0**
Clock Start/From: **12**
Clock To: **12**
1st Value:
2nd Value:
Value Percent:
Step: **NO**
Remarks:

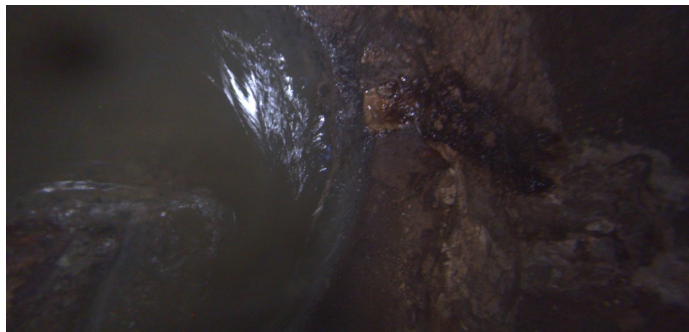
Code: **IW**
Description: **Infil Weeper**

Distance (ft): **14.1**
Structural Grade: **0**
O&M Grade: **2**
Clock Start/From: **2**
Clock To:
1st Value:
2nd Value:
Value Percent:
Step: **NO**
Remarks:

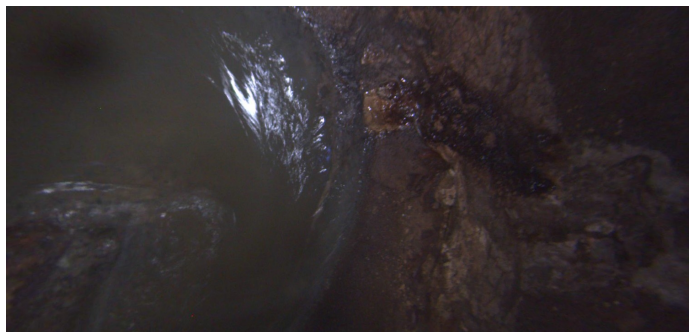
Code: **DAE**
Description: **Deposits Attached Encrustation**

Distance (ft): **14.1**
Structural Grade: **0**
O&M Grade: **2**
Clock Start/From: **3**
Clock To: **4**
1st Value:
2nd Value:
Value Percent: **10.000**
Step: **NO**
Remarks:

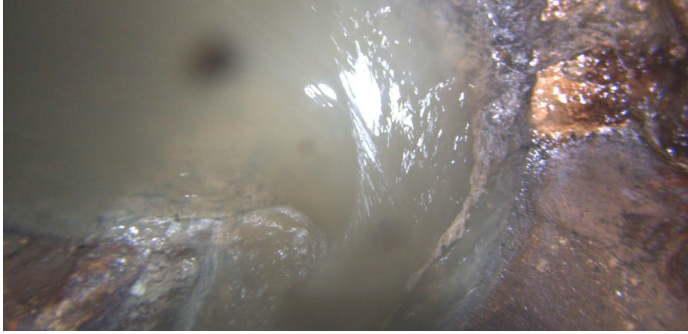
Code:	MGO
Description:	General Observation
Distance (ft):	15.1
Structural Grade:	0
O&M Grade:	0
Clock Start/From:	
Clock To:	
1st Value:	
2nd Value:	
Value Percent:	
Step:	NO
Remarks:	END SURVEY
