Manhole Inspection Report

Date:	05/03/2018	Weather:		Coding:	RZMACP
MH#:	M-805-031	Owner:	NA	Len. Surveyed:	15.2
P.O.#:		Surveyor:	Jen Costello	Rim to Invert:	17.5
Customer:		Cert. #:	U-907-5518	Wall Material:	Concrete (reinforced)

Street:	Indiana St. 347' North of 6th St.	Project:	Hobart, IN
City:	Hobart, IN	GPS Northing:	2907809.246
Location:		GPS Easting:	2907809.246
Drain Area:	Southeast	GPS Accuracy:	Sub-Meter
Cover Shape:	Circular	Evidence of Surcharge:	No
Cover Size:	22.5	Potential for Runoff:	None
Comments:

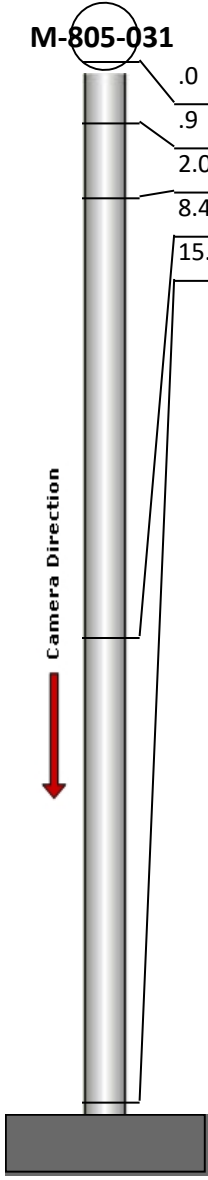
Position	Code	Observation	Video (sec)	Grade

.0	MGP	General Photo	10	NA
	.9	FM	Fracture Multiple	23	S 4
	2.0	MGO	General Observation	39	NA
	8.4	IW	Infil Weeper	66	M 2
	15.2	MGO	General Observation	91	NA

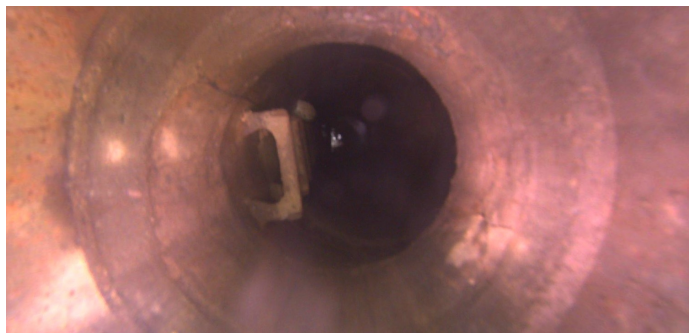
Code: **MGP**
Description: **General Photo**

Distance (ft): **.0**
Structural Grade: **0**
O&M Grade: **0**
Clock Start/From:
Clock To:
1st Value:
2nd Value:
Value Percent:
Step: **NO**
Remarks: **ACCESS MH**

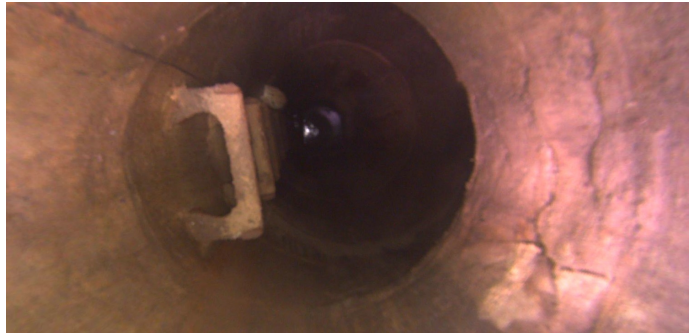
Code: **FM**
Description: **Fracture Multiple**

Distance (ft): **.9**
Structural Grade: **4**
O&M Grade: **0**
Clock Start/From: **3**
Clock To: **4**
1st Value:
2nd Value:
Value Percent:
Step: **NO**
Remarks:

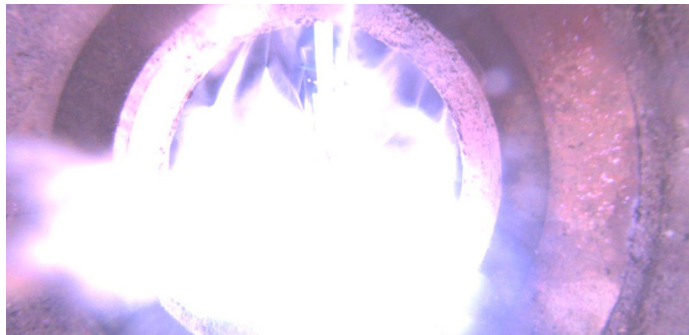
Code: **MGO**
Description: **General Observation**

Distance (ft): **2.0**
Structural Grade: **0**
O&M Grade: **0**
Clock Start/From:
Clock To:
1st Value:
2nd Value:
Value Percent:
Step: **NO**
Remarks: **UNDERSIDE OF FRAME**

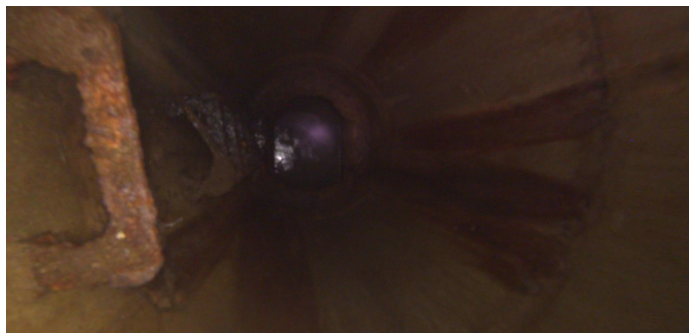
Code: **IW**
Description: **Infil Weeper**

Distance (ft): **8.4**
Structural Grade: **0**
O&M Grade: **2**
Clock Start/From: **12**
Clock To: **12**
1st Value:
2nd Value:
Value Percent:
Step: **NO**
Remarks:

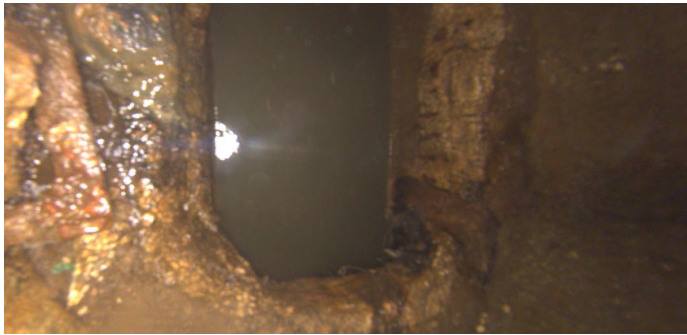
Code: **MGO**
Description: **General Observation**

Distance (ft): **15.2**

Remarks: **END SURVEY**
