Manhole Inspection Report

O&M Index:	2.00	O&M Quick:	2200	O&M Rating:	4.00
Structural Index:	0.00	Structural Quick:	0000	Structural Rating:	0.00
Overall Index:	2.00	Overall Quick:	2200	Overall Rating:	4.00

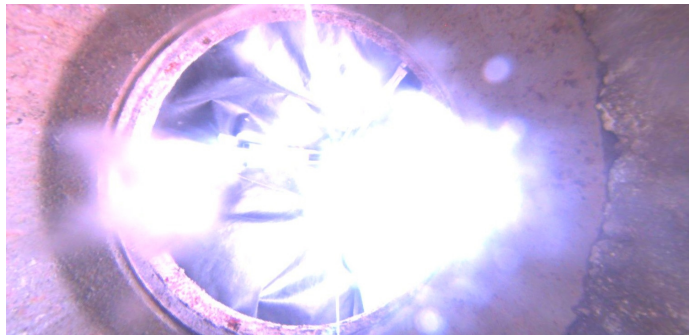
Code: **MGO**
Description: **General Observation**
