# Manhole Inspection Report

Date:	05/03/2018	Weather:		Coding:	RZMACP
MH#:	M-805-035	Owner:	NA	Len. Surveyed:	14.4
P.O.#:		Surveyor:	Jen Costello	Rim to Invert:	14.5
Customer:		Cert. #:	U-907-5518	Wall Material:	Concrete (reinforced)

Street:	Indiana St. 32' South of 4th St.	Project:	Hobart, IN
City:	Hobart, IN	GPS Northing:	2907816.002
Location:		GPS Easting:	2907816.002
Drain Area:	South	GPS Accuracy:	Sub-Meter
Cover Shape:	Circular	Evidence of Surcharge:	No
Cover Size:	22.5	Potential for Runoff:	None
Comments:

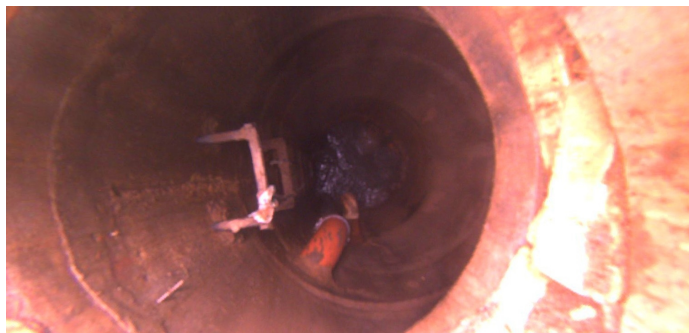
Code: **MGP**  
Description: **General Photo**

Distance (ft): **.0**  
Structural Grade: **0**  
O&M Grade: **0**  
Clock Start/From:  
Clock To:  
1st Value:  
2nd Value:  
Value Percent:  
Step: **NO**  
Remarks: **ACCESS MH**

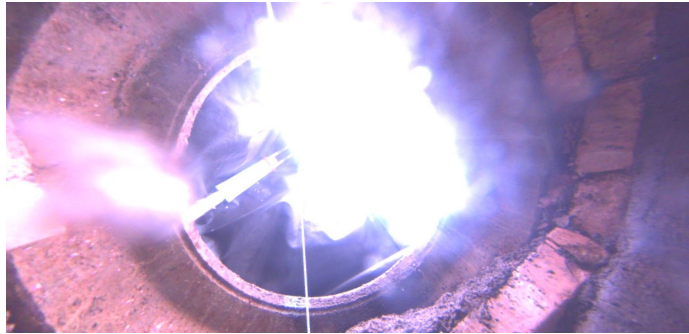
Code:	<b>MGO</b>
Description:	<b>General Observation</b>
Distance (ft):	<b>1.6</b>
Structural Grade:	<b>0</b>
O&M Grade:	<b>0</b>
Clock Start/From:	
Clock To:	
1st Value:	
2nd Value:	
Value Percent:	
Step:	<b>NO</b>
Remarks:	<b>UNDERSIDE OF FRAME</b>

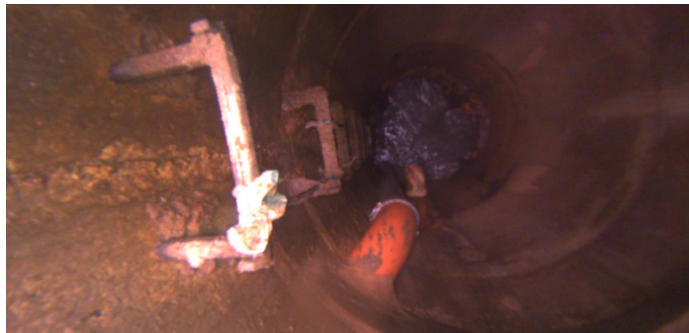
Code:	<b>FL</b>
Description:	<b>Fracture Longitudinal</b>
Distance (ft):	<b>1.6</b>
Structural Grade:	<b>3</b>
O&M Grade:	<b>0</b>
Clock Start/From:	<b>9</b>
Clock To:	
1st Value:	
2nd Value:	
Value Percent:	
Step:	<b>NO</b>
Remarks:

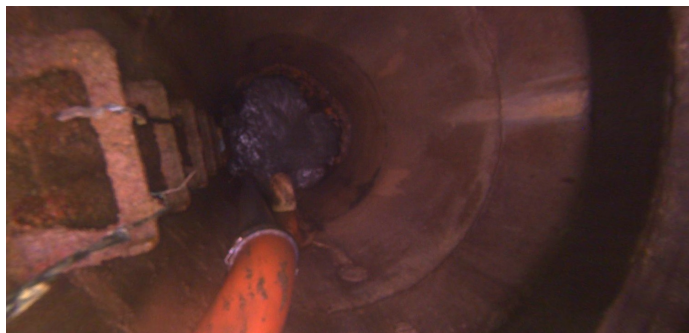
Code:	<b>OBP</b>
Description:	<b>Obstacle External Pipe or Cable</b>
Distance (ft):	<b>2.8</b>
Structural Grade:	<b>0</b>
O&M Grade:	<b>2</b>
Clock Start/From:	<b>7</b>
Clock To:	
1st Value:	
2nd Value:	
Value Percent:	<b>10.000</b>
Step:	<b>NO</b>
Remarks:

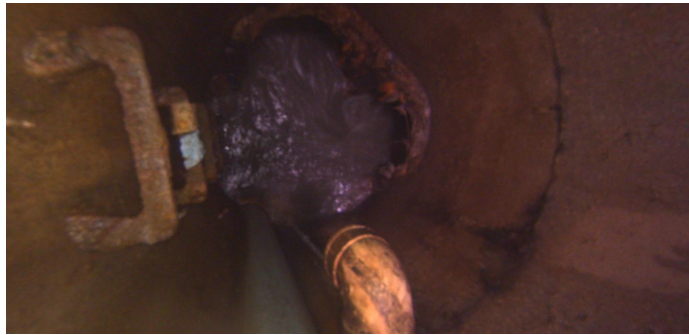
Code: **OBP**  
Description: **Obstacle External Pipe or Cable**

Distance (ft): **7.7**  
Structural Grade: **0**  
O&M Grade: **2**  
Clock Start/From: **6**  
Clock To:  
1st Value:  
2nd Value:  
Value Percent: **5.000**  
Step: **NO**  
Remarks:

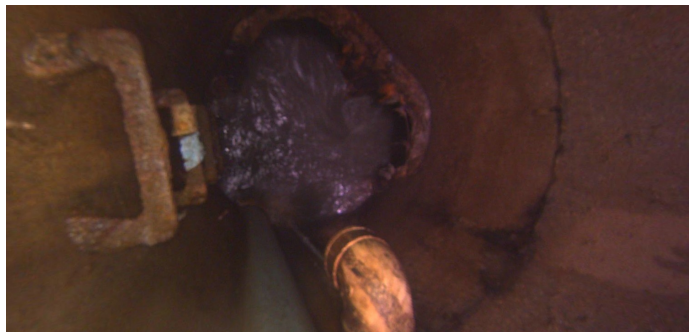
Code: **RFJ**  
Description: **Roots Fine Joint**

Distance (ft): **7.7**  
Structural Grade: **0**  
O&M Grade: **1**  
Clock Start/From: **5**  
Clock To: **6**  
1st Value:  
2nd Value:  
Value Percent:  
Step: **NO**  
Remarks:

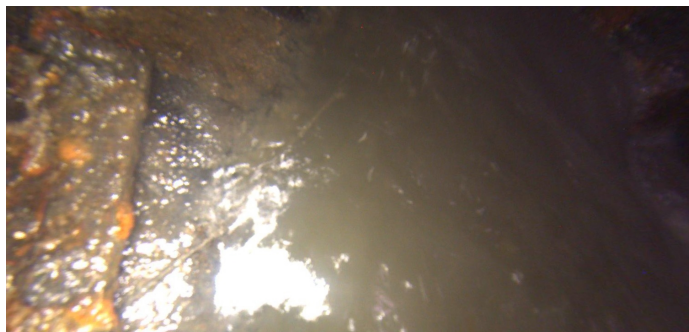
Code: **MGO**  
Description: **General Observation**

Distance (ft): **14.4**  
Structural Grade: **0**  
O&M Grade: **0**  
Clock Start/From:  
Clock To:  
1st Value:  
2nd Value:  
Value Percent:  
Step: **NO**  
Remarks: **END SURVEY**
