# Manhole Inspection Report

Date:	<b>05/07/2018</b>	Weather:		Coding:	<b>RZMACP</b>
MH#:	<b>M-805-036.1</b>	Owner:	<b>NA</b>	Len. Surveyed:	<b>3.4</b>
P.O.#:		Surveyor:	<b>Jen Costello</b>	Rim to Invert:	<b>3.8</b>
Customer:		Cert. #:	<b>U-907-5518</b>	Wall Material:	<b>Concrete (reinforced)</b>

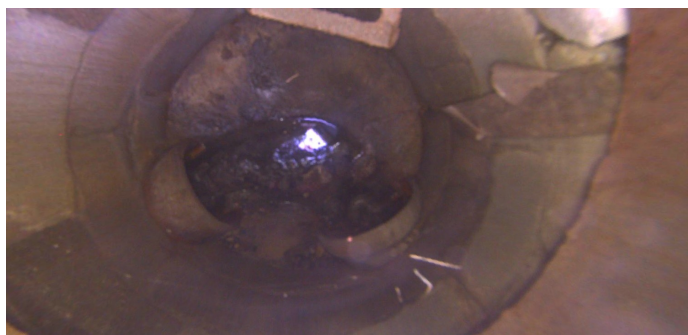
Code: **RFJ**  
Description: **Roots Fine Joint**

Distance (ft): **.0**  
Structural Grade: **0**  
O&M Grade: **1**  
Clock Start/From: **5**  
Clock To:  
1st Value:  
2nd Value:  
Value Percent:  
Step: **NO**  
Remarks:

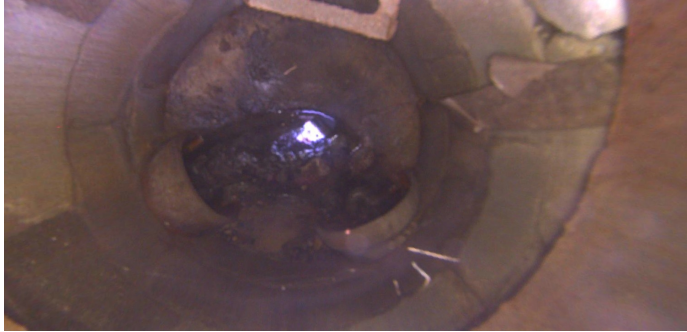
Code: **MGO**  
Description: **General Observation**

Distance (ft): **.0**  
Structural Grade: **0**  
O&M Grade: **0**  
Clock Start/From:  
Clock To:  
1st Value:  
2nd Value:  
Value Percent:  
Step: **NO**  
Remarks: **ACCESS MH**

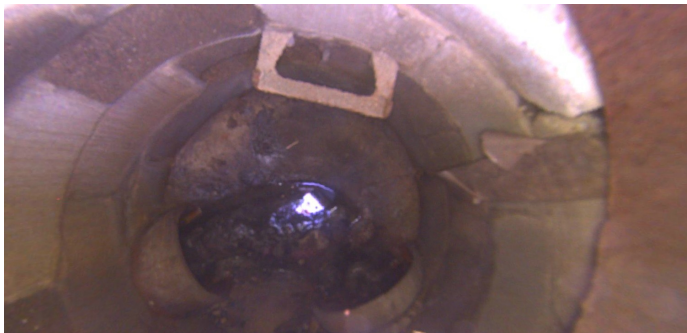
Code: **DAR**  
Description: **Deposits Attached Ragging**

Distance (ft): **.0**  
Structural Grade: **0**  
O&M Grade: **2**  
Clock Start/From: **3**  
Clock To:  
1st Value:  
2nd Value:  
Value Percent: **5.000**  
Step: **NO**  
Remarks:

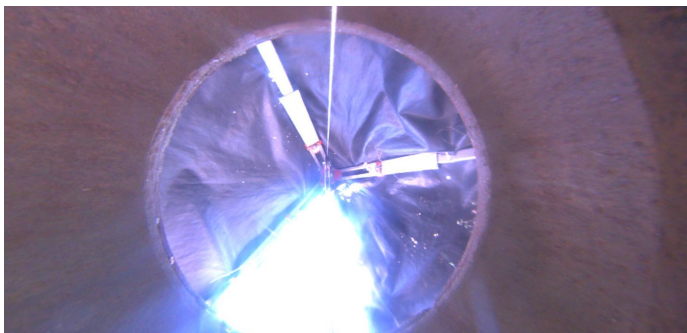
Code: **MGO**  
Description: **General Observation**

Distance (ft): **1.4**  
Structural Grade: **0**  
O&M Grade: **0**  
Clock Start/From:  
Clock To:  
1st Value:  
2nd Value:  
Value Percent:  
Step: **NO**  
Remarks: **UNDERSIDE OF FRAME**

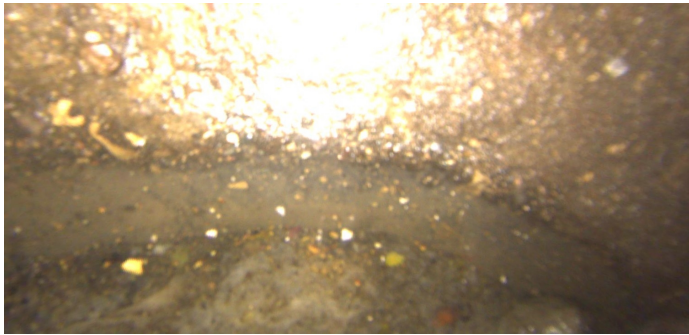
Code:	<b>MGO</b>
Description:	<b>General Observation</b>
Distance (ft):	<b>3.4</b>
Structural Grade:	<b>0</b>
O&M Grade:	<b>0</b>
Clock Start/From:	
Clock To:	
1st Value:	
2nd Value:	
Value Percent:	
Step:	<b>NO</b>
Remarks:	<b>END SURVEY</b>
