Manhole Inspection Report

Street:	Joliet St. and Devonshire St. to the E	Project:	Hobart, IN
City:	Hobart, IN	GPS Northing:	2908930.12
Location:		GPS Easting:	2908930.12
Drain Area:	South	GPS Accuracy:	Sub-Meter
Cover Shape:	Circular	Evidence of Surcharge:	No
Cover Size:	22.5	Potential for Runoff:	None
Comments:

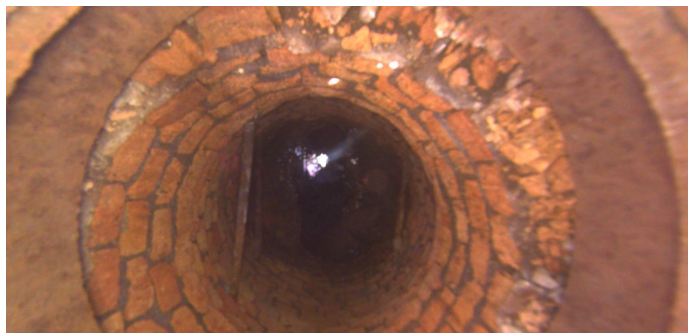
Code: **MGP**
 Description: **General Photo**

Distance (ft): **.0**
 Structural Grade: **0**
 O&M Grade: **0**
 Clock Start/From:
 Clock To:
 1st Value:
 2nd Value:
 Value Percent:
 Step: **NO**
 Remarks: **ACCESS MH**

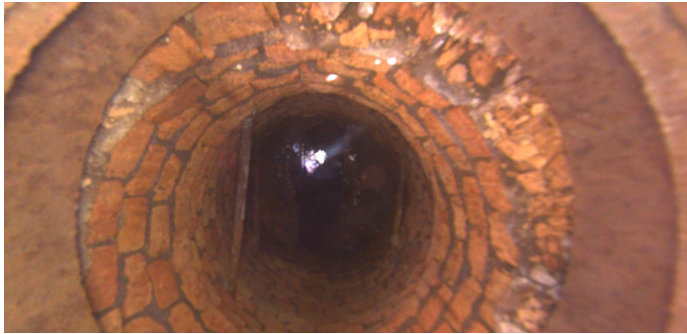
Code: **B**
Description: **Broken**

Distance (ft): **.0**
Structural Grade: **5**
O&M Grade: **0**
Clock Start/From: **12**
Clock To: **4**
1st Value:
2nd Value:
Value Percent:
Step: **NO**
Remarks:

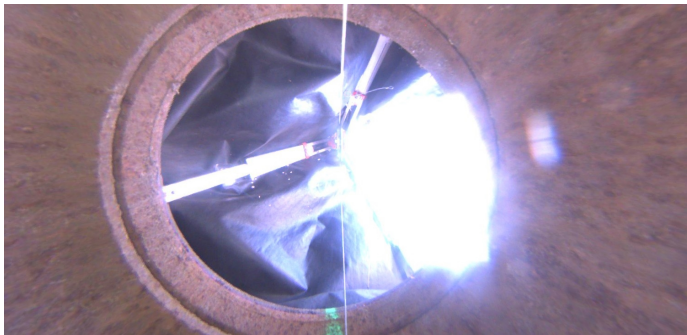
Code: **MGO**
Description: **General Observation**

Distance (ft): **1.6**
Structural Grade: **0**
O&M Grade: **0**
Clock Start/From:
Clock To:
1st Value:
2nd Value:
Value Percent:
Step: **NO**
Remarks: **UNDERSIDE OF FRAME**

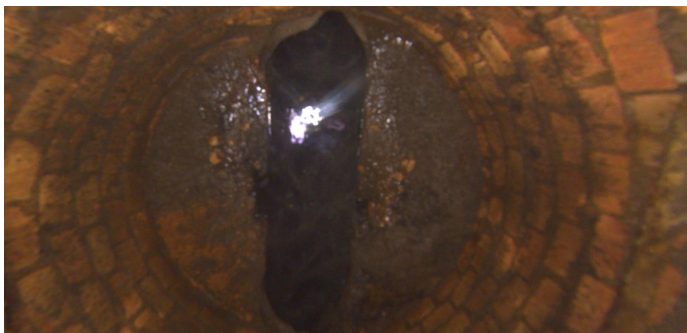
Code: **IS**
Description: **Infil Stain**

Distance (ft): **3.8**
Structural Grade: **0**
O&M Grade: **0**
Clock Start/From: **12**
Clock To: **12**
1st Value:
2nd Value:
Value Percent:
Step: **NO**
Remarks:

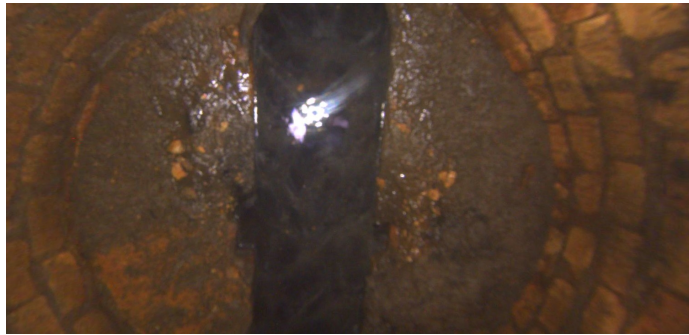
Code: **DSF**
Description: **Deposits Settled Fine**

Distance (ft): **4.6**
Structural Grade: **0**
O&M Grade: **2**
Clock Start/From: **12**
Clock To: **12**
1st Value:
2nd Value:
Value Percent: **5.000**
Step: **NO**
Remarks:

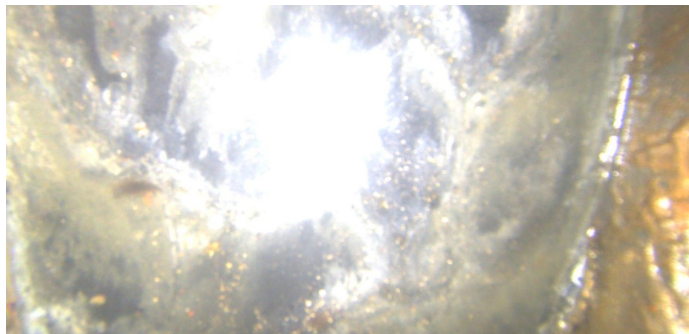
Code: **MGO**
Description: **General Observation**

Distance (ft): **6.5**
Structural Grade: **0**
O&M Grade: **0**
Clock Start/From:
Clock To:
1st Value:
2nd Value:
Value Percent:
Step: **NO**
Remarks: **END SURVEY**
