Manhole Inspection Report

Date:	05/07/2018	Weather:		Coding:	RZMACP
MH#:	M-805-042	Owner:	NA	Len. Surveyed:	5.9
P.O.#:		Surveyor:	Jen Costello	Rim to Invert:	6.5
Customer:		Cert. #:	U-907-5518	Wall Material:	Concrete (reinforced)

Street:	Lillian St. and Ohio St. to the East.	Project:	Hobart, IN
City:	Hobart, IN	GPS Northing:	2908581.655
Location:		GPS Easting:	2908581.655
Drain Area:	South	GPS Accuracy:	Sub-Meter
Cover Shape:	Circular	Evidence of Surcharge:	No
Cover Size:	22.5	Potential for Runoff:	None
Comments:

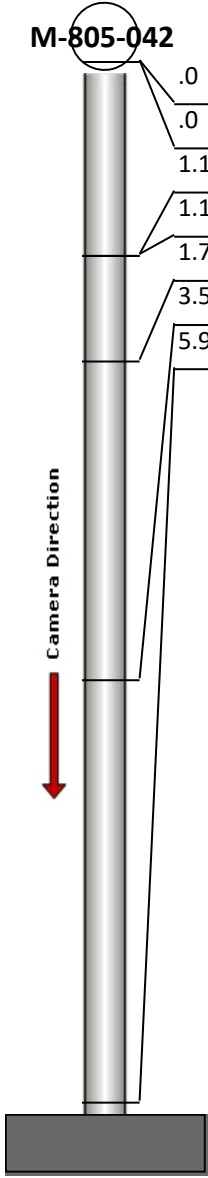
Position	Code	Observation	Video (sec)	Grade

.0	MGP	General Photo	10	NA
	.0	ISSR	Intruding Sealing Ring	21	M 2
	1.1	RFB	Roots Fine Barrel	35	M 2
	1.1	FL	Fracture Longitudinal	48	S 3
	1.7	MGO	General Observation	64	NA
	3.5	RFB	Roots Fine Barrel	81	M 2
	5.9	MGO	General Observation	96	NA

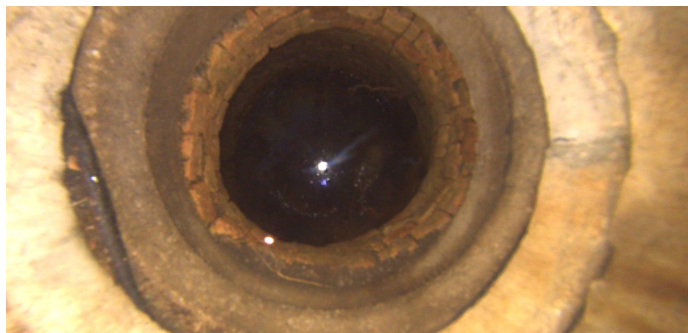
Code: **MGP**
Description: **General Photo**

Distance (ft): **.0**
Structural Grade: **0**
O&M Grade: **0**
Clock Start/From:
Clock To:
1st Value:
2nd Value:
Value Percent:
Step: **NO**
Remarks: **ACCESS MH**

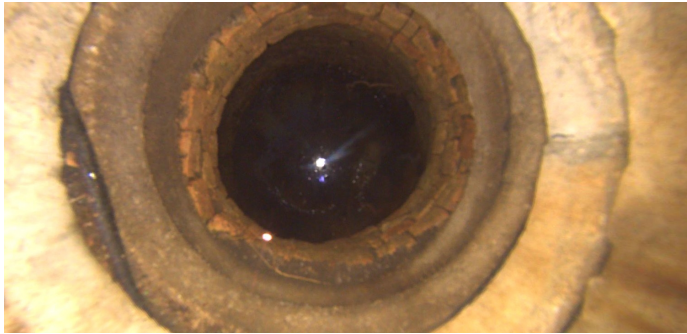
Code:	ISSR
Description:	Intruding Sealing Ring
Distance (ft):	.0
Structural Grade:	0
O&M Grade:	2
Clock Start/From:	8
Clock To:	9
1st Value:	
2nd Value:	
Value Percent:	5.000
Step:	NO
Remarks:

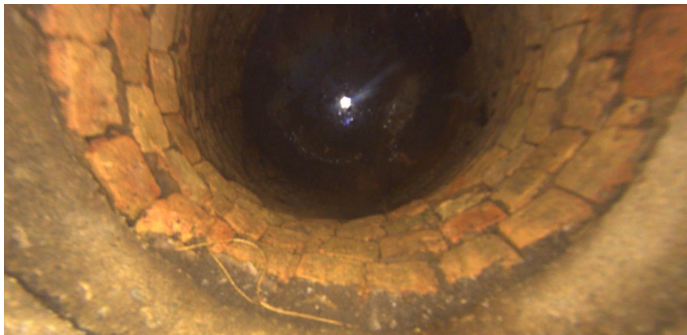
Code:	RFB
Description:	Roots Fine Barrel
Distance (ft):	1.1
Structural Grade:	0
O&M Grade:	2
Clock Start/From:	6
Clock To:	7
1st Value:	
2nd Value:	
Value Percent:	
Step:	NO
Remarks:

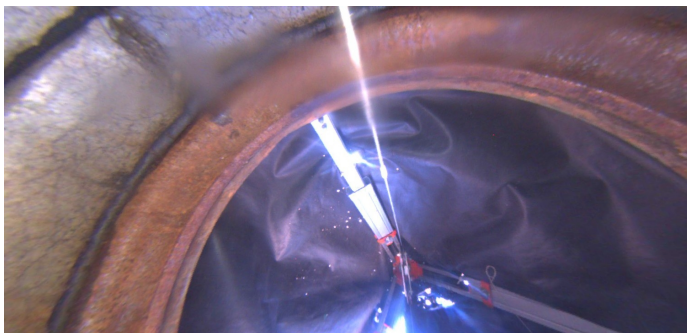
Code:	FL
Description:	Fracture Longitudinal
Distance (ft):	1.1
Structural Grade:	3
O&M Grade:	0
Clock Start/From:	2
Clock To:	
1st Value:	
2nd Value:	
Value Percent:	
Step:	NO
Remarks:

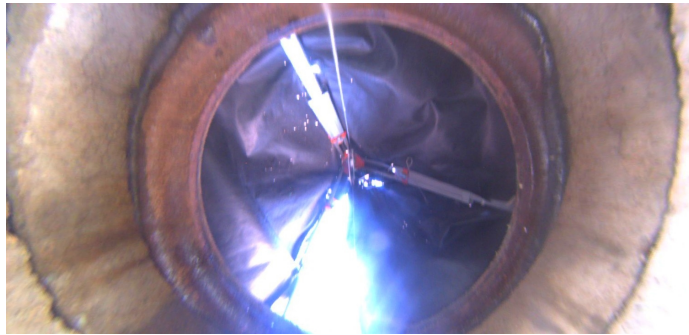
Code: **MGO**
Description: **General Observation**

Distance (ft): **1.7**
Structural Grade: **0**
O&M Grade: **0**
Clock Start/From:
Clock To:
1st Value:
2nd Value:
Value Percent:
Step: **NO**
Remarks: **UNDERSIDE OF FRAME**

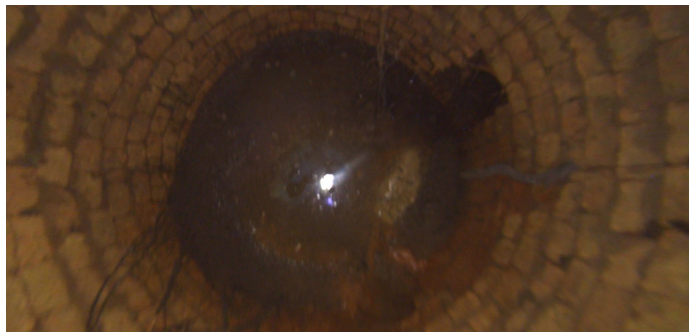
Code: **RFB**
Description: **Roots Fine Barrel**

Distance (ft): **3.5**
Structural Grade: **0**
O&M Grade: **2**
Clock Start/From: **12**
Clock To: **12**
1st Value:
2nd Value:
Value Percent:
Step: **NO**
Remarks:

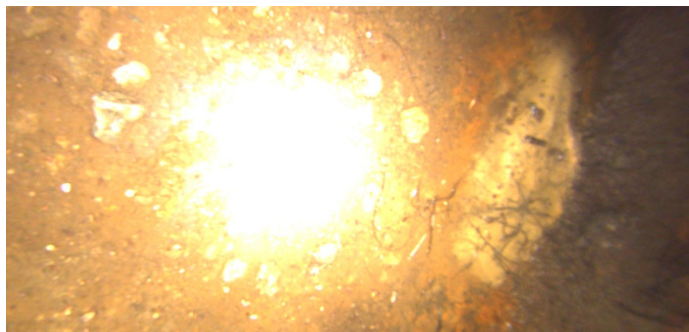
Code: **MGO**
Description: **General Observation**

Distance (ft): **5.9**
Structural Grade: **0**
O&M Grade: **0**
Clock Start/From:
Clock To:
1st Value:
2nd Value:
Value Percent:
Step: **NO**
Remarks: **END SURVEY**
