Manhole Inspection Report

Date:	05/07/2018	Weather:		Coding:	RZMACP
MH#:	M-805-044	Owner:	NA	Len. Surveyed:	6.1
P.O.#:		Surveyor:	Jen Costello	Rim to Invert:	6.8
Customer:		Cert. #:	U-907-5518	Wall Material:	Concrete (reinforced)

Street:	Joliet St. 221' North of Devonshire S	Project:	Hobart, IN
City:	Hobart, IN	GPS Northing:	2908772.603
Location:		GPS Easting:	2908772.603
Drain Area:	South	GPS Accuracy:	Sub-Meter
Cover Shape:	Circular	Evidence of Surcharge:	No
Cover Size:	22.5	Potential for Runoff:	None
Comments:

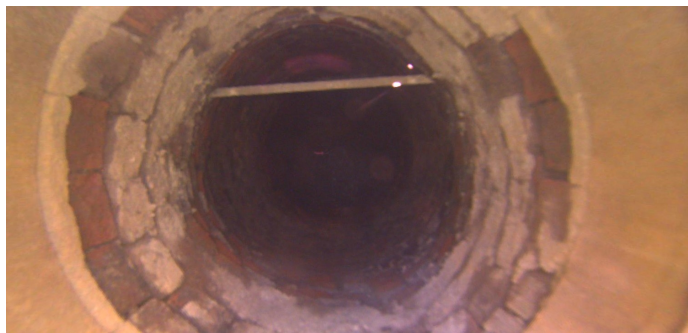
Code: **MGO**
Description: **General Observation**

Distance (ft): **.0**
Structural Grade: **0**
O&M Grade: **0**
Clock Start/From:
Clock To:
1st Value:
2nd Value:
Value Percent:
Step: **NO**
Remarks: **ACCESS MH**

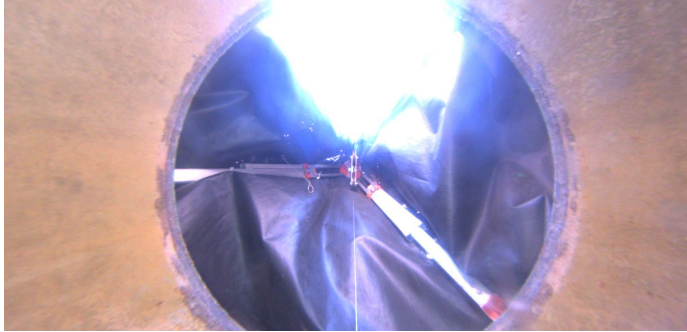
Code:	MGO
Description:	General Observation
Distance (ft):	1.4
Structural Grade:	0
O&M Grade:	0
Clock Start/From:	
Clock To:	
1st Value:	
2nd Value:	
Value Percent:	
Step:	NO
Remarks:	UNDERSIDE OF FRAME

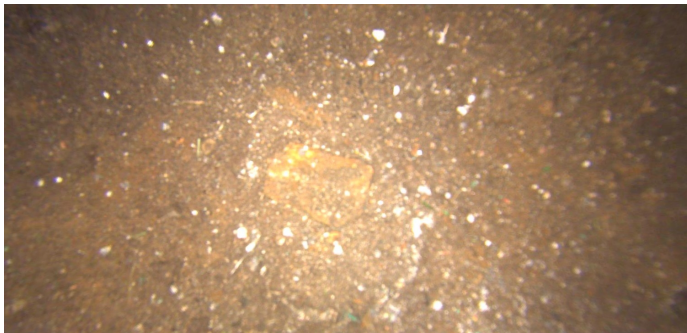
Code:	DSF
Description:	Deposits Settled Fine
Distance (ft):	6.1
Structural Grade:	0
O&M Grade:	2
Clock Start/From:	12
Clock To:	12
1st Value:	
2nd Value:	
Value Percent:	10.000
Step:	NO
Remarks:
