Manhole Inspection Report

Date:	09/30/2022	Weather:		Coding:	RZMACP
MH#:	M-805-048	Owner:	NA	Len. Surveyed:	6.6
P.O.#:		Surveyor:	Jen Costello	Rim to Invert:	7.6
Customer:		Cert. #:	U-907-5518	Wall Material:	Concrete (cast in place)

Street:	Georgiana St. 311' West of Ohio St.	Project:	Hobart, IN
City:	Hobart, IN	GPS Northing:	2289492.416
Location:	Local Rural Streets	GPS Easting:	2907892.354
Drain Area:	South	GPS Accuracy:	Sub-Meter
Cover Shape:	Circular	Evidence of Surcharge:	No
Cover Size:	24.0	Potential for Runoff:	None
Comments:

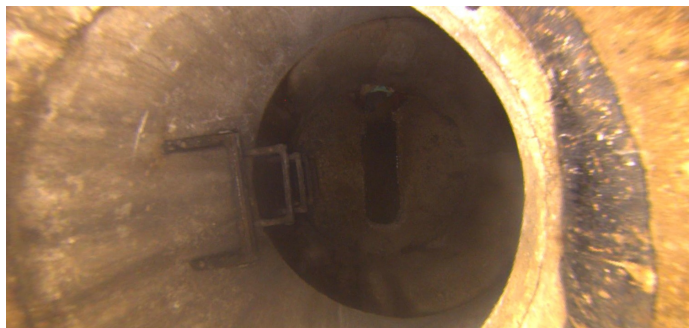
Code: **MGO**
Description: **General Observation**

Distance (ft): **.0**
Structural Grade: **0**
O&M Grade: **0**
Clock Start/From:
Clock To:
1st Value:
2nd Value:
Value Percent:
Step: **NO**
Remarks: **access mh**

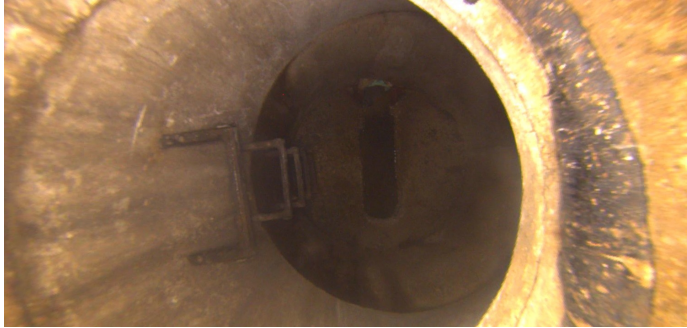
Code: **ISGT**
Description: **Intruding Sealing Grout**

Distance (ft): **.0**
Structural Grade: **0**
O&M Grade: **2**
Clock Start/From: **12**
Clock To: **12**
1st Value:
2nd Value:
Value Percent: **5.000**
Step: **NO**
Remarks:

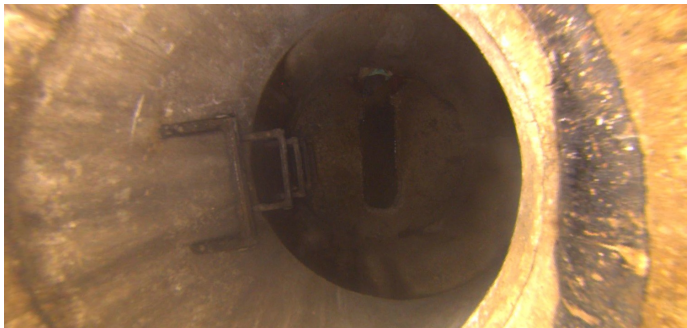
Code: **SRI**
Description: **Surface Roughness Increased**

Distance (ft): **.0**
Structural Grade: **1**
O&M Grade: **0**
Clock Start/From: **12**
Clock To: **12**
1st Value:
2nd Value:
Value Percent:
Step: **NO**
Remarks:

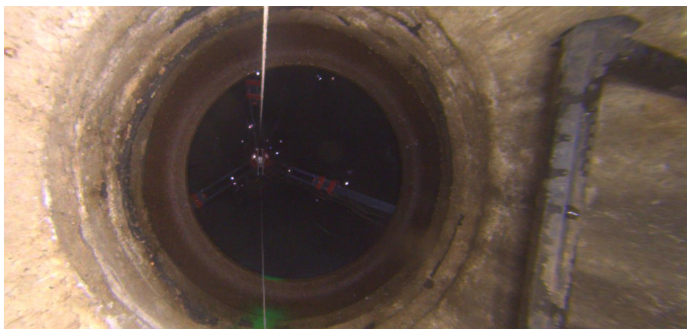
Code: **MGO**
Description: **General Observation**

Distance (ft): **2.6**
Structural Grade: **0**
O&M Grade: **0**
Clock Start/From:
Clock To:
1st Value:
2nd Value:
Value Percent:
Step: **NO**
Remarks: **underside of frame**

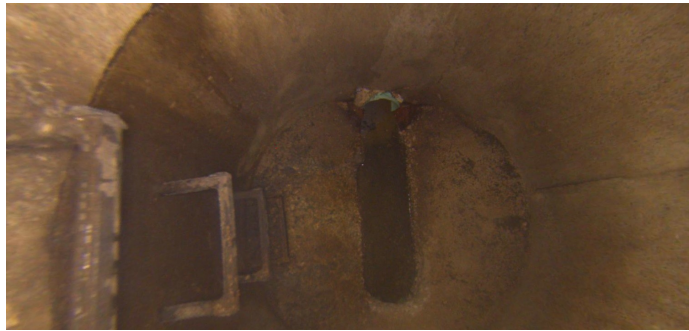
Code: **IW**
Description: **Infil Weeper**

Distance (ft): **2.6**
Structural Grade: **0**
O&M Grade: **2**
Clock Start/From: **6**
Clock To: **10**
1st Value:
2nd Value:
Value Percent:
Step: **NO**
Remarks:

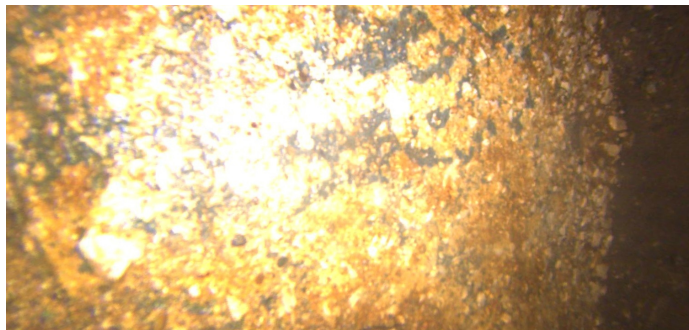
Code: **SAV**
Description: **Surface Aggregate Visible**

Distance (ft): **6.6**
Structural Grade: **3**
O&M Grade: **0**
Clock Start/From: **12**
Clock To: **12**
1st Value:
2nd Value:
Value Percent:
Step: **NO**
Remarks:

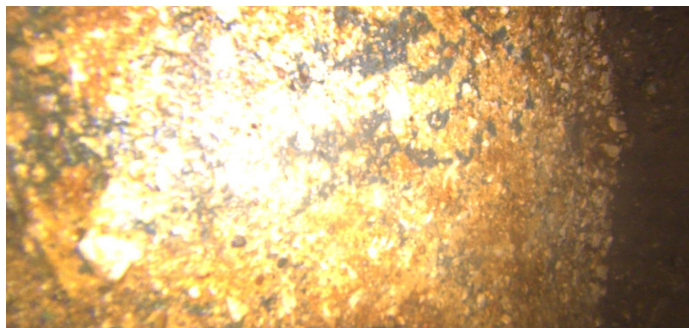
Code: **SRI**
Description: **Surface Roughness Increased**

Distance (ft): **6.6**
Structural Grade: **1**
O&M Grade: **0**
Clock Start/From: **12**
Clock To: **12**
1st Value:
2nd Value:
Value Percent:
Step: **NO**
Remarks:

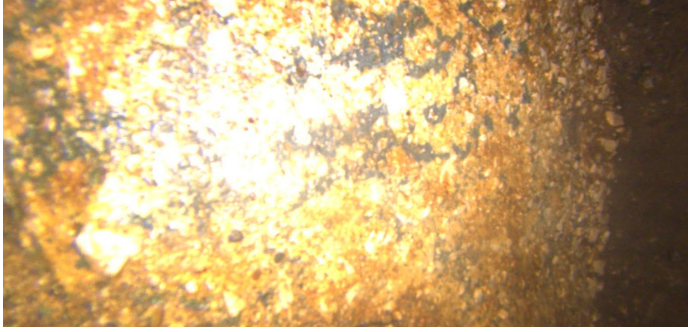
Code:	MGO
Description:	General Observation
Distance (ft):	6.6
Structural Grade:	0
O&M Grade:	0
Clock Start/From:	
Clock To:	
1st Value:	
2nd Value:	
Value Percent:	
Step:	NO
Remarks:	end of survey
