# Manhole Inspection Report

Date:	05/07/2018	Weather:		Coding:	RZMACP
MH#:	M-805-059	Owner:	NA	Len. Surveyed:	4.5
P.O.#:		Surveyor:	Jen Costello	Rim to Invert:	5.2
Customer:		Cert. #:	U-907-5518	Wall Material:	Brick

Street:	Devonshire St. 211' West of Ohio St.	Project:	Hobart, IN
City:	Hobart, IN	GPS Northing:	2908174.459
Location:		GPS Easting:	2908174.459
Drain Area:	South	GPS Accuracy:	Sub-Meter
Cover Shape:	Circular	Evidence of Surcharge:	No
Cover Size:	22.5	Potential for Runoff:	None
Comments:

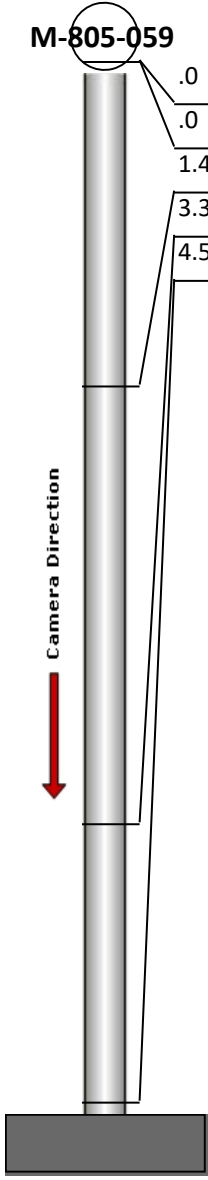
.0	MGP	General Photo	10	NA
	.0	DB	Displaced Brick	21	S 3
	1.4	MGO	General Observation	37	NA
	3.3	OBB	Obstacle Brick	54	M 2
	4.5	MGO	General Observation	68	NA

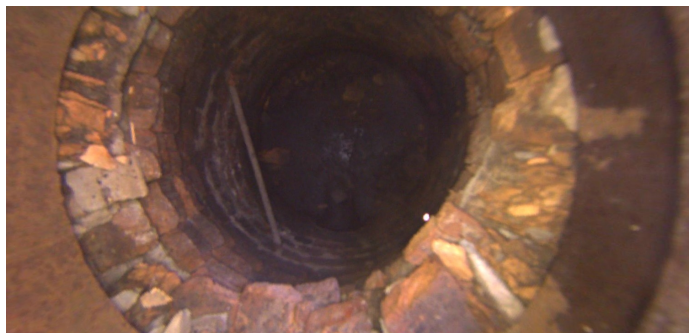
Code: **MGP**  
Description: **General Photo**

Distance (ft): **.0**  
Structural Grade: **0**  
O&M Grade: **0**  
Clock Start/From:  
Clock To:  
1st Value:  
2nd Value:  
Value Percent:  
Step: **NO**  
Remarks: **ACCESS MH**

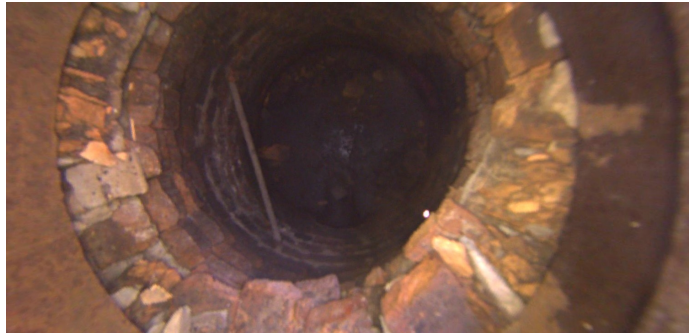
Code: **DB**  
Description: **Displaced Brick**

Distance (ft): **.0**  
Structural Grade: **3**  
O&M Grade: **0**  
Clock Start/From: **12**  
Clock To: **12**  
1st Value:  
2nd Value:  
Value Percent:  
Step: **NO**  
Remarks:

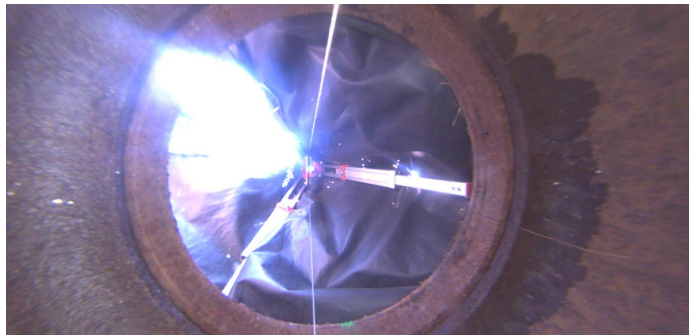
Code: **MGO**  
Description: **General Observation**

Distance (ft): **1.4**  
Structural Grade: **0**  
O&M Grade: **0**  
Clock Start/From:  
Clock To:  
1st Value:  
2nd Value:  
Value Percent:  
Step: **NO**  
Remarks: **UNDERSIDE OF FRAME**

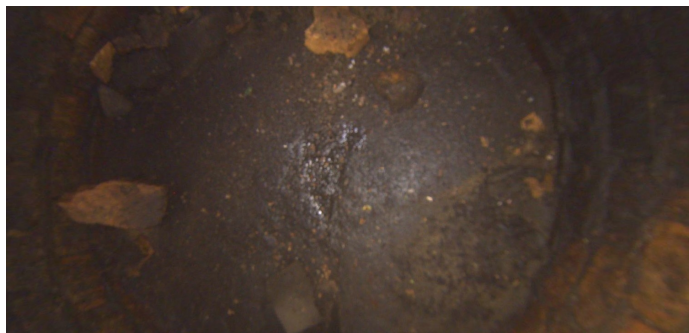
Code: **OBB**  
Description: **Obstacle Brick**

Distance (ft): **3.3**  
Structural Grade: **0**  
O&M Grade: **2**  
Clock Start/From: **6**  
Clock To: **12**  
1st Value:  
2nd Value:  
Value Percent: **5.000**  
Step: **NO**  
Remarks:

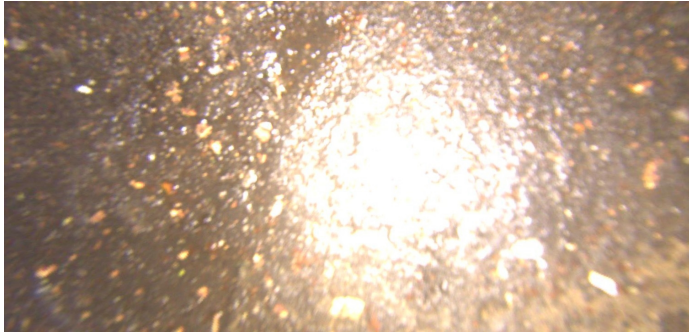
Code:	<b>MGO</b>
Description:	<b>General Observation</b>
Distance (ft):	<b>4.5</b>
Structural Grade:	<b>0</b>
O&M Grade:	<b>0</b>
Clock Start/From:	
Clock To:	
1st Value:	
2nd Value:	
Value Percent:	
Step:	<b>NO</b>
Remarks:	<b>END SURVEY</b>
