# Manhole Inspection Report

Date:	05/07/2018	Weather:		Coding:	RZMACP
MH#:	M-805-062	Owner:	NA	Len. Surveyed:	8.4
P.O.#:		Surveyor:	Jen Costello	Rim to Invert:	9.8
Customer:		Cert. #:	U-907-5518	Wall Material:	Concrete (reinforced)

Street:	North St. 368' East of Illinois St.	Project:	Hobart, IN
City:	Hobart, IN	GPS Northing:	2907971.875
Location:		GPS Easting:	2907971.875
Drain Area:	South	GPS Accuracy:	Sub-Meter
Cover Shape:	Circular	Evidence of Surcharge:	No
Cover Size:	22.5	Potential for Runoff:	None
Comments:

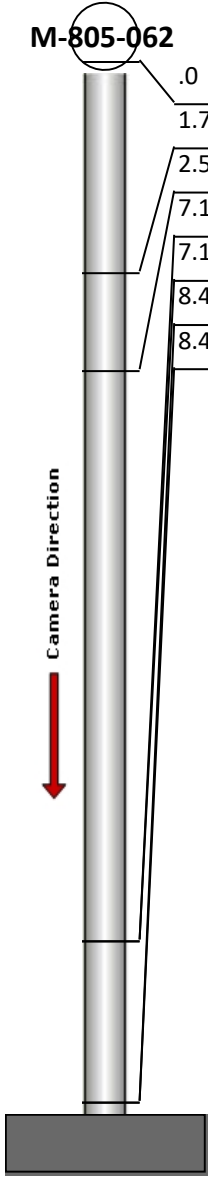
.0	MB	Missing Brick	10	S 4
	1.7	MGO	General Observation	27	NA
	2.5	MGO	General Observation	43	NA
	7.1	MMM	Mortar Missing Medium	66	S 3
	7.1	RFB	Roots Fine Barrel	77	M 2
	8.4	OBB	Obstacle Brick	91	M 2
	8.4	MGO	General Observation	103	NA

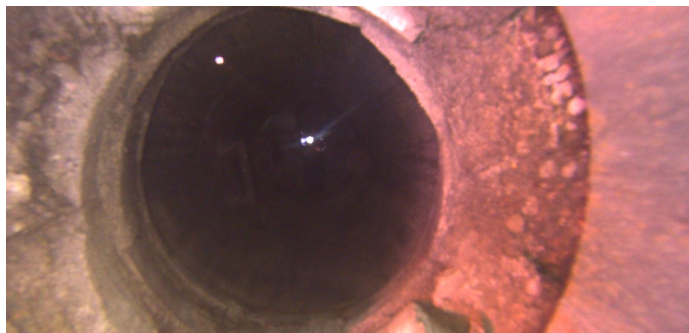
Code: **MB**  
Description: **Missing Brick**

Distance (ft): **.0**  
Structural Grade: **4**  
O&M Grade: **0**  
Clock Start/From: **2**  
Clock To: **4**  
1st Value:  
2nd Value:  
Value Percent:  
Step: **NO**  
Remarks:

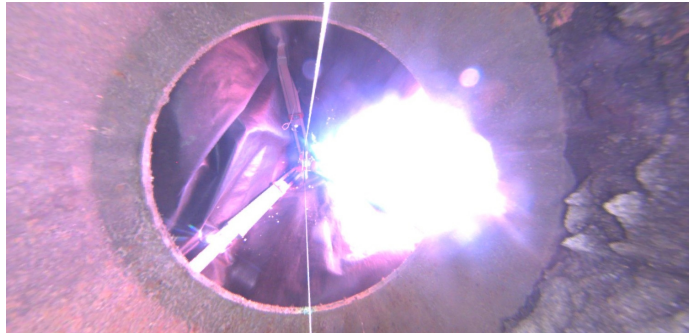
Code: **MGO**  
Description: **General Observation**

Distance (ft): **1.7**  
Structural Grade: **0**  
O&M Grade: **0**  
Clock Start/From:  
Clock To:  
1st Value:  
2nd Value:  
Value Percent:  
Step: **NO**  
Remarks: **underside of frame**

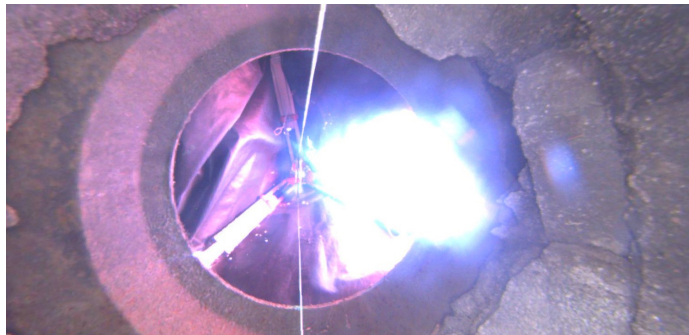
Code: **MGO**  
Description: **General Observation**

Distance (ft): **2.5**  
Structural Grade: **0**  
O&M Grade: **0**  
Clock Start/From:  
Clock To:  
1st Value:  
2nd Value:  
Value Percent:  
Step: **NO**  
Remarks: **underside of frame**

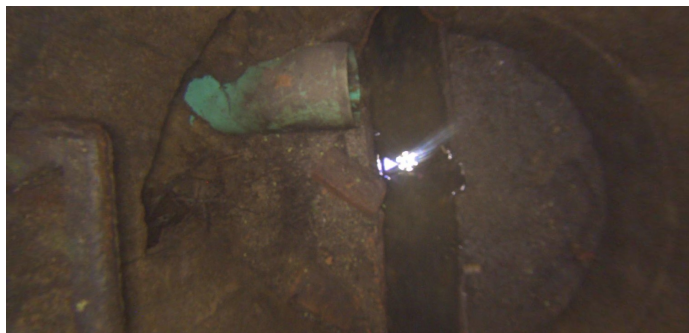
Code: **MMM**  
Description: **Mortar Missing Medium**

Distance (ft): **7.1**  
Structural Grade: **3**  
O&M Grade: **0**  
Clock Start/From: **9**  
Clock To: **11**  
1st Value:  
2nd Value:  
Value Percent:  
Step: **NO**  
Remarks:

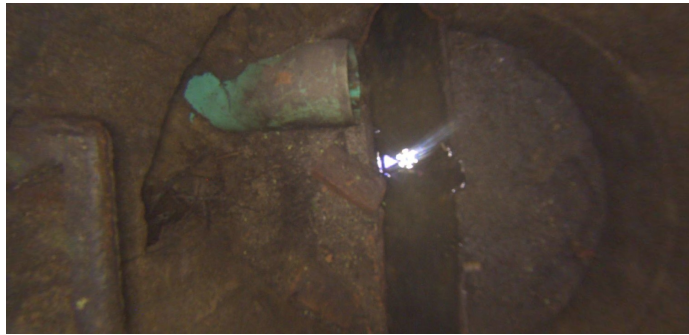
Code: **RFB**  
Description: **Roots Fine Barrel**

Distance (ft): **7.1**  
Structural Grade: **0**  
O&M Grade: **2**  
Clock Start/From: **9**  
Clock To:  
1st Value:  
2nd Value:  
Value Percent:  
Step: **NO**  
Remarks:

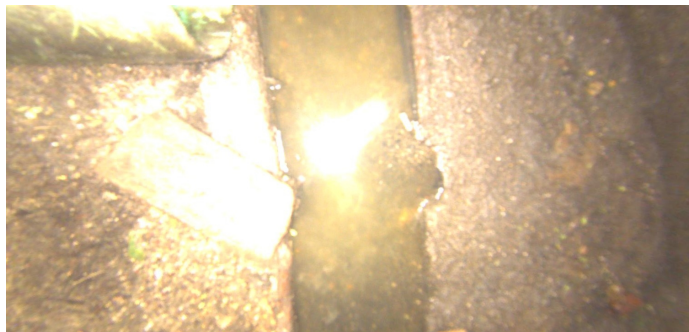
Code: **OBB**  
Description: **Obstacle Brick**

Distance (ft): **8.4**  
Structural Grade: **0**  
O&M Grade: **2**  
Clock Start/From: **9**  
Clock To:  
1st Value:  
2nd Value:  
Value Percent: **5.000**  
Step: **NO**  
Remarks:

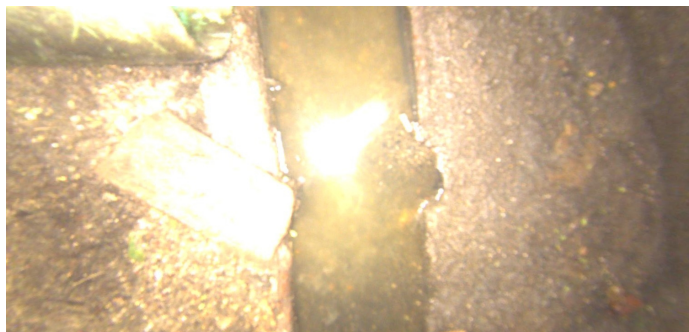
Code: **MGO**  
Description: **General Observation**

Distance (ft): **8.4**  
Structural Grade: **0**  
O&M Grade: **0**  
Clock Start/From:  
Clock To:  
1st Value:  
2nd Value:  
Value Percent:  
Step: **NO**  
Remarks: **end survey**
