Manhole Inspection Report

Date:	04/20/2018	Weather:		Coding:	RZMACP
MH#:	M-806-012	Owner:	NA	Len. Surveyed:	4.2
P.O.#:		Surveyor:	Jen Costello	Rim to Invert:	4.1
Customer:		Cert. #:	U-907-5518	Wall Material:	Brick

Street:	Intersection of 8th St. and Memory	Project:	Hobart, IN
City:	Hobart, IN	GPS Northing:	2907972.672
Location:		GPS Easting:	2907972.672
Drain Area:	Southeast	GPS Accuracy:	Sub-Meter
Cover Shape:	Circular	Evidence of Surcharge:	No
Cover Size:	22.5	Potential for Runoff:	None
Comments:

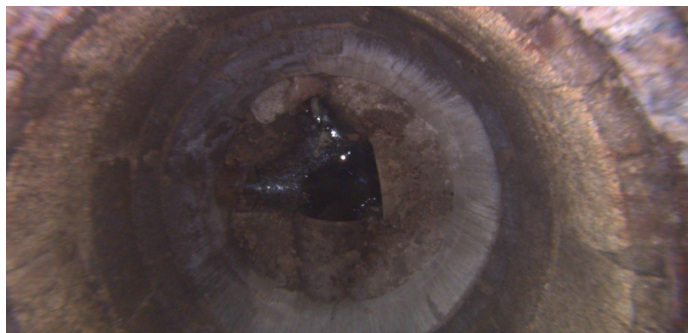
Code: **MGO**
Description: **General Observation**

Distance (ft): **.0**
Structural Grade: **0**
O&M Grade: **0**
Clock Start/From:
Clock To:
1st Value:
2nd Value:
Value Percent:
Step: **NO**
Remarks: **ACCESS MH**

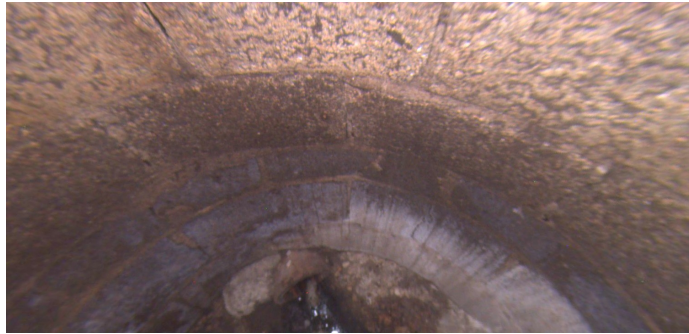
Code:	SAV
Description:	Surface Aggregate Visible
Distance (ft):	.9
Structural Grade:	3
O&M Grade:	0
Clock Start/From:	12
Clock To:	12
1st Value:	
2nd Value:	
Value Percent:	
Step:	NO
Remarks:

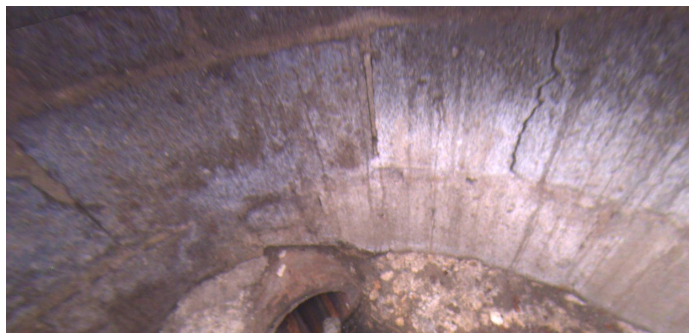
Code:	FL
Description:	Fracture Longitudinal
Distance (ft):	2.5
Structural Grade:	3
O&M Grade:	0
Clock Start/From:	1
Clock To:	
1st Value:	
2nd Value:	
Value Percent:	
Step:	NO
Remarks:

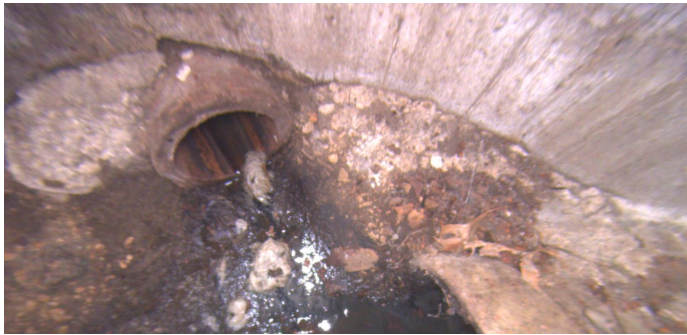
Code:	SAP
Description:	Surface Aggregate Projecting
Distance (ft):	2.8
Structural Grade:	3
O&M Grade:	0
Clock Start/From:	12
Clock To:	12
1st Value:	
2nd Value:	
Value Percent:	
Step:	NO
Remarks:
