# Manhole Inspection Report

Date:	<b>04/20/2018</b>	Weather:		Coding:	<b>RZMACP</b>
MH#:	<b>M-806-018</b>	Owner:	<b>NA</b>	Len. Surveyed:	<b>16.1</b>
P.O.#:		Surveyor:	<b>Jen Costello</b>	Rim to Invert:	<b>17.2</b>
Customer:		Cert. #:	<b>U-907-5518</b>	Wall Material:	<b>Concrete (reinforced)</b>

Street:	<b>Memory Ln. 244' North of 8th St.</b>	Project:	<b>Hobart, IN</b>
City:	<b>Hobart, IN</b>	GPS Northing:	<b>2907972.69</b>
Location:		GPS Easting:	<b>2907972.69</b>
Drain Area:	<b>Southeast</b>	GPS Accuracy:	<b>Sub-Meter</b>
Cover Shape:	<b>Circular</b>	Evidence of Surcharge:	<b>No</b>
Cover Size:	<b>22.5</b>	Potential for Runoff:	<b>None</b>
Comments:

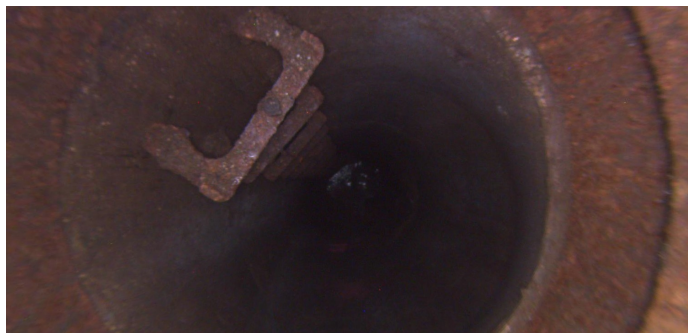
Code: **MGO**  
Description: **General Observation**

Distance (ft): **.0**  
Structural Grade: **0**  
O&M Grade: **0**  
Clock Start/From:  
Clock To:  
1st Value:  
2nd Value:  
Value Percent:  
Step: **NO**  
Remarks: **ACCESS MH**

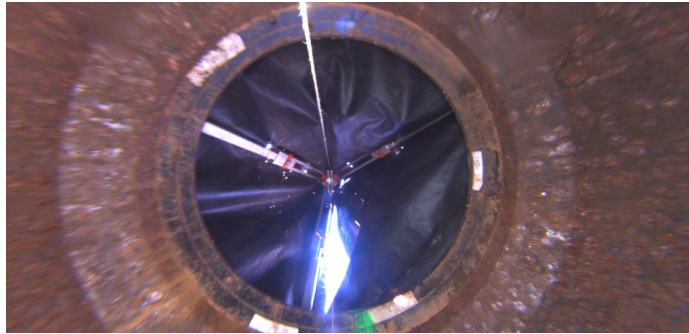
Code: **MGO**  
Description: **General Observation**

Distance (ft): **1.9**  
Structural Grade: **0**  
O&M Grade: **0**  
Clock Start/From:  
Clock To:  
1st Value:  
2nd Value:  
Value Percent:  
Step: **NO**  
Remarks: **UNDERSIDE OF FRAME**

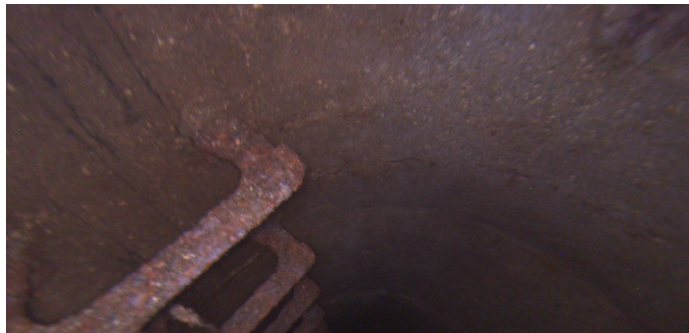
Code: **SAV**  
Description: **Surface Aggregate Visible**

Distance (ft): **1.9**  
Structural Grade: **3**  
O&M Grade: **0**  
Clock Start/From: **12**  
Clock To: **12**  
1st Value:  
2nd Value:  
Value Percent:  
Step: **NO**  
Remarks:

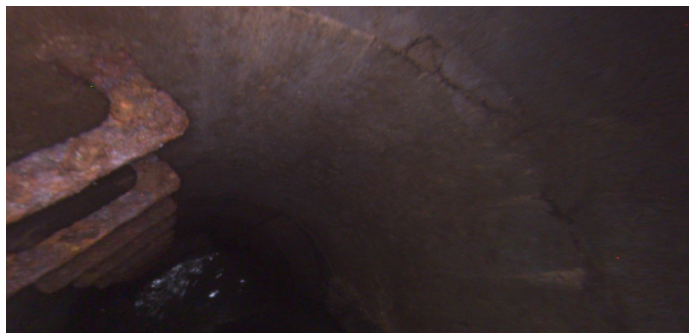
Code: **FM**  
Description: **Fracture Multiple**

Distance (ft): **6.5**  
Structural Grade: **4**  
O&M Grade: **0**  
Clock Start/From: **12**  
Clock To: **3**  
1st Value:  
2nd Value:  
Value Percent:  
Step: **NO**  
Remarks:

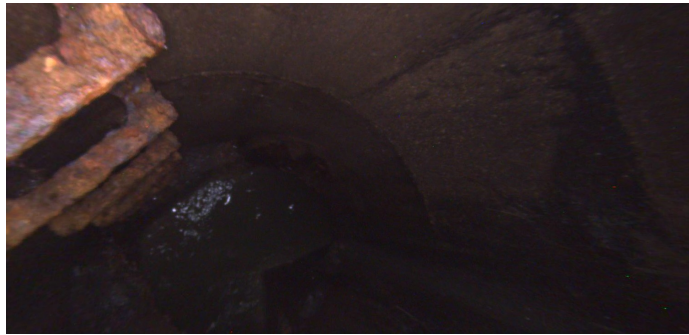
Code: **IW**  
Description: **Infil Weeper**

Distance (ft): **11.1**  
Structural Grade: **0**  
O&M Grade: **2**  
Clock Start/From: **1**  
Clock To: **3**  
1st Value:  
2nd Value:  
Value Percent:  
Step: **NO**  
Remarks:

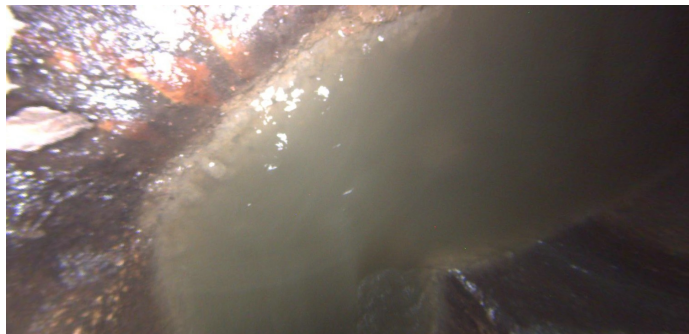
Code: **MGO**  
Description: **General Observation**

Distance (ft): **16.1**  
Structural Grade: **0**  
O&M Grade: **0**  
Clock Start/From:  
Clock To:  
1st Value:  
2nd Value:  
Value Percent:  
Step: **NO**  
Remarks: **END SURVEY**

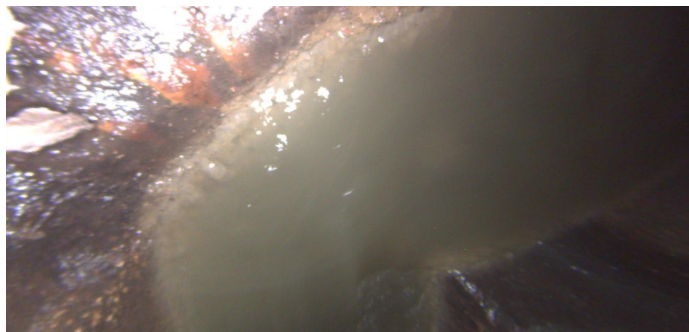
Code: **SAV**  
Description: **Surface Aggregate Visible**

Distance (ft): **16.1**  
Structural Grade: **3**  
O&M Grade: **0**  
Clock Start/From: **12**  
Clock To: **12**  
1st Value:  
2nd Value:  
Value Percent:  
Step: **NO**  
Remarks:
