# Manhole Inspection Report

Date:	04/20/2018	Weather:		Coding:	RZMACP
MH#:	M-806-021A	Owner:	NA	Len. Surveyed:	7.1
P.O.#:		Surveyor:	Jen Costello	Rim to Invert:	7.4
Customer:		Cert. #:	U-907-5518	Wall Material:	Concrete (reinforced)

Street:	Gilberts Ct. 220' South of 6th St.	Project:	Hobart, IN
City:	Hobart, IN	GPS Northing:	0.0
Location:		GPS Easting:	0.0
Drain Area:	Southeast	GPS Accuracy:	Nearest Meter
Cover Shape:	Circular	Evidence of Surcharge:	No
Cover Size:	22.5	Potential for Runoff:	None
Comments:

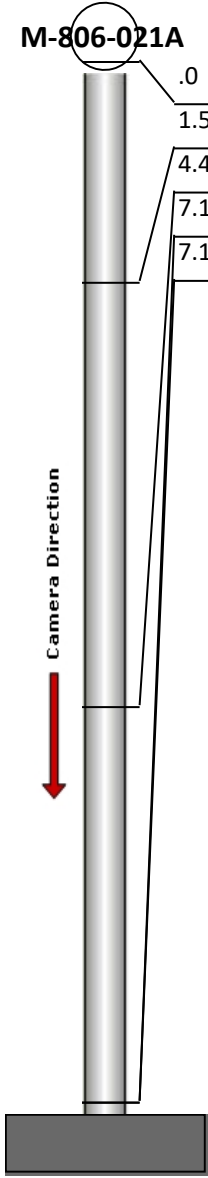
Position	Code	Observation	Video (sec)	Grade

.0	MGO	General Observation	10	NA
	1.5	MGO	General Observation	26	NA
	4.4	IW	Infil Weeper	46	M 2
	7.1	MGO	General Observation	63	NA
	7.1	SAV	Surface Aggregate Visible	74	S 3

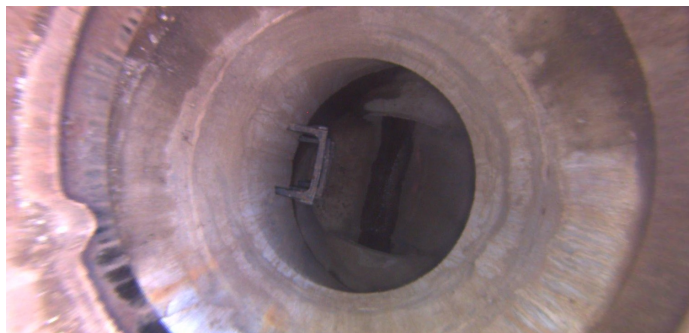
Code: **MGO**  
Description: **General Observation**

Distance (ft): **.0**  
Structural Grade: **0**  
O&M Grade: **0**  
Clock Start/From:  
Clock To:  
1st Value:  
2nd Value:  
Value Percent:  
Step: **NO**  
Remarks: **ACCESS MH**

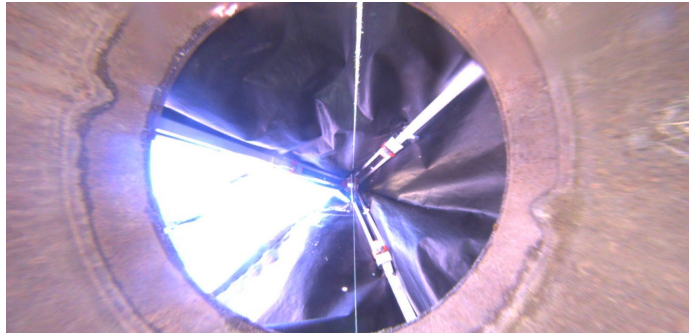
Code: **MGO**  
Description: **General Observation**

Distance (ft): **1.5**  
Structural Grade: **0**  
O&M Grade: **0**  
Clock Start/From:  
Clock To:  
1st Value:  
2nd Value:  
Value Percent:  
Step: **NO**  
Remarks: **UNDERSIDE OF FRAME**

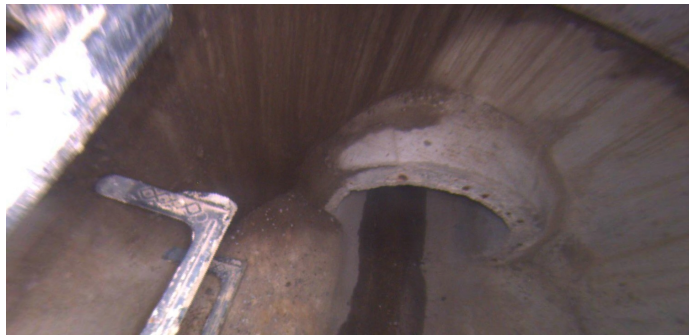
Code: **IW**  
Description: **Infil Weeper**

Distance (ft): **4.4**  
Structural Grade: **0**  
O&M Grade: **2**  
Clock Start/From: **9**  
Clock To: **12**  
1st Value:  
2nd Value:  
Value Percent:  
Step: **NO**  
Remarks:

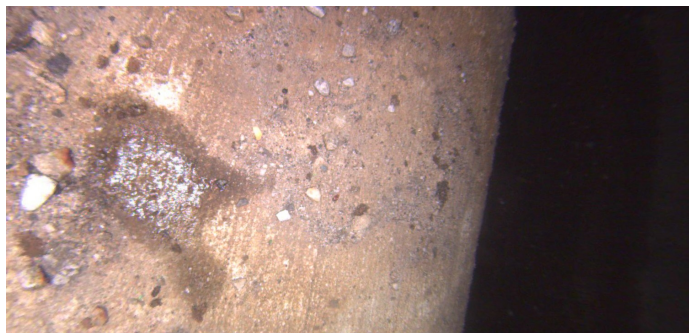
Code: **MGO**  
Description: **General Observation**

Distance (ft): **7.1**  
Structural Grade: **0**  
O&M Grade: **0**  
Clock Start/From:  
Clock To:  
1st Value:  
2nd Value:  
Value Percent:  
Step: **NO**  
Remarks: **END SURVEY**

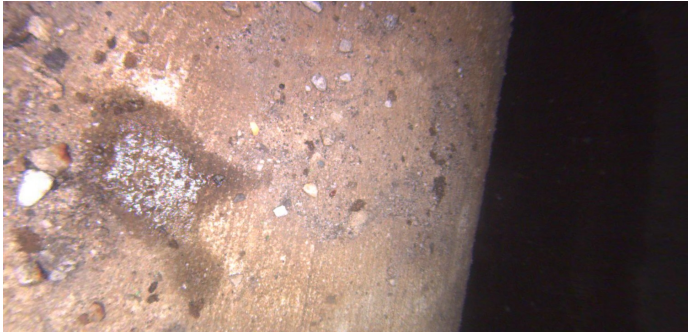
Code:	<b>SAV</b>
Description:	<b>Surface Aggregate Visible</b>
Distance (ft):	<b>7.1</b>
Structural Grade:	<b>3</b>
O&M Grade:	<b>0</b>
Clock Start/From:	<b>6</b>
Clock To:	<b>12</b>
1st Value:	
2nd Value:	
Value Percent:	
Step:	<b>NO</b>
Remarks:
