# Manhole Inspection Report

Date:	<b>09/25/2022</b>	Weather:		Coding:	<b>RZMACP</b>
MH#:	<b>M-806-025</b>	Owner:	<b>NA</b>	Len. Surveyed:	<b>5.1</b>
P.O.#:		Surveyor:	<b>Jen Costello</b>	Rim to Invert:	<b>5.8</b>
Customer:		Cert. #:	<b>U-907-5518</b>	Wall Material:	<b>Brick</b>

Street:	<b>North of 8th St. 150' East of Linda St</b>	Project:	<b>Hobart, IN</b>
City:	<b>Hobart, IN</b>	GPS Northing:	<b>2286764.075</b>
Location:	<b>Local Rural Streets</b>	GPS Easting:	<b>2907316.194</b>
Drain Area:	<b>South</b>	GPS Accuracy:	<b>Sub-Meter</b>
Cover Shape:	<b>Circular</b>	Evidence of Surcharge:	<b>No</b>
Cover Size:	<b>24.0</b>	Potential for Runoff:	<b>None</b>
Comments:

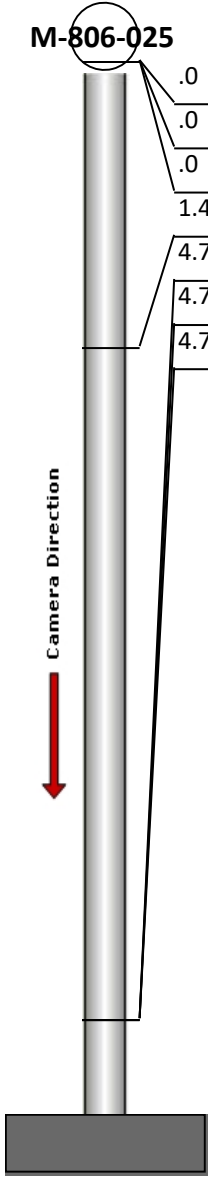
.0	MGO	General Observation	10	NA
	.0	SRI	Surface Roughness Increased	21	S 1
	.0	ISGT	Intruding Sealing Grout	33	M 2
	1.4	MGO	General Observation	49	NA
	4.7	DSGV	Deposits Settled Gravel	68	M 2
	4.7	SRI	Surface Roughness Increased	80	S 1
	4.7	MGO	General Observation	91	NA

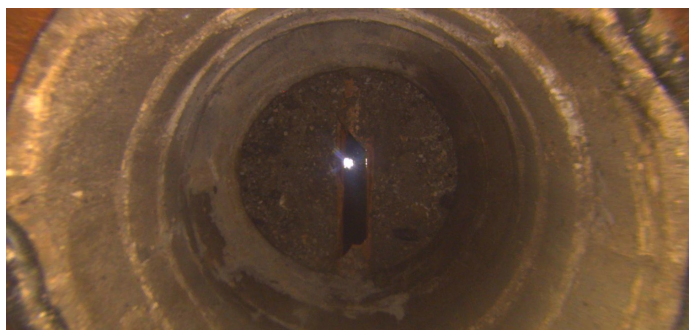
Code: **MGO**  
Description: **General Observation**

Distance (ft): **.0**  
Structural Grade: **0**  
O&M Grade: **0**  
Clock Start/From:  
Clock To:  
1st Value:  
2nd Value:  
Value Percent:  
Step: **NO**  
Remarks: **access mh**

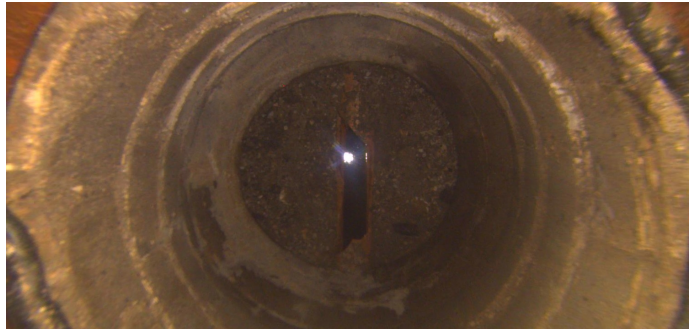
Code: **SRI**  
Description: **Surface Roughness Increased**

Distance (ft): **.0**  
Structural Grade: **1**  
O&M Grade: **0**  
Clock Start/From: **12**  
Clock To: **12**  
1st Value:  
2nd Value:  
Value Percent:  
Step: **NO**  
Remarks:

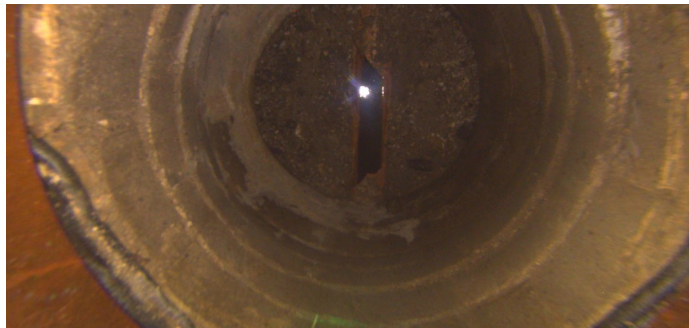
Code: **ISGT**  
Description: **Intruding Sealing Grout**

Distance (ft): **.0**  
Structural Grade: **0**  
O&M Grade: **2**  
Clock Start/From: **12**  
Clock To: **12**  
1st Value:  
2nd Value:  
Value Percent: **5.000**  
Step: **NO**  
Remarks:

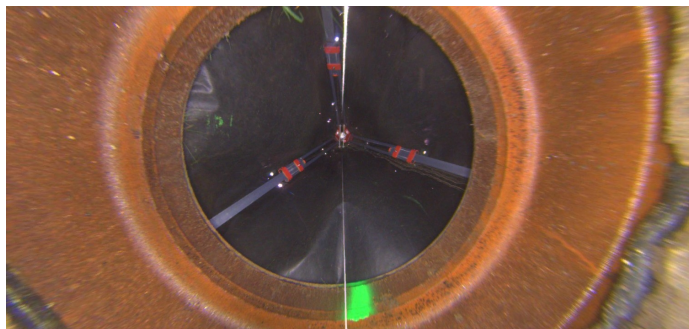
Code: **MGO**  
Description: **General Observation**

Distance (ft): **1.4**  
Structural Grade: **0**  
O&M Grade: **0**  
Clock Start/From:  
Clock To:  
1st Value:  
2nd Value:  
Value Percent:  
Step: **NO**  
Remarks: **underside of frame**

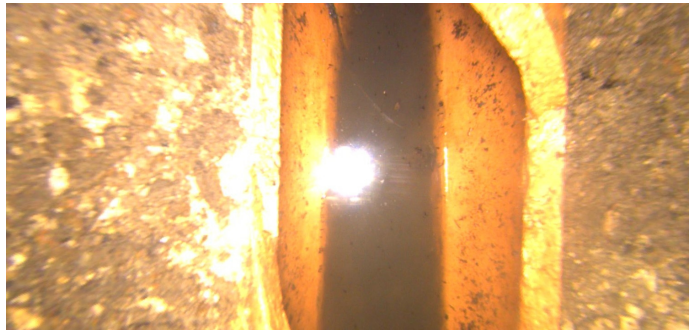
Code: **DSGV**  
Description: **Deposits Settled Gravel**

Distance (ft): **4.7**  
Structural Grade: **0**  
O&M Grade: **2**  
Clock Start/From: **12**  
Clock To: **12**  
1st Value:  
2nd Value:  
Value Percent: **5.000**  
Step: **NO**  
Remarks:

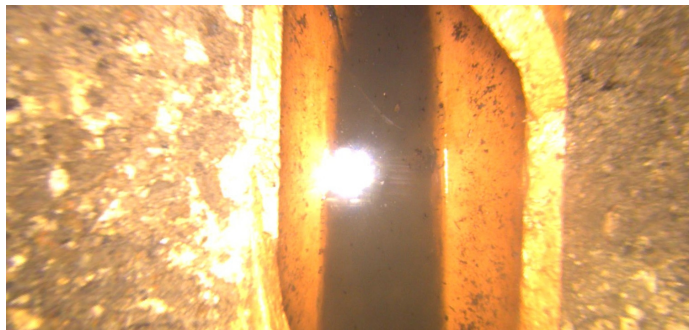
Code: **SRI**  
Description: **Surface Roughness Increased**

Distance (ft): **4.7**  
Structural Grade: **1**  
O&M Grade: **0**  
Clock Start/From: **12**  
Clock To: **12**  
1st Value:  
2nd Value:  
Value Percent:  
Step: **NO**  
Remarks:

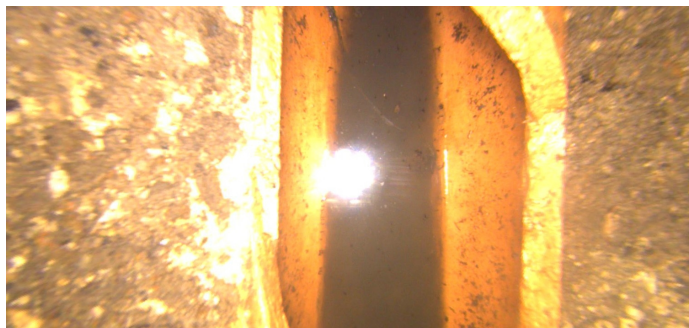
Code: **MGO**  
Description: **General Observation**

Distance (ft): **4.7**  
Structural Grade: **0**  
O&M Grade: **0**  
Clock Start/From:  
Clock To:  
1st Value:  
2nd Value:  
Value Percent:  
Step: **NO**  
Remarks: **end of survey**
