# Manhole Inspection Report

Date:	04/20/2018	Weather:		Coding:	RZMACP
MH#:	M-806-029	Owner:	NA	Len. Surveyed:	15.4
P.O.#:		Surveyor:	Jen Costello	Rim to Invert:	14.9
Customer:		Cert. #:	U-907-5518	Wall Material:	Concrete (reinforced)

Street:	Intersection of Springdale Dr. and 9t	Project:	Hobart, IN
City:	Hobart, IN	GPS Northing:	0.0
Location:		GPS Easting:	0.0
Drain Area:	Southeast	GPS Accuracy:	Nearest Meter
Cover Shape:	Circular	Evidence of Surcharge:	No
Cover Size:	22.5	Potential for Runoff:	None
Comments:

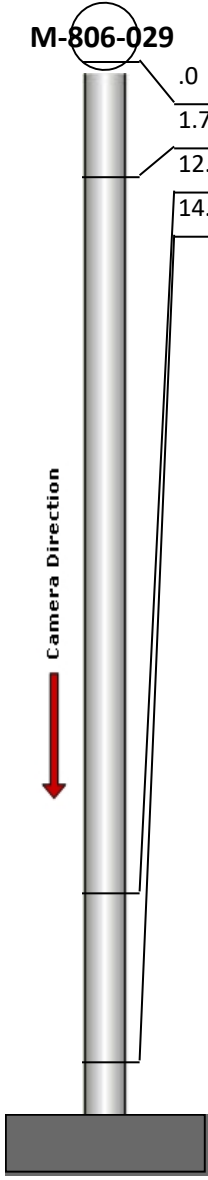
Position	Code	Observation	Video (sec)	Grade

.0	MGO	General Observation	10	NA
	1.7	MGO	General Observation	27	NA
	12.3	IW	Infil Weeper	61	M 2
	14.8	MGO	General Observation	78	NA

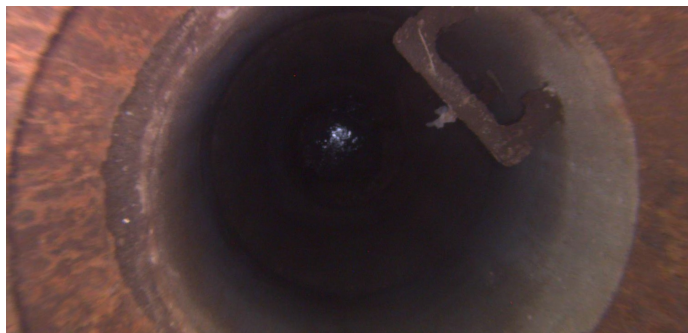
Code: **MGO**  
Description: **General Observation**

Distance (ft): **.0**  
Structural Grade: **0**  
O&M Grade: **0**  
Clock Start/From:  
Clock To:  
1st Value:  
2nd Value:  
Value Percent:  
Step: **NO**  
Remarks: **access mh**

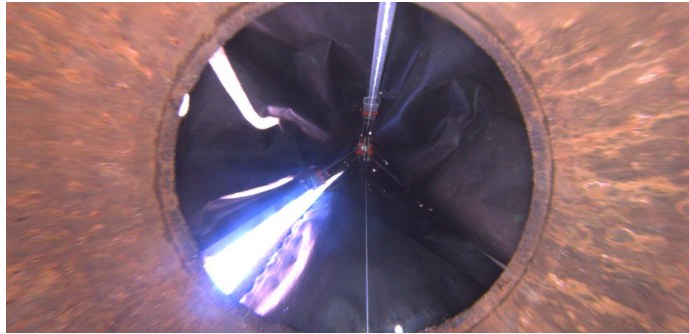
Code: **MGO**  
Description: **General Observation**

Distance (ft): **1.7**  
Structural Grade: **0**  
O&M Grade: **0**  
Clock Start/From:  
Clock To:  
1st Value:  
2nd Value:  
Value Percent:  
Step: **NO**  
Remarks: **underside of frame**

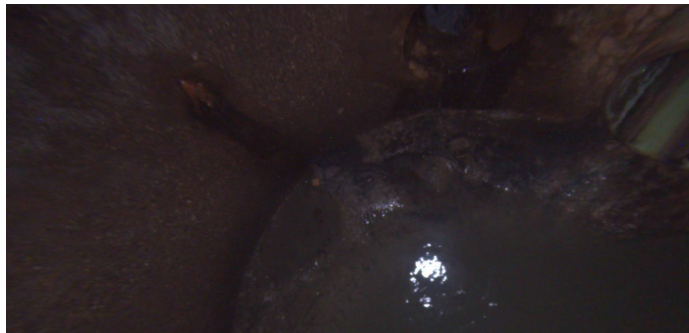
Code: **IW**  
Description: **Infil Weeper**

Distance (ft): **12.3**  
Structural Grade: **0**  
O&M Grade: **2**  
Clock Start/From: **10**  
Clock To:  
1st Value:  
2nd Value:  
Value Percent:  
Step: **NO**  
Remarks:

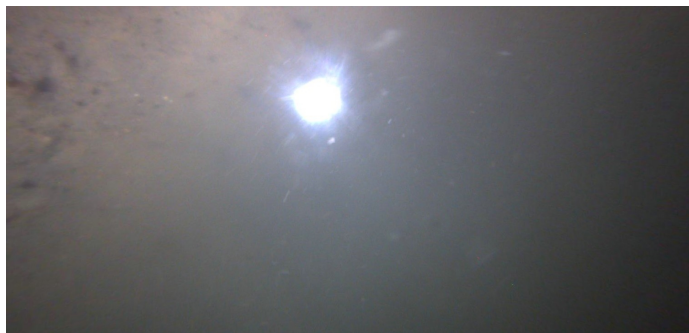
Code: **MGO**  
Description: **General Observation**

Distance (ft): **14.8**  
Structural Grade: **0**  
O&M Grade: **0**  
Clock Start/From:  
Clock To:  
1st Value:  
2nd Value:  
Value Percent:  
Step: **NO**  
Remarks: **end survey**
