# Manhole Inspection Report

Date:	<b>04/24/2018</b>	Weather:		Coding:	<b>RZMACP</b>
MH#:	<b>M-806-036</b>	Owner:	<b>NA</b>	Len. Surveyed:	<b>11.4</b>
P.O.#:		Surveyor:	<b>John Kuglmaier</b>	Rim to Invert:	<b>11.5</b>
Customer:	<b>8.7</b>	Cert. #:	<b>U-1215-07002349</b>	Wall Material:	<b>Concrete (reinforced)</b>

Street:	<b>Intersection of Port Ct. and 10th St.</b>	Project:	<b>Hobart, IN</b>
City:	<b>Hobart, IN</b>	GPS Northing:	<b>0.0</b>
Location:		GPS Easting:	<b>0.0</b>
Drain Area:	<b>Southeast</b>	GPS Accuracy:	<b>Nearest Meter</b>
Cover Shape:	<b>Circular</b>	Evidence of Surcharge:	<b>Yes</b>
Cover Size:	<b>22.5</b>	Potential for Runoff:	<b>None</b>
Comments:

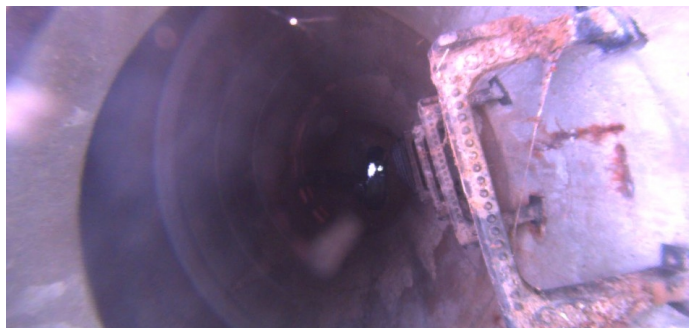
Code: **MGP**  
Description: **General Photo**

Distance (ft): **.0**  
Structural Grade: **0**  
O&M Grade: **0**  
Clock Start/From:  
Clock To:  
1st Value:  
2nd Value:  
Value Percent:  
Step: **NO**  
Remarks:

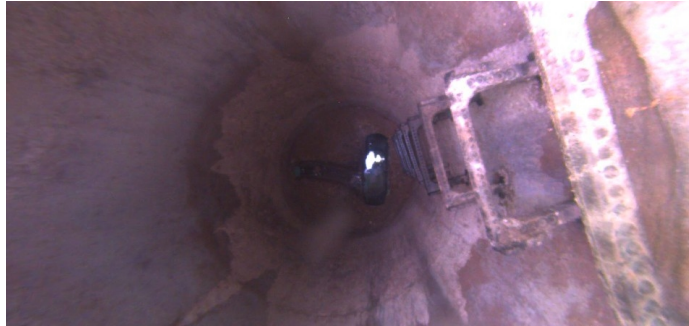
Code: **DAGS**  
Description: **Deposits Attached Grease**

Distance (ft): **1.5**  
Structural Grade: **0**  
O&M Grade: **2**  
Clock Start/From: **12**  
Clock To: **12**  
1st Value:  
2nd Value:  
Value Percent: **5.000**  
Step: **NO**  
Remarks:

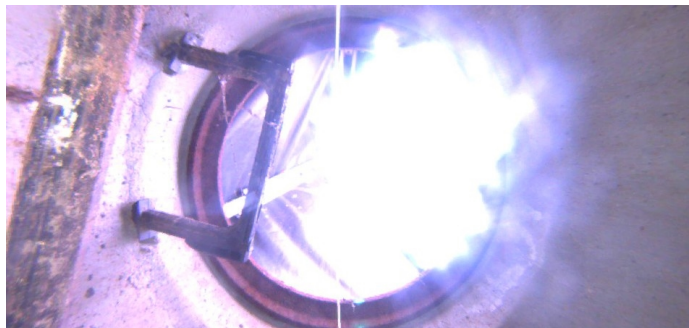
Code: **MGP**  
Description: **General Photo**

Distance (ft): **2.7**  
Structural Grade: **0**  
O&M Grade: **0**  
Clock Start/From:  
Clock To:  
1st Value:  
2nd Value:  
Value Percent:  
Step: **NO**  
Remarks:

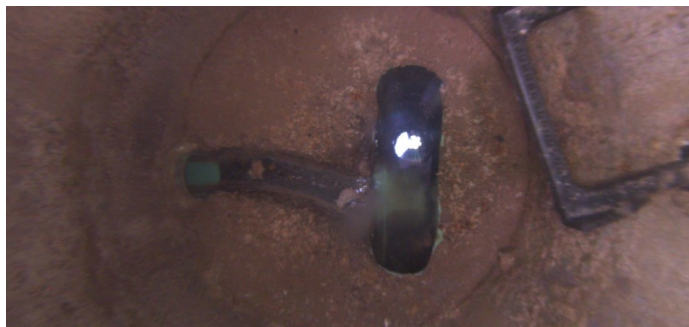
Code: **DSF**  
Description: **Deposits Settled Fine**

Distance (ft): **7.9**  
Structural Grade: **0**  
O&M Grade: **2**  
Clock Start/From: **12**  
Clock To: **12**  
1st Value:  
2nd Value:  
Value Percent: **5.000**  
Step: **NO**  
Remarks:

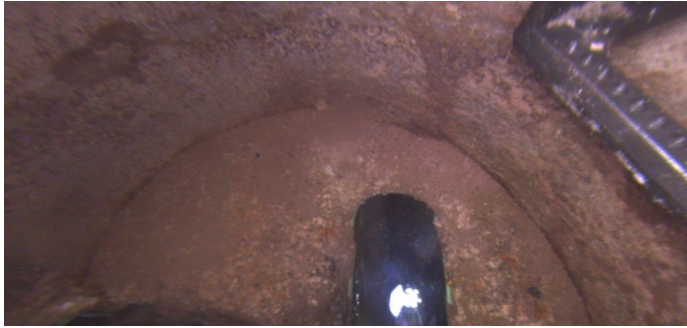
Code:	<b>DAGS</b>
Description:	<b>Deposits Attached Grease</b>
Distance (ft):	<b>8.8</b>
Structural Grade:	<b>0</b>
O&M Grade:	<b>2</b>
Clock Start/From:	<b>12</b>
Clock To:	<b>12</b>
1st Value:	
2nd Value:	
Value Percent:	<b>5.000</b>
Step:	<b>NO</b>
Remarks:

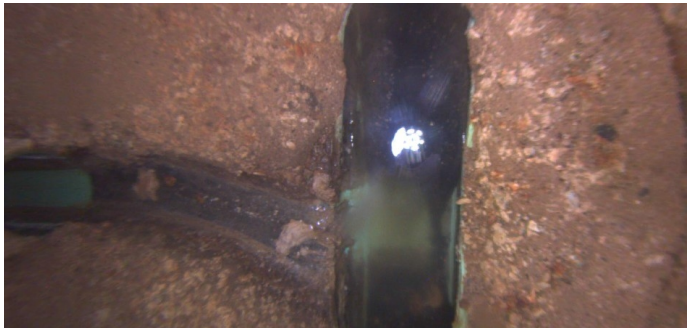
Code:	<b>MGO</b>
Description:	<b>General Observation</b>
Distance (ft):	<b>9.7</b>
Structural Grade:	<b>0</b>
O&M Grade:	<b>0</b>
Clock Start/From:	
Clock To:	
1st Value:	
2nd Value:	
Value Percent:	
Step:	<b>NO</b>
Remarks:	<b>Ins. Comp.</b>
