Manhole Inspection Report

Date:	04/21/2018	Weather:		Coding:	RZMACP
MH#:	M-806-041	Owner:	NA	Len. Surveyed:	8.1
P.O.#:		Surveyor:	John Kuglmaier	Rim to Invert:	8.7
Customer:	8.7	Cert. #:	U-1215-07002349	Wall Material:	Concrete (reinforced)

Street:	Intersection of Hobart Rd. and 10th	Project:	Hobart, IN
City:	Hobart, IN	GPS Northing:	0.0
Location:		GPS Easting:	0.0
Drain Area:	Southeast	GPS Accuracy:	Nearest Meter
Cover Shape:	Circular	Evidence of Surcharge:	Yes
Cover Size:	22.5	Potential for Runoff:	None
Comments:

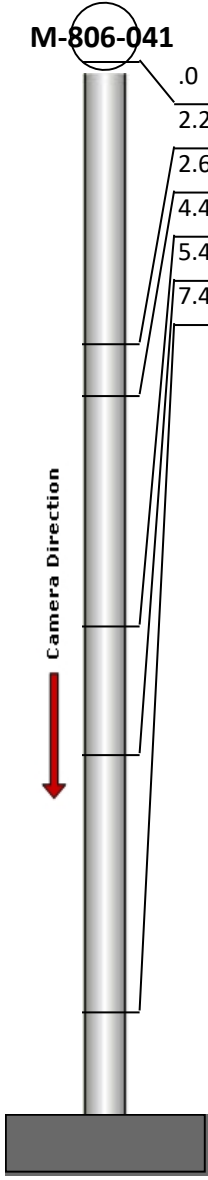
.0	MGP	General Photo	10	NA
	2.2	IS	Infil Stain	26	NA
	2.6	MGP	General Photo	41	NA
	4.4	IS	Infil Stain	59	NA
	5.4	DAZ	Deposits Attached Other	73	M 2
	7.4	MGO	General Observation	88	NA

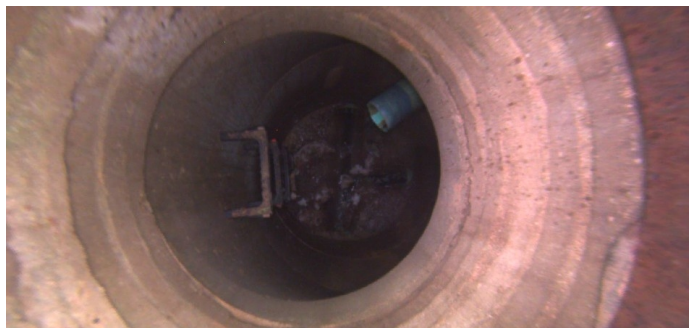
Code: **MGP**
Description: **General Photo**

Distance (ft): **.0**
Structural Grade: **0**
O&M Grade: **0**
Clock Start/From:
Clock To:
1st Value:
2nd Value:
Value Percent:
Step: **NO**
Remarks:

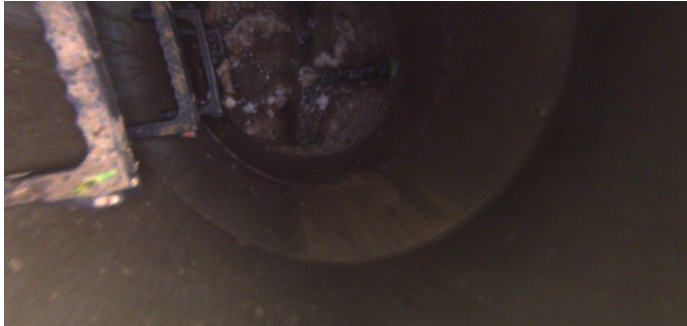
Code: **IS**
Description: **Infil Stain**

Distance (ft): **2.2**
Structural Grade: **0**
O&M Grade: **0**
Clock Start/From: **5**
Clock To: **6**
1st Value:
2nd Value:
Value Percent:
Step: **NO**
Remarks:

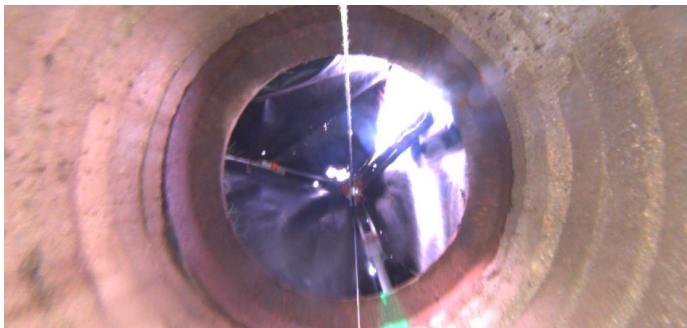
Code: **MGP**
Description: **General Photo**

Distance (ft): **2.6**
Structural Grade: **0**
O&M Grade: **0**
Clock Start/From:
Clock To:
1st Value:
2nd Value:
Value Percent:
Step: **NO**
Remarks:

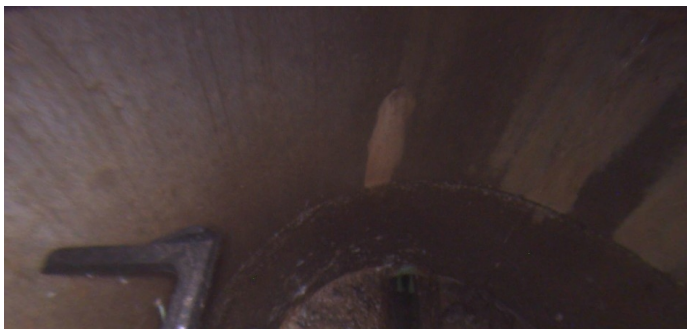
Code: **IS**
Description: **Infil Stain**

Distance (ft): **4.4**
Structural Grade: **0**
O&M Grade: **0**
Clock Start/From: **11**
Clock To:
1st Value:
2nd Value:
Value Percent:
Step: **NO**
Remarks:

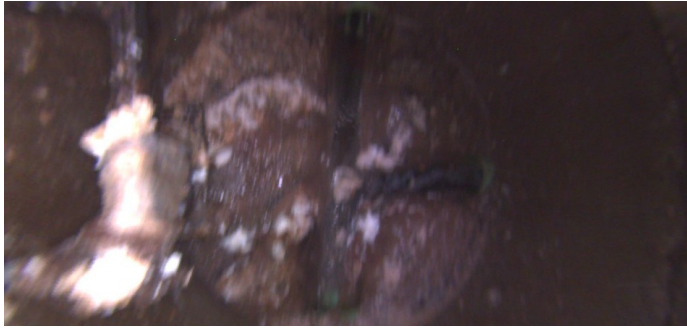
Code:	DAZ
Description:	Deposits Attached Other
Distance (ft):	5.4
Structural Grade:	0
O&M Grade:	2
Clock Start/From:	12
Clock To:	12
1st Value:	
2nd Value:	
Value Percent:	10.000
Step:	NO
Remarks:	Mixed materials

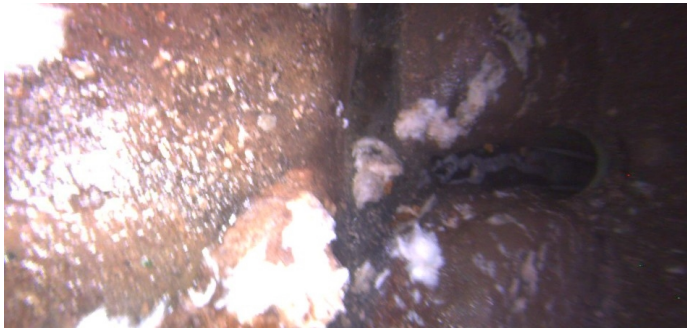
Code:	MGO
Description:	General Observation
Distance (ft):	7.4
Structural Grade:	0
O&M Grade:	0
Clock Start/From:	
Clock To:	
1st Value:	
2nd Value:	
Value Percent:	
Step:	NO
Remarks:	Ins. Comp.
