Manhole Inspection Report

Date:	04/17/2018	Weather:		Coding:	RZMACP
MH#:	M-807-001	Owner:	NA	Len. Surveyed:	6.7
P.O.#:		Surveyor:	Jen Costello	Rim to Invert:	7.1
Customer:		Cert. #:	U-907-5518	Wall Material:	Concrete (reinforced)

Street:	12th St. 1175' West of Hobart Rd.	Project:	Hobart, IN
City:	Hobart, IN	GPS Northing:	2908785.738
Location:		GPS Easting:	2908785.738
Drain Area:	Southeast	GPS Accuracy:	Sub-Meter
Cover Shape:	Circular	Evidence of Surcharge:	No
Cover Size:	22.5	Potential for Runoff:	None
Comments:

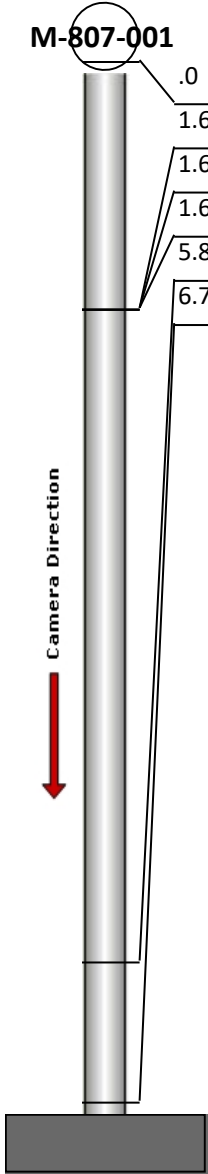
.0	MGO	General Observation	10	NA
	1.6	MGO	General Observation	26	NA
	1.6	SRV	Surface Reinforcement Visible	39	S 5
	1.6	IS	Infil Stain	51	NA
	5.8	DSF	Deposits Settled Fine	71	M 2
	6.7	MGO	General Observation	84	NA

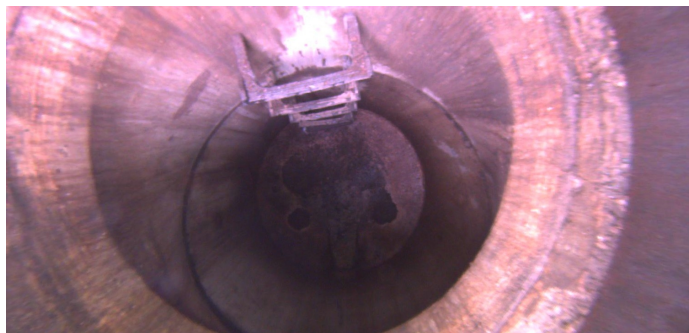
Code: **MGO**
Description: **General Observation**

Distance (ft): **.0**
Structural Grade: **0**
O&M Grade: **0**
Clock Start/From:
Clock To:
1st Value:
2nd Value:
Value Percent:
Step: **NO**
Remarks: **ACCESS MH**

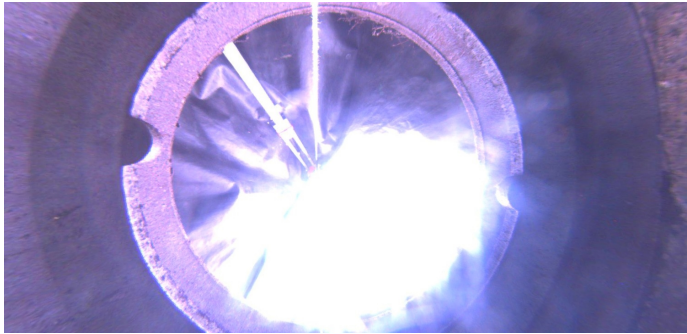
Code:	MGO
Description:	General Observation
Distance (ft):	1.6
Structural Grade:	0
O&M Grade:	0
Clock Start/From:	
Clock To:	
1st Value:	
2nd Value:	
Value Percent:	
Step:	NO
Remarks:	UNDERSIDE OF FRAME

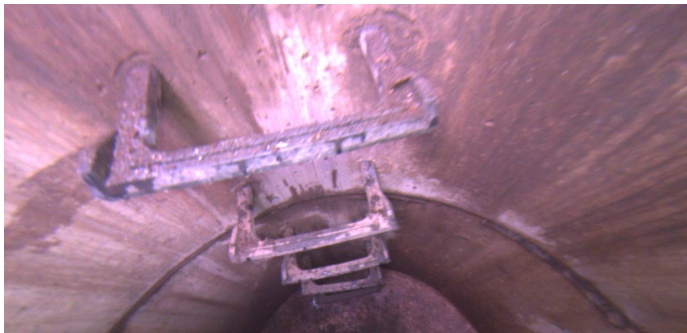
Code:	SRV
Description:	Surface Reinforcement Visible
Distance (ft):	1.6
Structural Grade:	5
O&M Grade:	0
Clock Start/From:	12
Clock To:	12
1st Value:	
2nd Value:	
Value Percent:	
Step:	NO
Remarks:

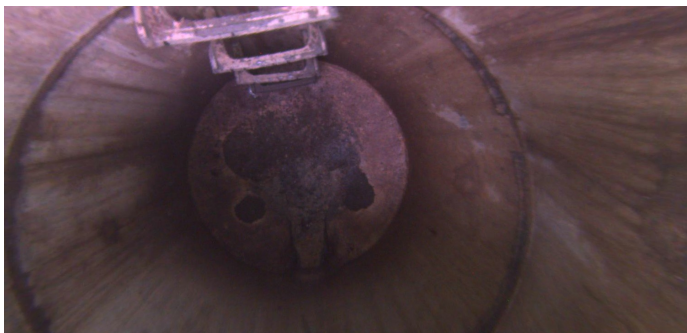
Code:	IS
Description:	Infil Stain
Distance (ft):	1.6
Structural Grade:	0
O&M Grade:	0
Clock Start/From:	12
Clock To:	12
1st Value:	
2nd Value:	
Value Percent:	
Step:	NO
Remarks:

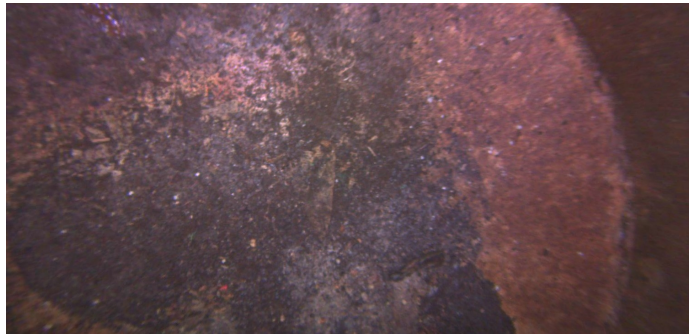
Code:	DSF
Description:	Deposits Settled Fine
Distance (ft):	5.8
Structural Grade:	0
O&M Grade:	2
Clock Start/From:	12
Clock To:	12
1st Value:	
2nd Value:	
Value Percent:	5.000
Step:	NO
Remarks:

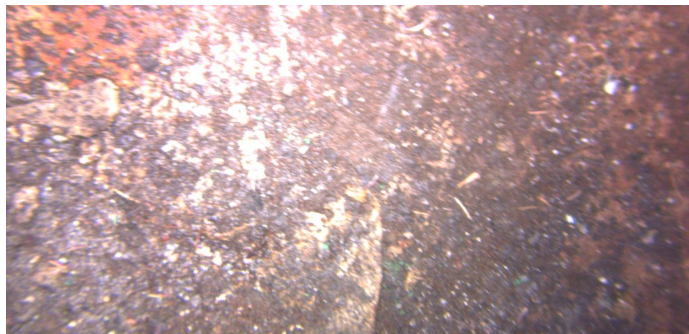
Code:	MGO
Description:	General Observation
Distance (ft):	6.7
Structural Grade:	0
O&M Grade:	0
Clock Start/From:	
Clock To:	
1st Value:	
2nd Value:	
Value Percent:	
Step:	NO
Remarks:	END SURVEY
