Manhole Inspection Report

| MH#: | M-807-002 | Owner: | NA | Len. Surveyed: | 8.6 |

| Street: | 12th St. 662' East of Kelly St. | Project: | Hobart, IN |

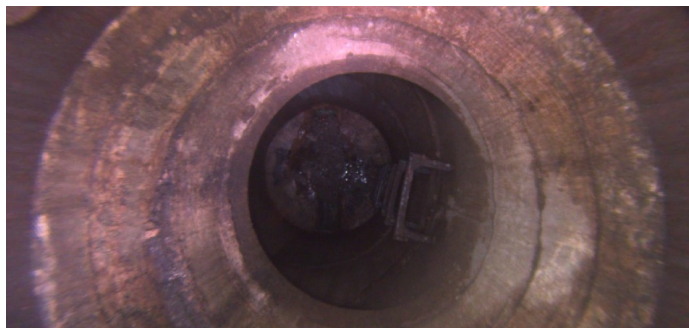
Code: **MGP**
Description: **General Photo**

Distance (ft): **.0**
Structural Grade: **0**
O&M Grade: **0**
Clock Start/From:
Clock To:
1st Value:
2nd Value:
Value Percent:
Step: **NO**
Remarks:

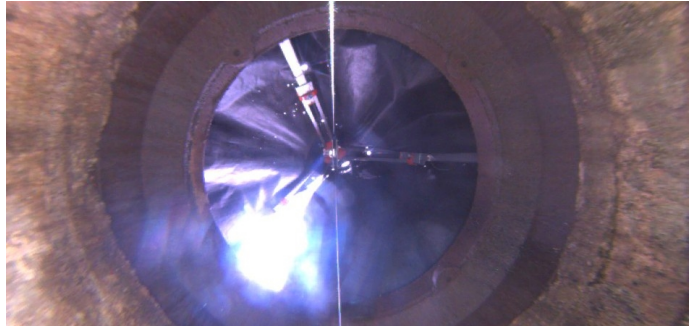
Code: **MGP**
Description: **General Photo**

Distance (ft): **2.2**
Structural Grade: **0**
O&M Grade: **0**
Clock Start/From:
Clock To:
1st Value:
2nd Value:
Value Percent:
Step: **NO**
Remarks:

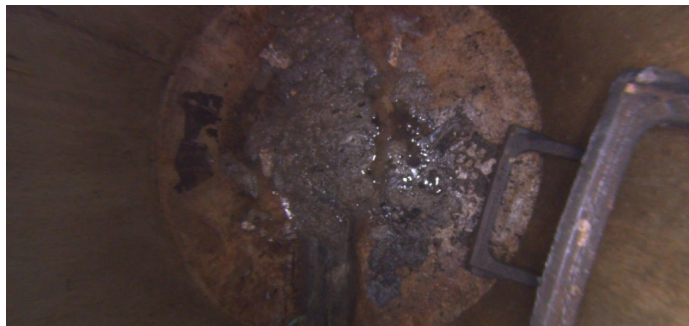
Code: **DAZ**
Description: **Deposits Attached Other**

Distance (ft): **6.2**
Structural Grade: **0**
O&M Grade: **2**
Clock Start/From: **12**
Clock To: **12**
1st Value:
2nd Value:
Value Percent: **5.000**
Step: **NO**
Remarks: **Mixed materials**

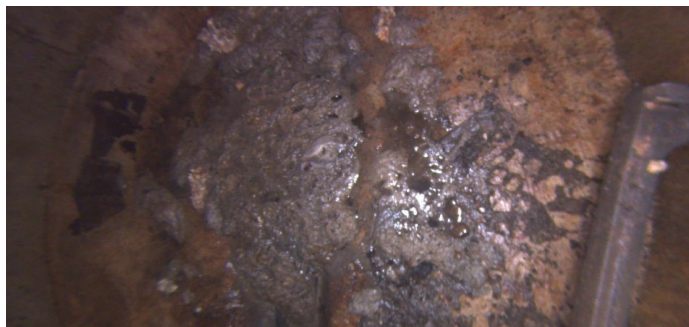
Code: **MGO**
Description: **General Observation**

Distance (ft): **7.3**
Structural Grade: **0**
O&M Grade: **0**
Clock Start/From:
Clock To:
1st Value:
2nd Value:
Value Percent:
Step: **NO**
Remarks: **Ins. Comp.**
