Manhole Inspection Report

Date:	04/17/2018	Weather:		Coding:	RZMACP
MH#:	M-807-003	Owner:	NA	Len. Surveyed:	10.0
P.O.#:		Surveyor:	Jen Costello	Rim to Invert:	10.3
Customer:		Cert. #:	U-907-5518	Wall Material:	Concrete (reinforced)

Street:	12th St. 267' East of Kelly St.	Project:	Hobart, IN
City:	Hobart, IN	GPS Northing:	2908023.052
Location:		GPS Easting:	2908023.052
Drain Area:	Southeast	GPS Accuracy:	Sub-Meter
Cover Shape:	Circular	Evidence of Surcharge:	No
Cover Size:	22.5	Potential for Runoff:	None
Comments:

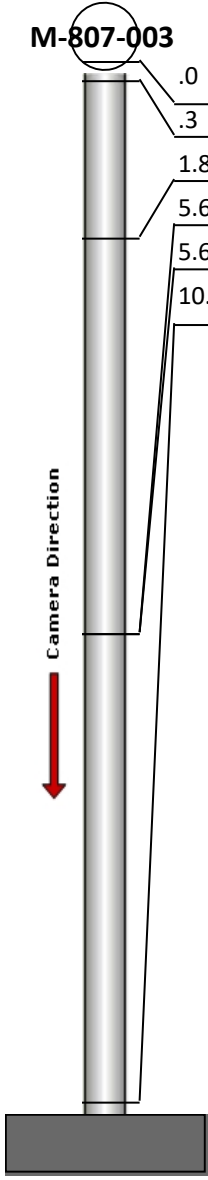
.0	MGO	General Observation	10	NA
	.3	SRI	Surface Roughness Increased	22	S 1
	1.8	MGO	General Observation	38	NA
	5.6	IS	Infil Stain	58	NA
	5.6	RFJ	Roots Fine Joint	70	M 1
	10.0	MGO	General Observation	90	NA

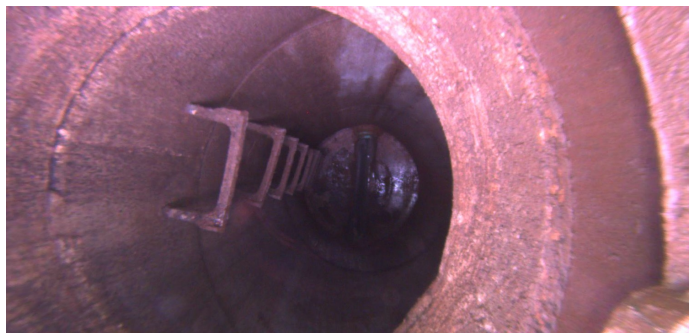
Code: **MGO**
Description: **General Observation**

Distance (ft): **.0**
Structural Grade: **0**
O&M Grade: **0**
Clock Start/From:
Clock To:
1st Value:
2nd Value:
Value Percent:
Step: **NO**
Remarks: **ACCESS MH**

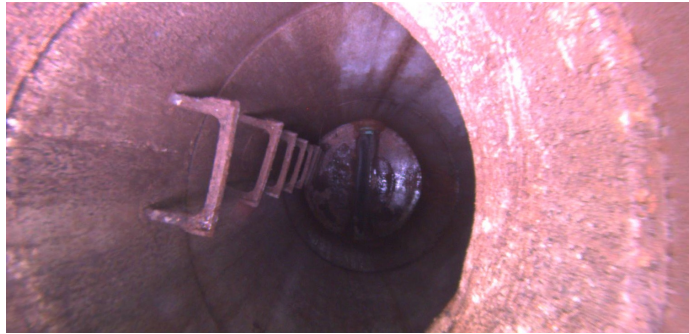
Code: **SRI**
Description: **Surface Roughness Increased**

Distance (ft): **.3**
Structural Grade: **1**
O&M Grade: **0**
Clock Start/From: **12**
Clock To: **12**
1st Value:
2nd Value:
Value Percent:
Step: **NO**
Remarks:

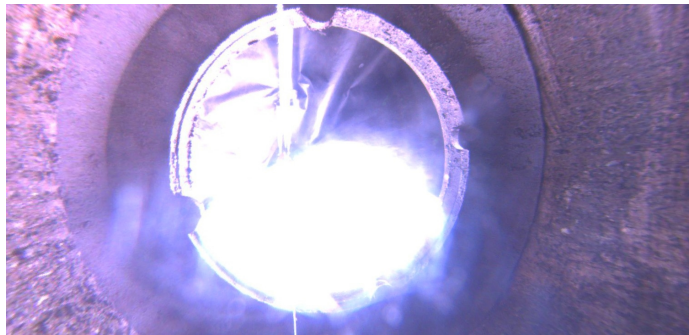
Code: **MGO**
Description: **General Observation**

Distance (ft): **1.8**
Structural Grade: **0**
O&M Grade: **0**
Clock Start/From:
Clock To:
1st Value:
2nd Value:
Value Percent:
Step: **NO**
Remarks: **UNDERSIDE OF FRAME**

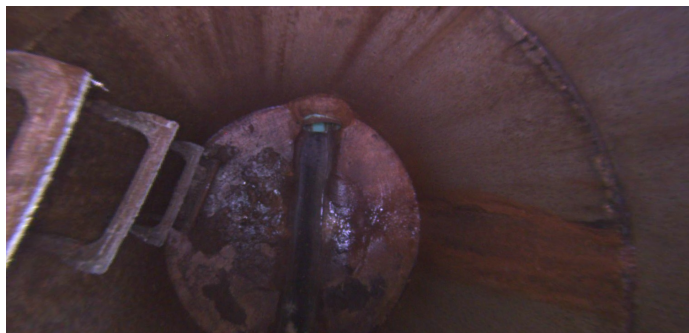
Code: **IS**
Description: **Infil Stain**

Distance (ft): **5.6**
Structural Grade: **0**
O&M Grade: **0**
Clock Start/From: **12**
Clock To: **12**
1st Value:
2nd Value:
Value Percent:
Step: **NO**
Remarks:

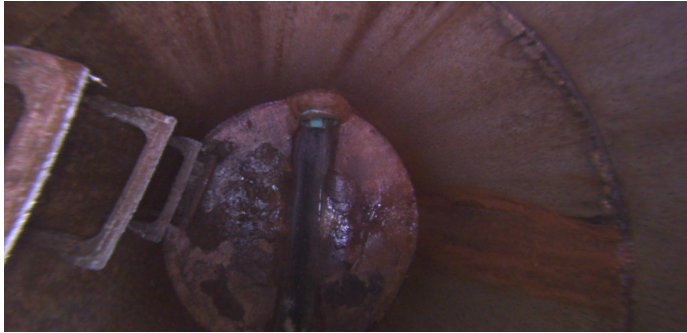
Code: **RFJ**
Description: **Roots Fine Joint**

Distance (ft): **5.6**
Structural Grade: **0**
O&M Grade: **1**
Clock Start/From: **12**
Clock To: **3**
1st Value:
2nd Value:
Value Percent:
Step: **NO**
Remarks:

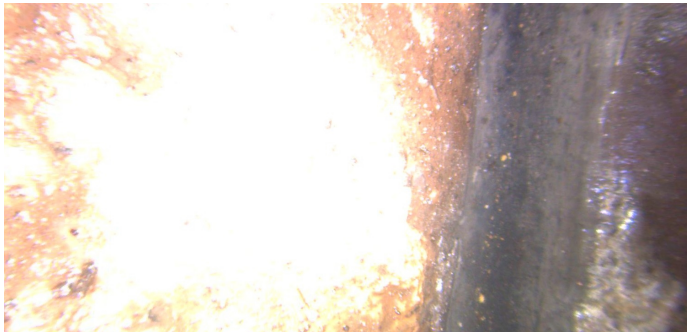
Code: **MGO**
Description: **General Observation**

Distance (ft): **10.0**
Structural Grade: **0**
O&M Grade: **0**
Clock Start/From:
Clock To:
1st Value:
2nd Value:
Value Percent:
Step: **NO**
Remarks: **END SURVEY**
