Manhole Inspection Report

Date:	04/17/2018	Weather:		Coding:	RZMACP
MH#:	M-807-007	Owner:	NA	Len. Surveyed:	8.7
P.O.#:		Surveyor:	Jen Costello	Rim to Invert:	9.1
Customer:		Cert. #:	U-907-5518	Wall Material:	Concrete (reinforced)

Street:	Intersection of Illinois St. and 13th S	Project:	Hobart, IN
City:	Hobart, IN	GPS Northing:	2907636.174
Location:		GPS Easting:	2907636.174
Drain Area:	Southeast	GPS Accuracy:	Sub-Meter
Cover Shape:	Circular	Evidence of Surcharge:	No
Cover Size:	22.5	Potential for Runoff:	None
Comments:

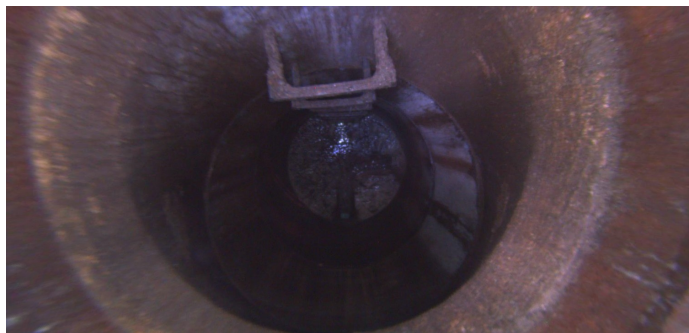
Code: **MGO**
Description: **General Observation**

Distance (ft): **.0**
Structural Grade: **0**
O&M Grade: **0**
Clock Start/From:
Clock To:
1st Value:
2nd Value:
Value Percent:
Step: **NO**
Remarks: **ACCESS MH**

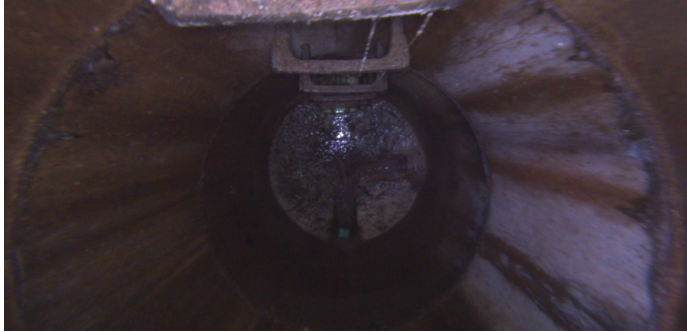
Code: **IW**
Description: **Infil Weeper**

Distance (ft): **2.3**
Structural Grade: **0**
O&M Grade: **2**
Clock Start/From: **12**
Clock To: **5**
1st Value:
2nd Value:
Value Percent:
Step: **NO**
Remarks:

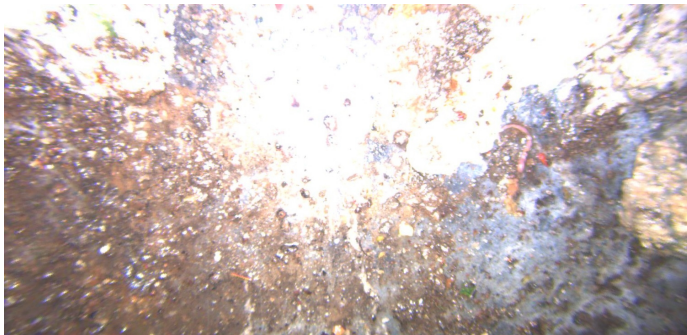
Code: **MGO**
Description: **General Observation**

Distance (ft): **8.7**
Structural Grade: **0**
O&M Grade: **0**
Clock Start/From:
Clock To:
1st Value:
2nd Value:
Value Percent:
Step: **NO**
Remarks: **END SURVEY**
