Manhole Inspection Report

Date:	04/09/2018	Weather:		Coding:	RZMACP
MH#:	M-808-001	Owner:	NA	Len. Surveyed:	13.7
P.O.#:		Surveyor:	John Kuglmaier	Rim to Invert:	14.3
Customer:		Cert. #:	U-1215-07002349	Wall Material:	Concrete (reinforced)

Street:	Capitol Dr. 173' East of Hidden Oak	Project:	Hobart, IN
City:	Hobart, IN	GPS Northing:	2907360.934
Location:		GPS Easting:	2907360.934
Drain Area:	Southwest	GPS Accuracy:	Sub-Meter
Cover Shape:	Circular	Evidence of Surcharge:	No
Cover Size:	22.5	Potential for Runoff:	None
Comments:

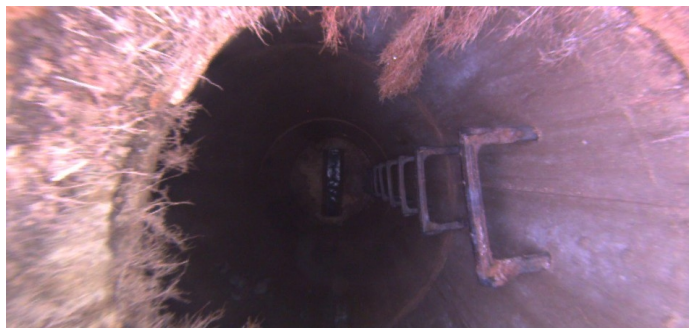
Code: **MGP**
Description: **General Photo**

Distance (ft): **.0**
Structural Grade: **0**
O&M Grade: **0**
Clock Start/From:
Clock To:
1st Value:
2nd Value:
Value Percent:
Step: **NO**
Remarks:

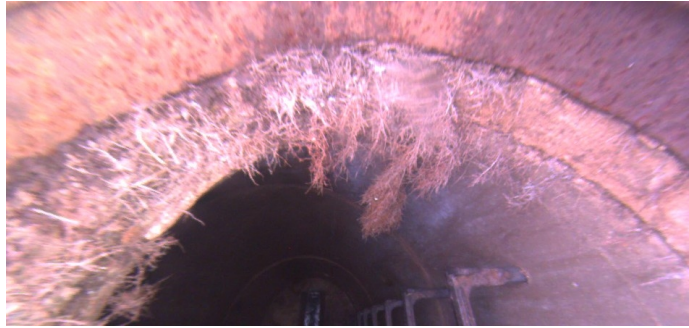
Code:	RFJ
Description:	Roots Fine Joint
Distance (ft):	.0
Structural Grade:	0
O&M Grade:	1
Clock Start/From:	12
Clock To:	12
1st Value:	
2nd Value:	
Value Percent:	
Step:	NO
Remarks:

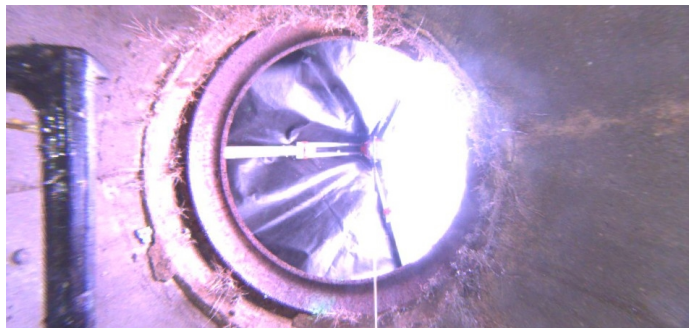
Code:	MGP
Description:	General Photo
Distance (ft):	2.6
Structural Grade:	0
O&M Grade:	0
Clock Start/From:	
Clock To:	
1st Value:	
2nd Value:	
Value Percent:	
Step:	NO
Remarks:

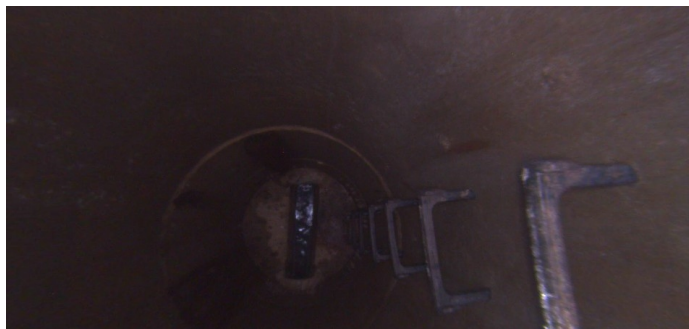
Code:	IS
Description:	Infil Stain
Distance (ft):	3.6
Structural Grade:	0
O&M Grade:	0
Clock Start/From:	2
Clock To:	
1st Value:	
2nd Value:	
Value Percent:	
Step:	NO
Remarks:

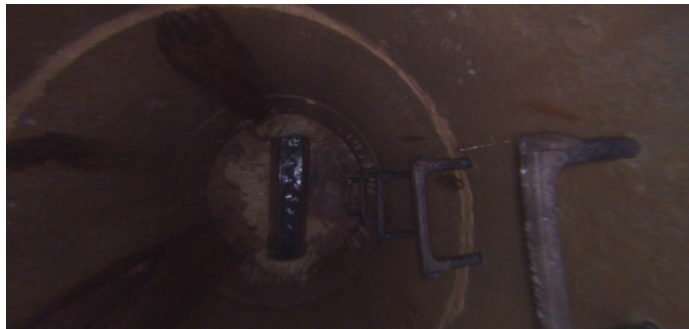
Code: **IS**
Description: **Infil Stain**

Distance (ft): **6.3**
Structural Grade: **0**
O&M Grade: **0**
Clock Start/From: **2**
Clock To:
1st Value:
2nd Value:
Value Percent:
Step: **NO**
Remarks:

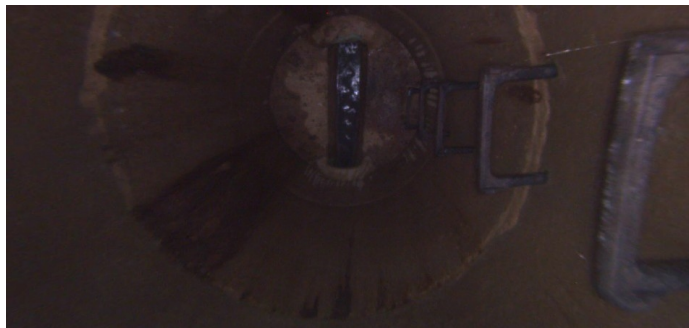
Code: **IS**
Description: **Infil Stain**

Distance (ft): **6.3**
Structural Grade: **0**
O&M Grade: **0**
Clock Start/From: **4**
Clock To: **9**
1st Value:
2nd Value:
Value Percent:
Step: **NO**
Remarks:

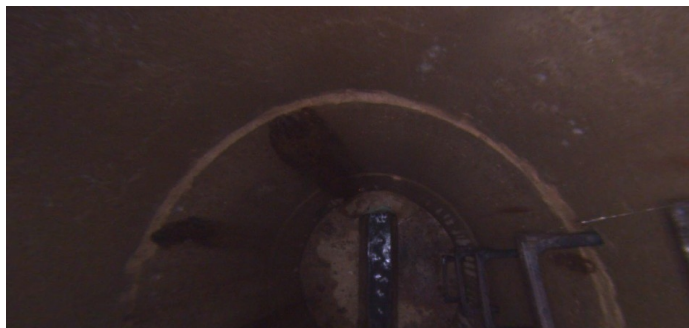
Code: **IS**
Description: **Infil Stain**

Distance (ft): **6.3**
Structural Grade: **0**
O&M Grade: **0**
Clock Start/From: **11**
Clock To:
1st Value:
2nd Value:
Value Percent:
Step: **NO**
Remarks:

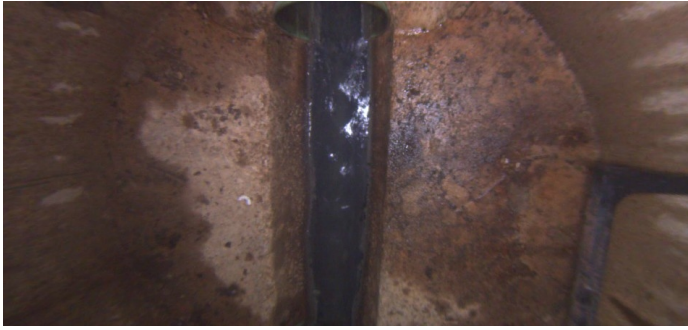
Code:	MGO
Description:	General Observation
Distance (ft):	11.9
Structural Grade:	0
O&M Grade:	0
Clock Start/From:	
Clock To:	
1st Value:	
2nd Value:	
Value Percent:	
Step:	NO
Remarks:	Ins. Comp.
