# Manhole Inspection Report

Date:	04/09/2018	Weather:		Coding:	RZMACP
MH#:	M-808-002	Owner:	NA	Len. Surveyed:	11.2
P.O.#:		Surveyor:	John Kuglmaier	Rim to Invert:	11.6
Customer:		Cert. #:	U-1215-07002349	Wall Material:	Concrete (reinforced)

Street:	Capitol Dr. 574' East of Hidden Oak	Project:	Hobart, IN
City:	Hobart, IN	GPS Northing:	2907763.788
Location:		GPS Easting:	2907763.788
Drain Area:	Southwest	GPS Accuracy:	Sub-Meter
Cover Shape:	Circular	Evidence of Surcharge:	No
Cover Size:	22.5	Potential for Runoff:	None
Comments:

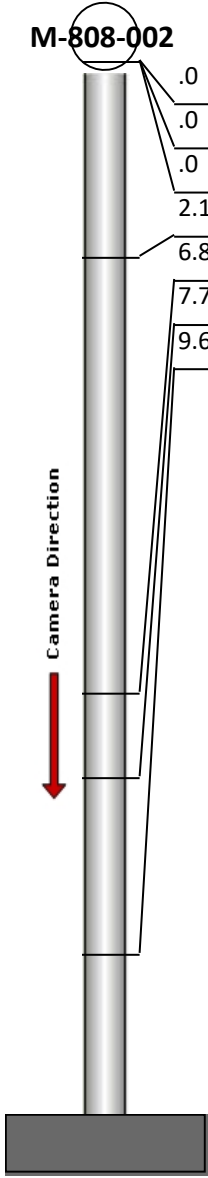
.0	MGP	General Photo	10	NA
	.0	RFJ	Roots Fine Joint	22	M 1
	.0	RFB	Roots Fine Barrel	33	M 2
	2.1	MGP	General Photo	51	NA
	6.8	RFB	Roots Fine Barrel	75	M 2
	7.7	DSF	Deposits Settled Fine	88	M 2
	9.6	MGO	General Observation	104	NA

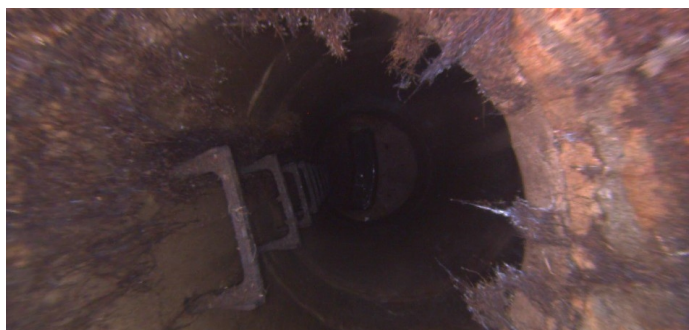
Code: **MGP**  
Description: **General Photo**

Distance (ft): **.0**  
Structural Grade: **0**  
O&M Grade: **0**  
Clock Start/From:  
Clock To:  
1st Value:  
2nd Value:  
Value Percent:  
Step: **NO**  
Remarks:

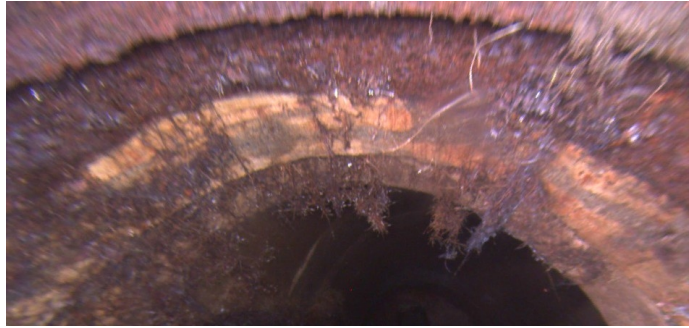
Code: **RFJ**  
Description: **Roots Fine Joint**

Distance (ft): **.0**  
Structural Grade: **0**  
O&M Grade: **1**  
Clock Start/From: **12**  
Clock To: **12**  
1st Value:  
2nd Value:  
Value Percent:  
Step: **NO**  
Remarks:

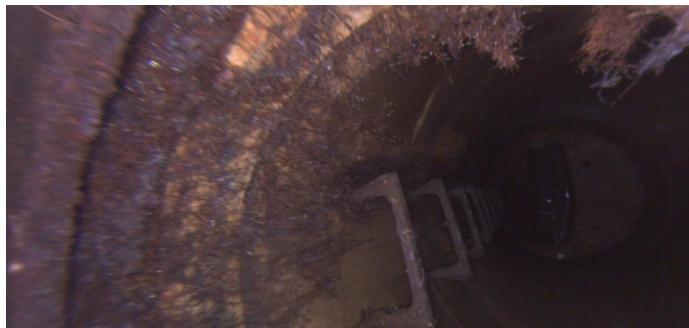
Code: **RFB**  
Description: **Roots Fine Barrel**

Distance (ft): **.0**  
Structural Grade: **0**  
O&M Grade: **2**  
Clock Start/From: **10**  
Clock To:  
1st Value:  
2nd Value:  
Value Percent:  
Step: **NO**  
Remarks:

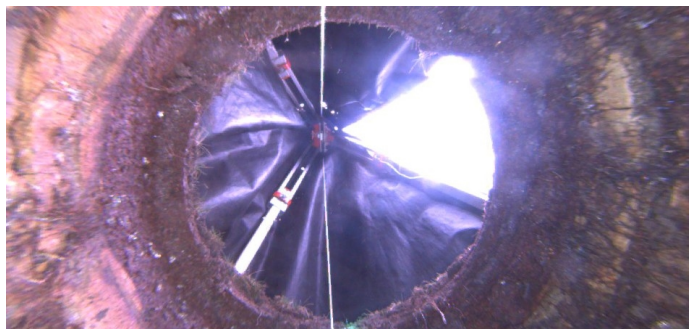
Code: **MGP**  
Description: **General Photo**

Distance (ft): **2.1**  
Structural Grade: **0**  
O&M Grade: **0**  
Clock Start/From:  
Clock To:  
1st Value:  
2nd Value:  
Value Percent:  
Step: **NO**  
Remarks:

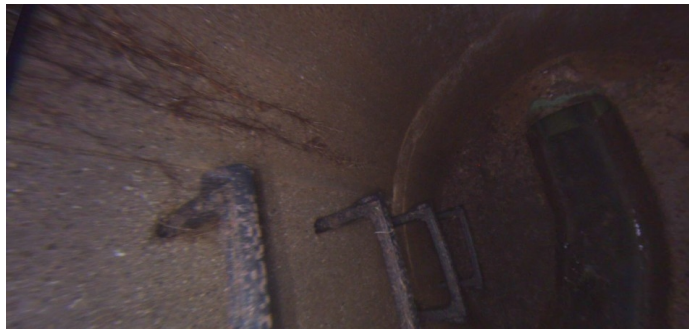
Code: **RFB**  
Description: **Roots Fine Barrel**

Distance (ft): **6.8**  
Structural Grade: **0**  
O&M Grade: **2**  
Clock Start/From: **10**  
Clock To:  
1st Value:  
2nd Value:  
Value Percent:  
Step: **NO**  
Remarks:

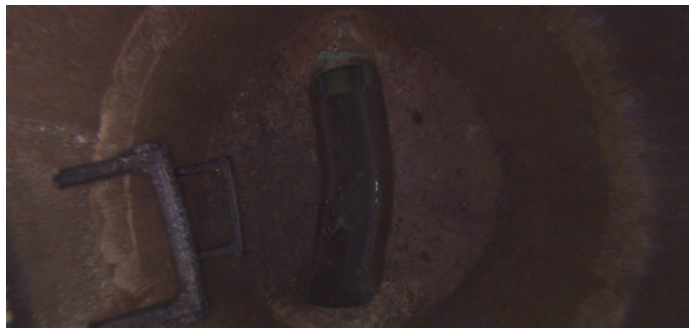
Code: **DSF**  
Description: **Deposits Settled Fine**

Distance (ft): **7.7**  
Structural Grade: **0**  
O&M Grade: **2**  
Clock Start/From: **6**  
Clock To: **11**  
1st Value:  
2nd Value:  
Value Percent: **5.000**  
Step: **NO**  
Remarks:

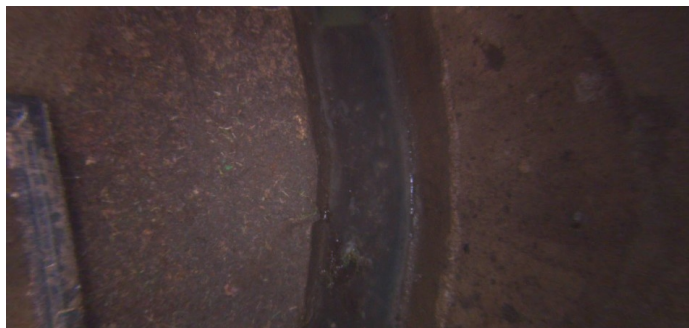
Code: **MGO**  
Description: **General Observation**

Distance (ft): **9.6**  
Structural Grade: **0**  
O&M Grade: **0**  
Clock Start/From:  
Clock To:  
1st Value:  
2nd Value:  
Value Percent:  
Step: **NO**  
Remarks: **Ins. Comp.**
