Manhole Inspection Report

Date:	04/11/2018	Weather:		Coding:	RZMACP
MH#:	M-808-026	Owner:	NA	Len. Surveyed:	3.7
P.O.#:		Surveyor:	John Kuglmaier	Rim to Invert:	4.8
Customer:		Cert. #:	U-1215-07002349	Wall Material:	Concrete (reinforced)

Street:	On Hobart Rd. 573' North of 61st Av	Project:	Hobart, IN
City:	Hobart, IN	GPS Northing:	0.0
Location:		GPS Easting:	0.0
Drain Area:	Southeast	GPS Accuracy:	Nearest Meter
Cover Shape:	Circular	Evidence of Surcharge:	Yes
Cover Size:	22.5	Potential for Runoff:	None
Comments:

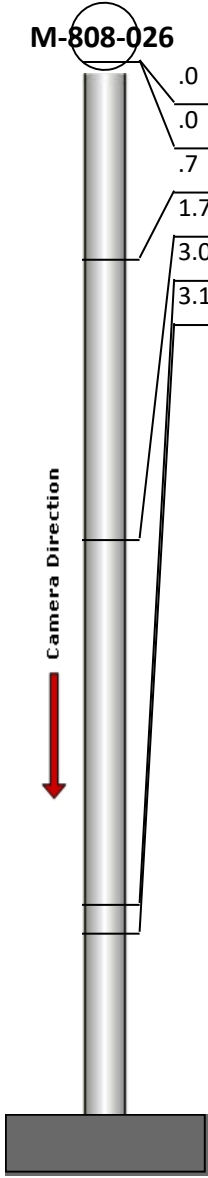
Position	Code	Observation	Video (sec)	Grade

.0	MGP	General Photo	10	NA
	.0	DAZ	Deposits Attached Other	22	M 2
	.7	DAZ	Deposits Attached Other	35	M 3
	1.7	MGP	General Photo	51	NA
	3.0	DAZ	Deposits Attached Other	68	M 2
	3.1	MGO	General Observation	80	NA

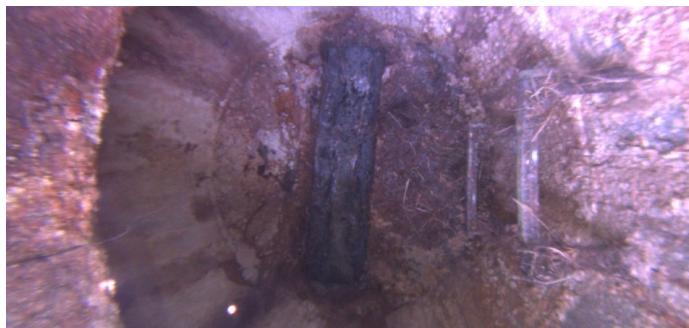
Code: **MGP**
Description: **General Photo**

Distance (ft): **.0**
Structural Grade: **0**
O&M Grade: **0**
Clock Start/From:
Clock To:
1st Value:
2nd Value:
Value Percent:
Step: **NO**
Remarks:

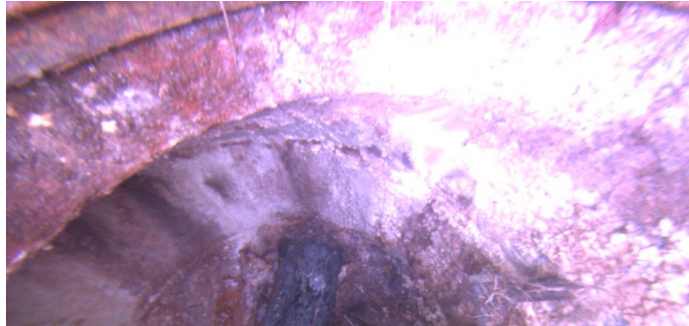
Code:	DAZ
Description:	Deposits Attached Other
Distance (ft):	.0
Structural Grade:	0
O&M Grade:	2
Clock Start/From:	12
Clock To:	12
1st Value:	
2nd Value:	
Value Percent:	10.000
Step:	NO
Remarks:	Mixed materials

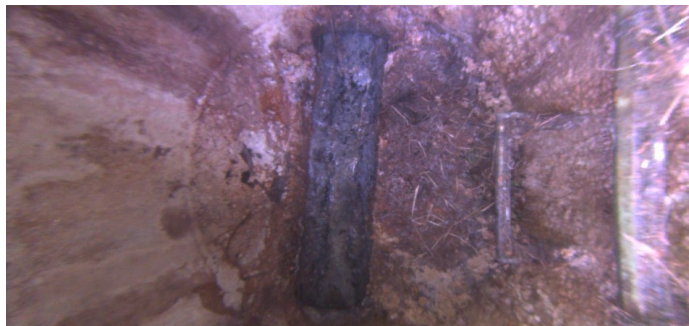
Code:	DAZ
Description:	Deposits Attached Other
Distance (ft):	.7
Structural Grade:	0
O&M Grade:	3
Clock Start/From:	12
Clock To:	12
1st Value:	
2nd Value:	
Value Percent:	15.000
Step:	NO
Remarks:	Mixed materials

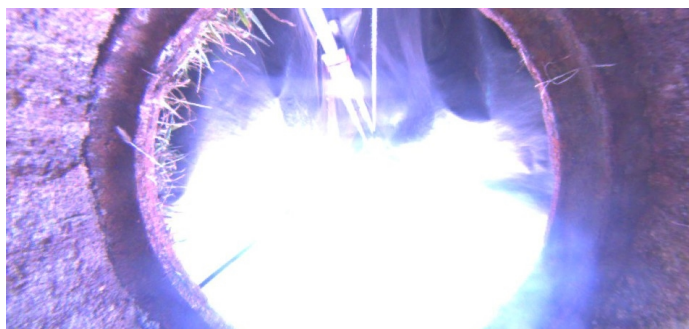
Code:	MGP
Description:	General Photo
Distance (ft):	1.7
Structural Grade:	0
O&M Grade:	0
Clock Start/From:	
Clock To:	
1st Value:	
2nd Value:	
Value Percent:	
Step:	NO
Remarks:

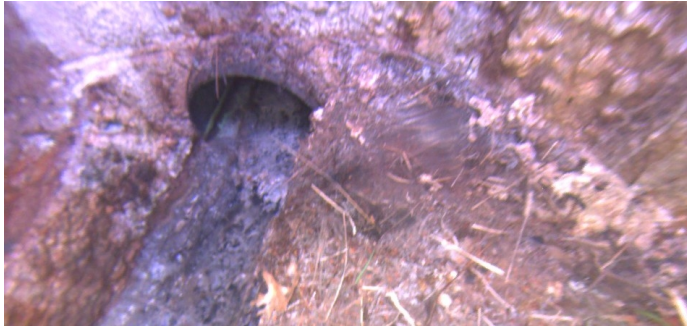
Code:	DAZ
Description:	Deposits Attached Other
Distance (ft):	3.0
Structural Grade:	0
O&M Grade:	2
Clock Start/From:	12
Clock To:	12
1st Value:	
2nd Value:	
Value Percent:	10.000
Step:	NO
Remarks:	Mixed materials

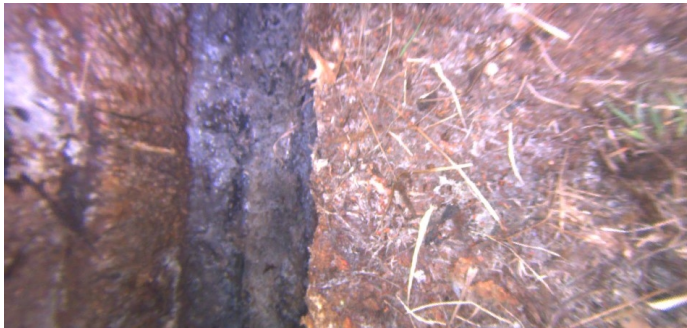
Code:	MGO
Description:	General Observation
Distance (ft):	3.1
Structural Grade:	0
O&M Grade:	0
Clock Start/From:	
Clock To:	
1st Value:	
2nd Value:	
Value Percent:	
Step:	NO
Remarks:	Ins. Comp.
