# Manhole Inspection Report

Position	Code	Observation	Video (sec)	Grade

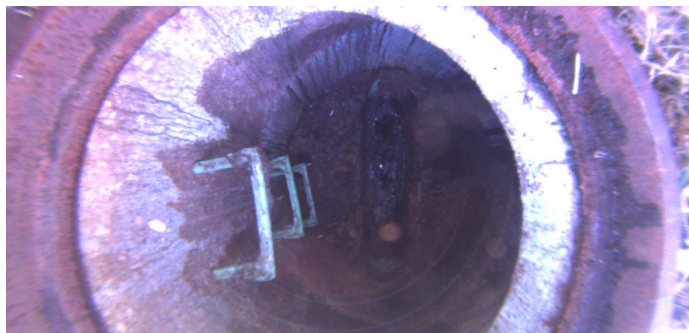
Code: **MGO**  
Description: **General Observation**

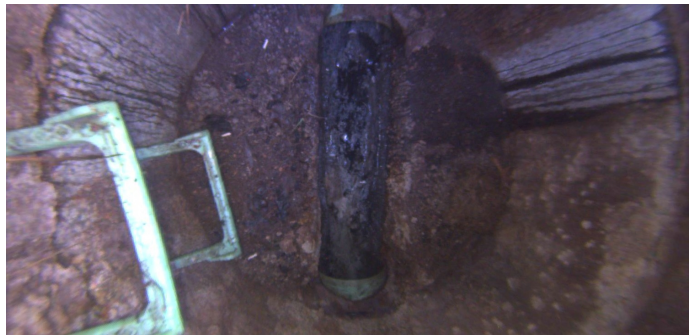
Code:	<b>IS</b>
Description:	<b>Infil Stain</b>
Distance (ft):	<b>2.3</b>
Structural Grade:	<b>0</b>
O&M Grade:	<b>0</b>
Clock Start/From:	<b>12</b>
Clock To:	<b>12</b>
1st Value:	
2nd Value:	
Value Percent:	
Step:	<b>NO</b>
Remarks:

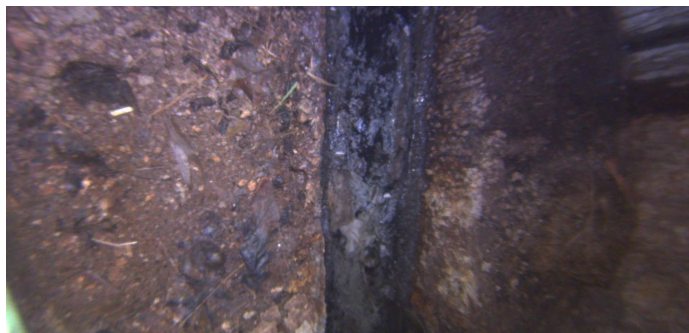
Code:	<b>DSF</b>
Description:	<b>Deposits Settled Fine</b>
Distance (ft):	<b>4.0</b>
Structural Grade:	<b>0</b>
O&M Grade:	<b>2</b>
Clock Start/From:	<b>12</b>
Clock To:	<b>12</b>
1st Value:	
2nd Value:	
Value Percent:	<b>5.000</b>
Step:	<b>NO</b>
Remarks:
