Manhole Inspection Report

Date:	04/19/2018	Weather:		Coding:	RZMACP
MH#:	M-808-031	Owner:	NA	Len. Surveyed:	7.4
P.O.#:		Surveyor:	Jen Costello	Rim to Invert:	8.2
Customer:		Cert. #:	U-907-5518	Wall Material:	Concrete (reinforced)

Street:	On Hobart Rd. 2487' North of 61st A	Project:	Hobart, IN
City:	Hobart, IN	GPS Northing:	0.0
Location:		GPS Easting:	0.0
Drain Area:	Southeast	GPS Accuracy:	Nearest Meter
Cover Shape:	Circular	Evidence of Surcharge:	No
Cover Size:	22.5	Potential for Runoff:	None
Comments:

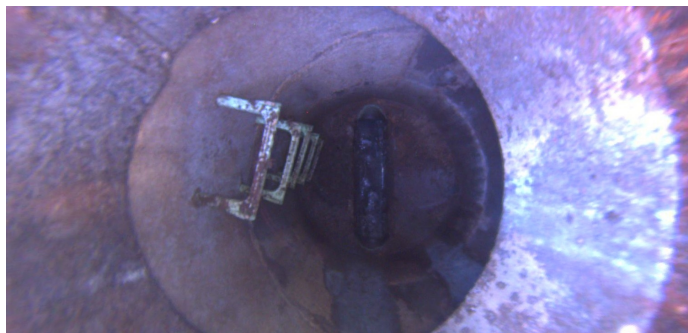
Code: **MGO**
Description: **General Observation**

Distance (ft): **.0**
Structural Grade: **0**
O&M Grade: **0**
Clock Start/From:
Clock To:
1st Value:
2nd Value:
Value Percent:
Step: **NO**
Remarks: **ACCESS MH**

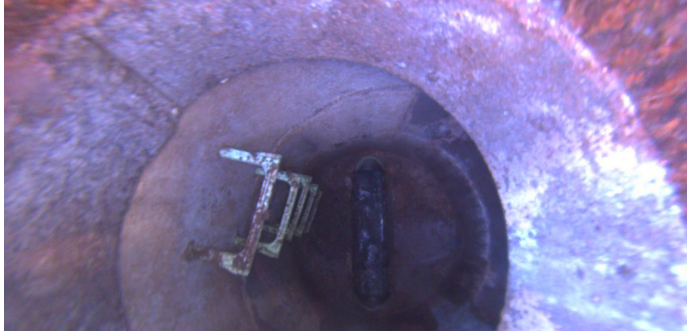
Code:	FL
Description:	Fracture Longitudinal
Distance (ft):	.0
Structural Grade:	3
O&M Grade:	0
Clock Start/From:	10
Clock To:	
1st Value:	
2nd Value:	
Value Percent:	
Step:	NO
Remarks:

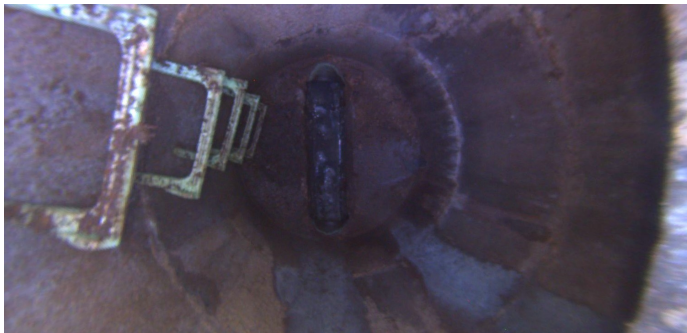
Code:	IW
Description:	Infil Weeper
Distance (ft):	1.2
Structural Grade:	0
O&M Grade:	2
Clock Start/From:	1
Clock To:	6
1st Value:	
2nd Value:	
Value Percent:	
Step:	NO
Remarks:

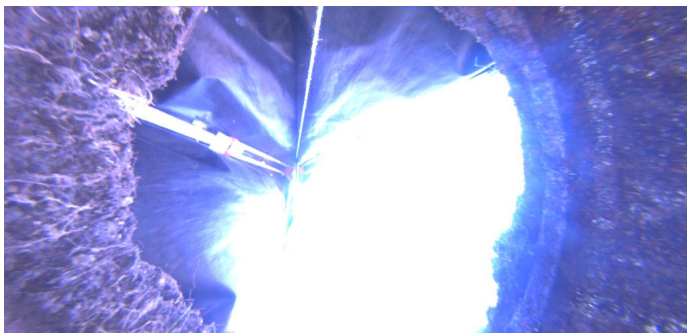
Code:	MGO
Description:	General Observation
Distance (ft):	1.2
Structural Grade:	0
O&M Grade:	0
Clock Start/From:	
Clock To:	
1st Value:	
2nd Value:	
Value Percent:	
Step:	NO
Remarks:	UNDERSIDE OF FRAME

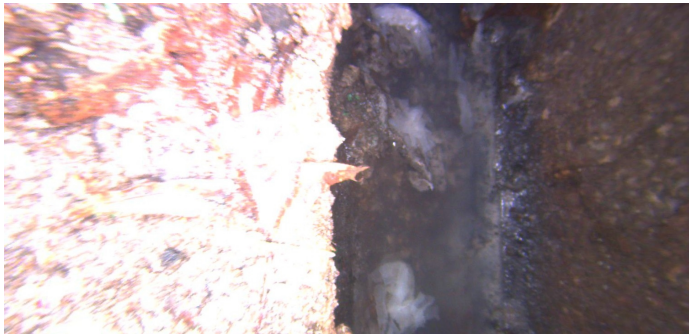
Code: **SAP**
Description: **Surface Aggregate Projecting**

Distance (ft): **7.4**
Structural Grade: **3**
O&M Grade: **0**
Clock Start/From: **3**
Clock To: **9**
1st Value:
2nd Value:
Value Percent:
Step: **NO**
Remarks:

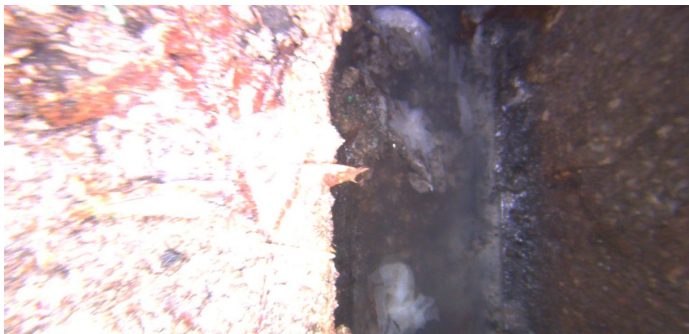
Code: **MGO**
Description: **General Observation**

Distance (ft): **7.4**
Structural Grade: **0**
O&M Grade: **0**
Clock Start/From:
Clock To:
1st Value:
2nd Value:
Value Percent:
Step: **NO**
Remarks: **END SURVEY**
