# Manhole Inspection Report

Date:	<b>04/11/2018</b>	Weather:		Coding:	<b>RZMACP</b>
MH#:	<b>M-809-025</b>	Owner:	<b>NA</b>	Len. Surveyed:	<b>5.7</b>
P.O.#:		Surveyor:	<b>John Kuglmaier</b>	Rim to Invert:	<b>6.2</b>
Customer:		Cert. #:	<b>U-1215-07002349</b>	Wall Material:	<b>Concrete (reinforced)</b>

Street:	<b>Intersection of Liberty St. and Murre</b>	Project:	<b>Hobart, IN</b>
City:	<b>Hobart, IN</b>	GPS Northing:	<b>2909629.539</b>
Location:		GPS Easting:	<b>2909629.539</b>
Drain Area:	<b>Southwest</b>	GPS Accuracy:	<b>Sub-Meter</b>
Cover Shape:	<b>Circular</b>	Evidence of Surcharge:	<b>No</b>
Cover Size:	<b>22.5</b>	Potential for Runoff:	<b>None</b>
Comments:

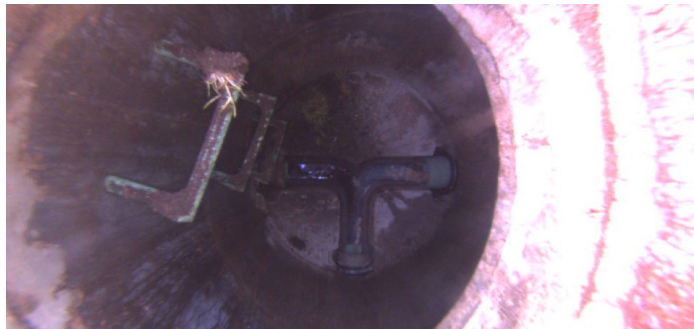
Code: **MGP**  
Description: **General Photo**

Distance (ft): **.0**  
Structural Grade: **0**  
O&M Grade: **0**  
Clock Start/From:  
Clock To:  
1st Value:  
2nd Value:  
Value Percent:  
Step: **NO**  
Remarks:

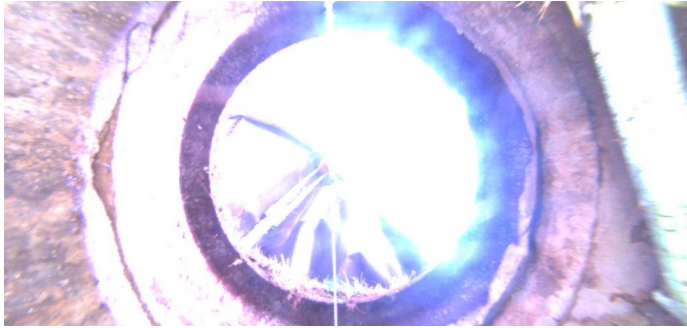
Code: **MGP**  
Description: **General Photo**

Distance (ft): **2.5**  
Structural Grade: **0**  
O&M Grade: **0**  
Clock Start/From:  
Clock To:  
1st Value:  
2nd Value:  
Value Percent:  
Step: **NO**  
Remarks:

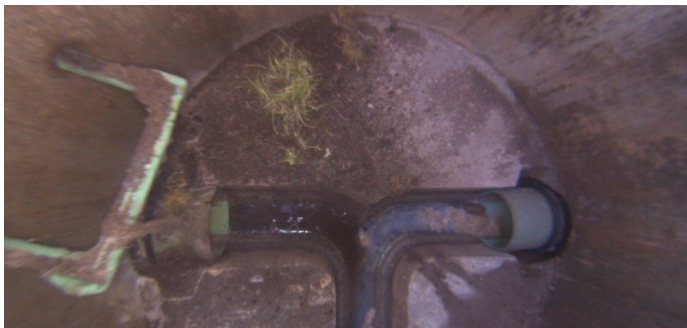
Code: **DAZ**  
Description: **Deposits Attached Other**

Distance (ft): **3.3**  
Structural Grade: **0**  
O&M Grade: **2**  
Clock Start/From: **9**  
Clock To: **12**  
1st Value:  
2nd Value:  
Value Percent: **5.000**  
Step: **NO**  
Remarks: **Mixed materials**

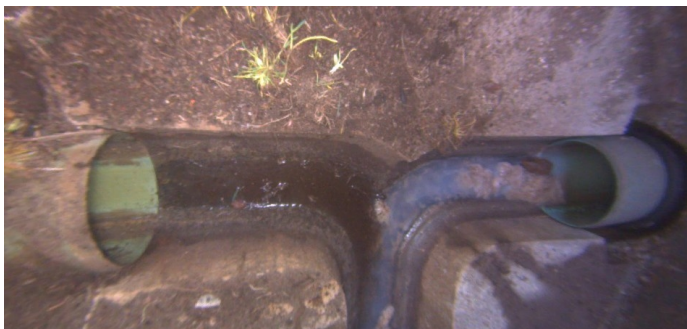
Code: **MGO**  
Description: **General Observation**

Distance (ft): **4.7**  
Structural Grade: **0**  
O&M Grade: **0**  
Clock Start/From:  
Clock To:  
1st Value:  
2nd Value:  
Value Percent:  
Step: **NO**  
Remarks: **Ins. Comp.**
