Manhole Inspection Report

Date:	04/11/2018	Weather:		Coding:	RZMACP
MH#:	M-809-032	Owner:	NA	Len. Surveyed:	8.4
P.O.#:		Surveyor:	John Kuglmaier	Rim to Invert:	9.0
Customer:		Cert. #:	U-1215-07002349	Wall Material:	Concrete (reinforced)

Street:	Eider Ave. 226' North of Bracken Par	Project:	Hobart, IN
City:	Hobart, IN	GPS Northing:	2908939.917
Location:		GPS Easting:	2908939.917
Drain Area:	Southwest	GPS Accuracy:	Sub-Meter
Cover Shape:	Circular	Evidence of Surcharge:	No
Cover Size:	22.5	Potential for Runoff:	None
Comments:

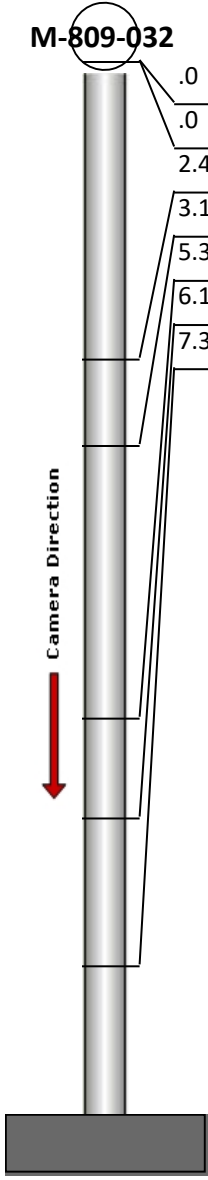
.0	MGP	General Photo	10	NA
	.0	RFJ	Roots Fine Joint	22	M 1
	2.4	MGP	General Photo	40	NA
	3.1	IS	Infil Stain	56	NA
	5.3	DSF	Deposits Settled Fine	72	M 2
	6.1	IS	Infil Stain	85	NA
	7.3	MGO	General Observation	99	NA

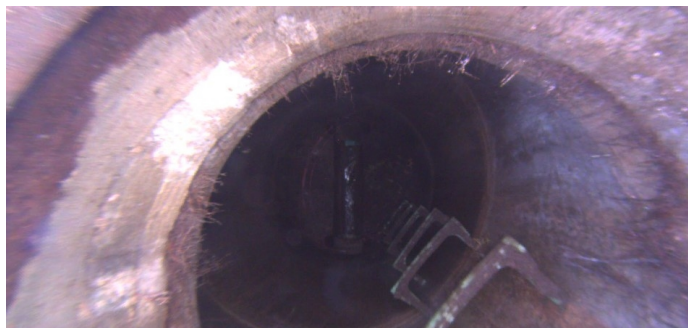
Code: **MGP**
Description: **General Photo**

Distance (ft): **.0**
Structural Grade: **0**
O&M Grade: **0**
Clock Start/From:
Clock To:
1st Value:
2nd Value:
Value Percent:
Step: **NO**
Remarks:

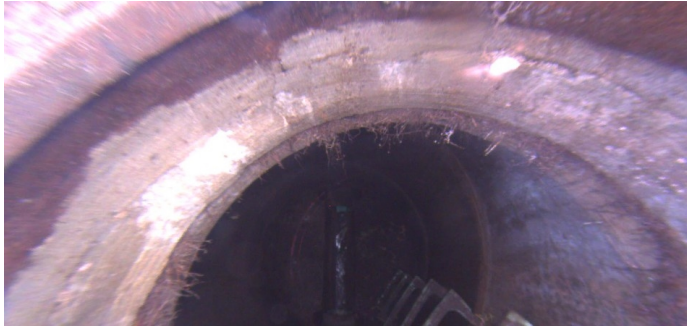
Code: **RFJ**
Description: **Roots Fine Joint**

Distance (ft): **.0**
Structural Grade: **0**
O&M Grade: **1**
Clock Start/From: **12**
Clock To: **12**
1st Value:
2nd Value:
Value Percent:
Step: **NO**
Remarks:

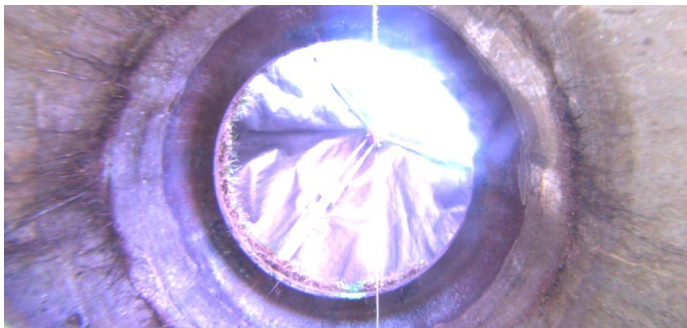
Code: **MGP**
Description: **General Photo**

Distance (ft): **2.4**
Structural Grade: **0**
O&M Grade: **0**
Clock Start/From:
Clock To:
1st Value:
2nd Value:
Value Percent:
Step: **NO**
Remarks:

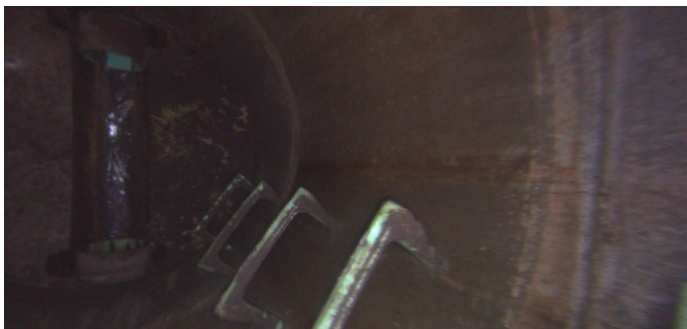
Code: **IS**
Description: **Infil Stain**

Distance (ft): **3.1**
Structural Grade: **0**
O&M Grade: **0**
Clock Start/From: **3**
Clock To:
1st Value:
2nd Value:
Value Percent:
Step: **NO**
Remarks:

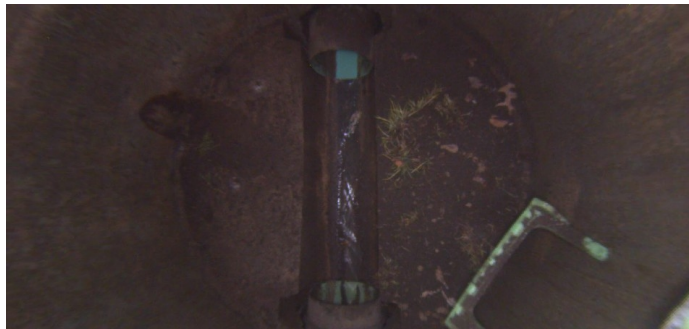
Code: **DSF**
Description: **Deposits Settled Fine**

Distance (ft): **5.3**
Structural Grade: **0**
O&M Grade: **2**
Clock Start/From: **12**
Clock To: **6**
1st Value:
2nd Value:
Value Percent: **5.000**
Step: **NO**
Remarks:

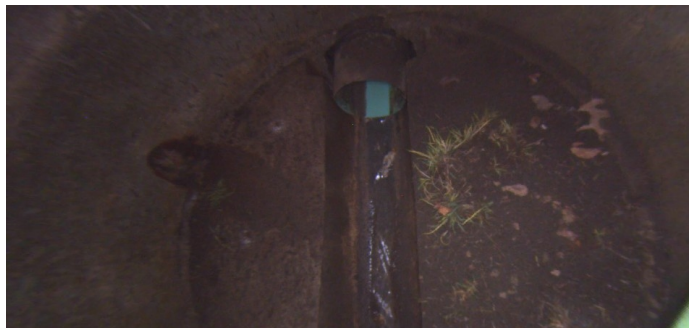
Code: **IS**
Description: **Infil Stain**

Distance (ft): **6.1**
Structural Grade: **0**
O&M Grade: **0**
Clock Start/From: **10**
Clock To:
1st Value:
2nd Value:
Value Percent:
Step: **NO**
Remarks:

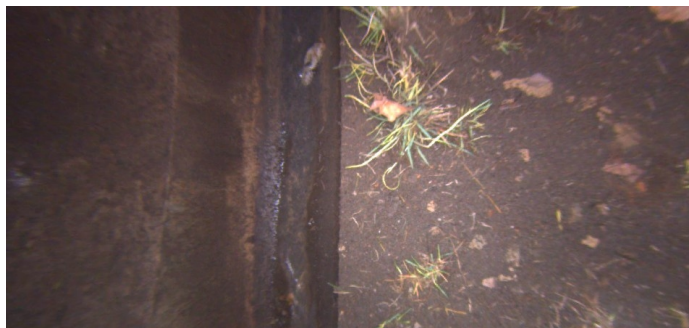
Code: **MGO**
Description: **General Observation**

Distance (ft): **7.3**
Structural Grade: **0**
O&M Grade: **0**
Clock Start/From:
Clock To:
1st Value:
2nd Value:
Value Percent:
Step: **NO**
Remarks: **Ins. Comp.**
