Manhole Inspection Report

Date:	04/11/2018	Weather:		Coding:	RZMACP
MH#:	M-809-036	Owner:	NA	Len. Surveyed:	13.0
P.O.#:		Surveyor:	John Kuglmaier	Rim to Invert:	13.3
Customer:		Cert. #:	U-1215-07002349	Wall Material:	Concrete (reinforced)

Street:	Merganser St. 119' West of Tanager	Project:	Hobart, IN
City:	Hobart, IN	GPS Northing:	2908166.464
Location:		GPS Easting:	2908166.464
Drain Area:	Southwest	GPS Accuracy:	Sub-Meter
Cover Shape:	Circular	Evidence of Surcharge:	Yes
Cover Size:	22.5	Potential for Runoff:	None
Comments:

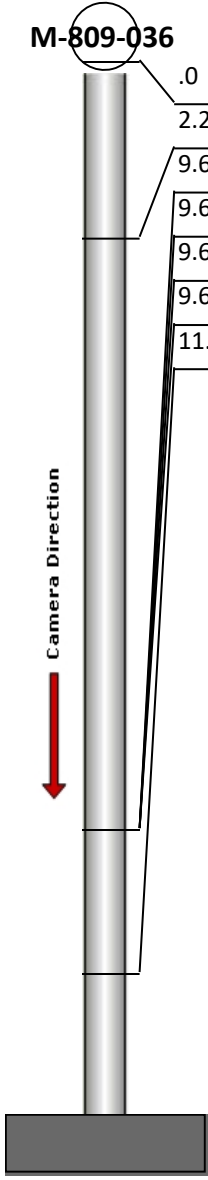
.0	MGP	General Photo	10	NA
	2.2	MGP	General Photo	28	NA
	9.6	IS	Infil Stain	57	NA
	9.6	IS	Infil Stain	68	NA
	9.6	IS	Infil Stain	80	NA
	9.6	IS	Infil Stain	91	NA
	11.4	MGO	General Observation	106	NA

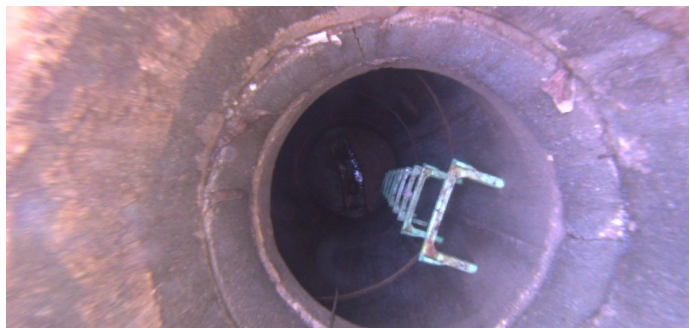
Code: **MGP**
 Description: **General Photo**

Distance (ft): **.0**
 Structural Grade: **0**
 O&M Grade: **0**
 Clock Start/From:
 Clock To:
 1st Value:
 2nd Value:
 Value Percent:
 Step: **NO**
 Remarks:

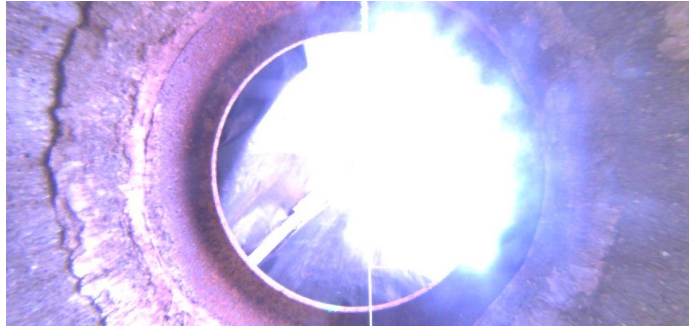
Code: **MGP**
Description: **General Photo**

Distance (ft): **2.2**
Structural Grade: **0**
O&M Grade: **0**
Clock Start/From:
Clock To:
1st Value:
2nd Value:
Value Percent:
Step: **NO**
Remarks:

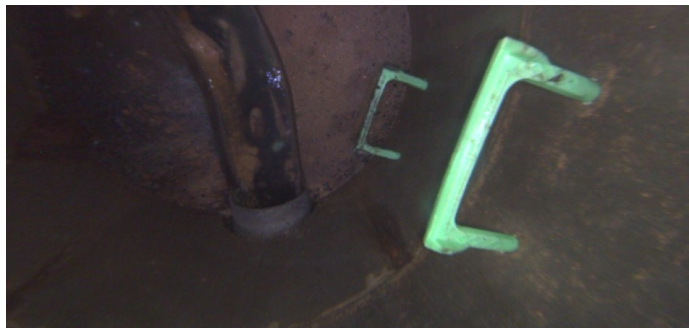
Code: **IS**
Description: **Infil Stain**

Distance (ft): **9.6**
Structural Grade: **0**
O&M Grade: **0**
Clock Start/From: **5**
Clock To:
1st Value:
2nd Value:
Value Percent:
Step: **NO**
Remarks:

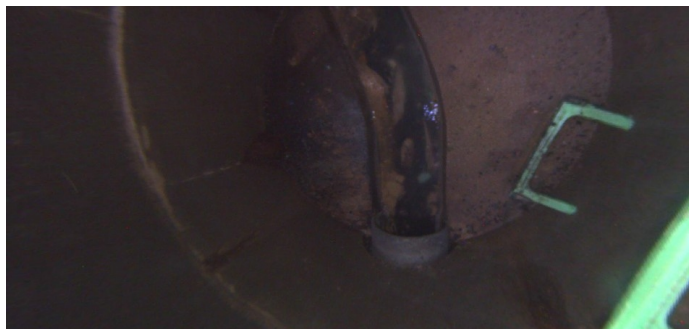
Code: **IS**
Description: **Infil Stain**

Distance (ft): **9.6**
Structural Grade: **0**
O&M Grade: **0**
Clock Start/From: **7**
Clock To:
1st Value:
2nd Value:
Value Percent:
Step: **NO**
Remarks:

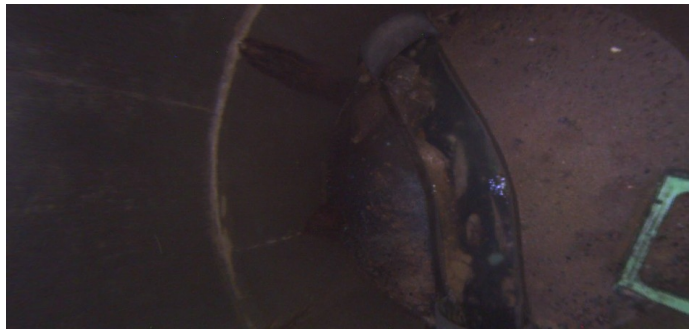
Code: **IS**
Description: **Infil Stain**

Distance (ft): **9.6**
Structural Grade: **0**
O&M Grade: **0**
Clock Start/From: **8**
Clock To:
1st Value:
2nd Value:
Value Percent:
Step: **NO**
Remarks:

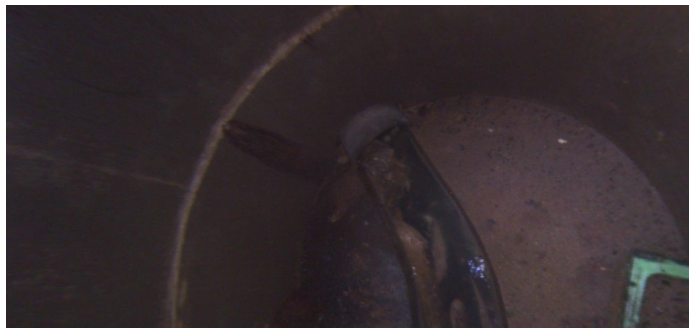
Code: **IS**
Description: **Infil Stain**

Distance (ft): **9.6**
Structural Grade: **0**
O&M Grade: **0**
Clock Start/From: **10**
Clock To:
1st Value:
2nd Value:
Value Percent:
Step: **NO**
Remarks:

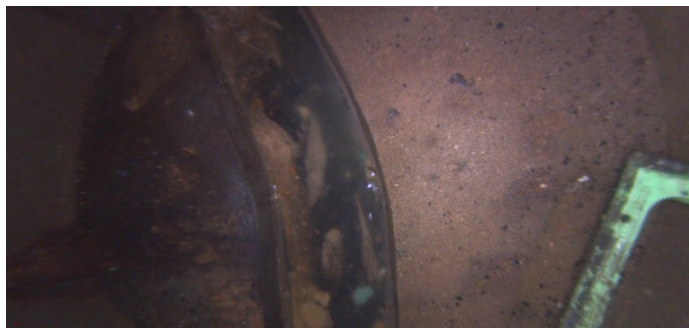
Code: **MGO**
Description: **General Observation**

Distance (ft): **11.4**
Structural Grade: **0**
O&M Grade: **0**
Clock Start/From:
Clock To:
1st Value:
2nd Value:
Value Percent:
Step: **NO**
Remarks: **Ins. Comp.**
