# Manhole Inspection Report

Date:	<b>04/11/2018</b>	Weather:		Coding:	<b>RZMACP</b>
MH#:	<b>M-809-038</b>	Owner:	<b>NA</b>	Len. Surveyed:	<b>13.1</b>
P.O.#:		Surveyor:	<b>John Kuglmaier</b>	Rim to Invert:	<b>13.5</b>
Customer:		Cert. #:	<b>U-1215-07002349</b>	Wall Material:	<b>Concrete (reinforced)</b>

Street:	<b>Merganser St. 252' East of Kestrel St.</b>	Project:	<b>Hobart, IN</b>
City:	<b>Hobart, IN</b>	GPS Northing:	<b>2907565.653</b>
Location:		GPS Easting:	<b>2907565.653</b>
Drain Area:	<b>Southwest</b>	GPS Accuracy:	<b>Sub-Meter</b>
Cover Shape:	<b>Circular</b>	Evidence of Surcharge:	<b>No</b>
Cover Size:	<b>22.5</b>	Potential for Runoff:	<b>None</b>
Comments:

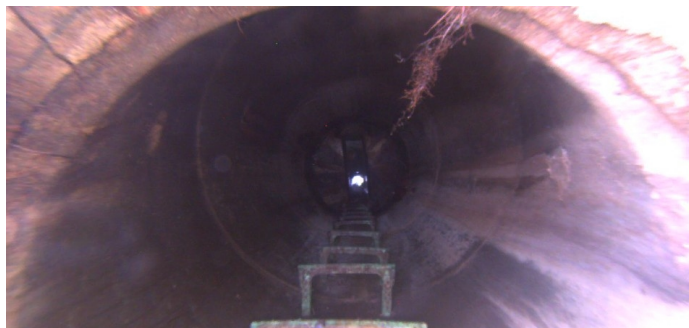
Code: **MGP**  
Description: **General Photo**

Distance (ft): **.0**  
Structural Grade: **0**  
O&M Grade: **0**  
Clock Start/From:  
Clock To:  
1st Value:  
2nd Value:  
Value Percent:  
Step: **NO**  
Remarks:

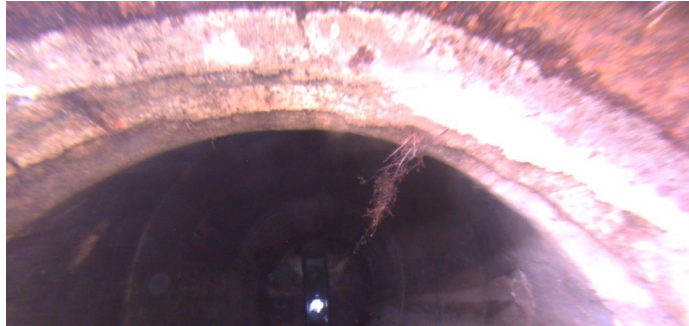
Code: **RFJ**  
Description: **Roots Fine Joint**

Distance (ft): **.0**  
Structural Grade: **0**  
O&M Grade: **1**  
Clock Start/From: **1**  
Clock To:  
1st Value:  
2nd Value:  
Value Percent:  
Step: **NO**  
Remarks:

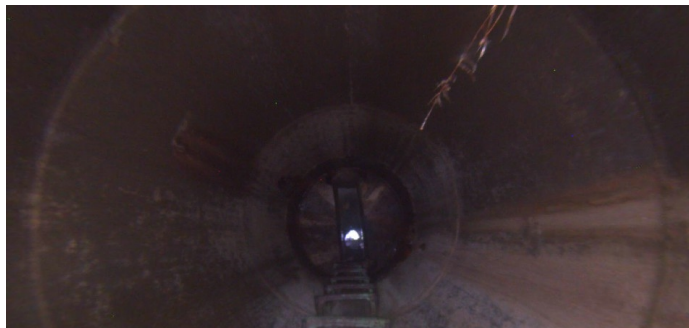
Code: **IS**  
Description: **Infil Stain**

Distance (ft): **1.8**  
Structural Grade: **0**  
O&M Grade: **0**  
Clock Start/From: **10**  
Clock To:  
1st Value:  
2nd Value:  
Value Percent:  
Step: **NO**  
Remarks:

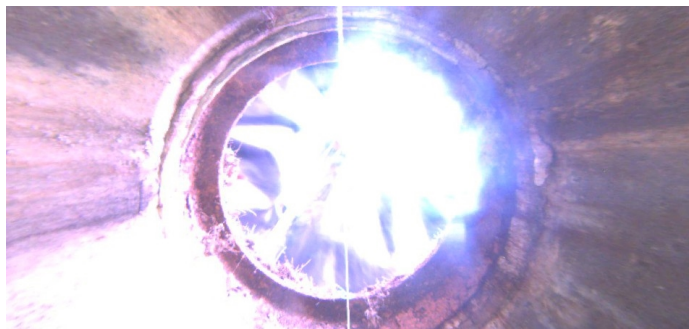
Code: **MGP**  
Description: **General Photo**

Distance (ft): **2.4**  
Structural Grade: **0**  
O&M Grade: **0**  
Clock Start/From:  
Clock To:  
1st Value:  
2nd Value:  
Value Percent:  
Step: **NO**  
Remarks:

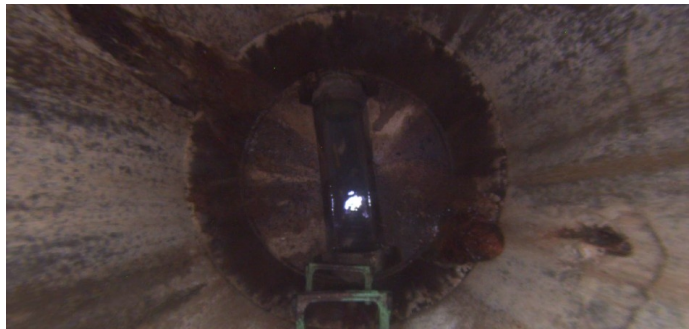
Code: **IS**  
Description: **Infil Stain**

Distance (ft): **7.4**  
Structural Grade: **0**  
O&M Grade: **0**  
Clock Start/From: **12**  
Clock To: **12**  
1st Value:  
2nd Value:  
Value Percent:  
Step: **NO**  
Remarks:

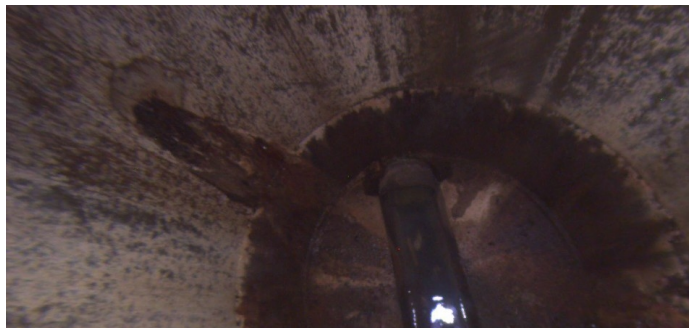
Code: **IS**  
Description: **Infil Stain**

Distance (ft): **8.0**  
Structural Grade: **0**  
O&M Grade: **0**  
Clock Start/From: **10**  
Clock To:  
1st Value:  
2nd Value:  
Value Percent:  
Step: **NO**  
Remarks:

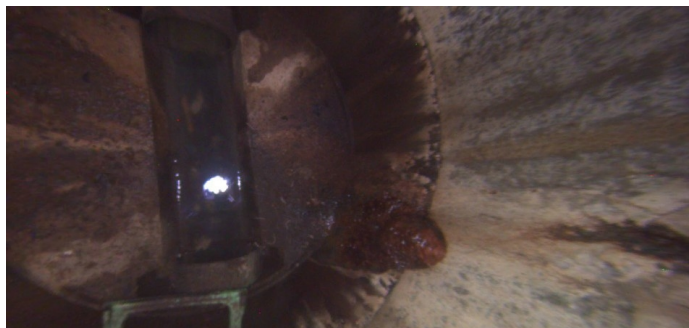
Code: **DAE**  
Description: **Deposits Attached Encrustation**

Distance (ft): **9.1**  
Structural Grade: **0**  
O&M Grade: **2**  
Clock Start/From: **4**  
Clock To:  
1st Value:  
2nd Value:  
Value Percent: **5.000**  
Step: **NO**  
Remarks:

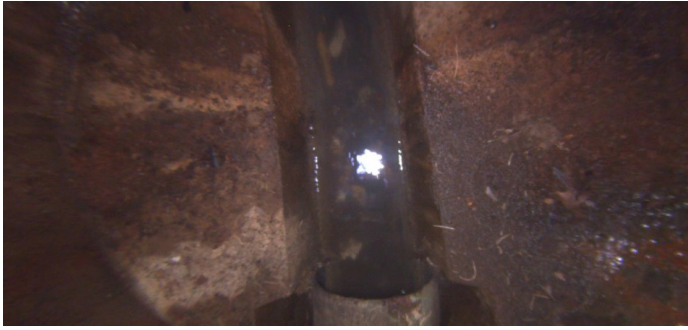
Code:	<b>MGO</b>
Description:	<b>General Observation</b>
Distance (ft):	<b>10.9</b>
Structural Grade:	<b>0</b>
O&M Grade:	<b>0</b>
Clock Start/From:	
Clock To:	
1st Value:	
2nd Value:	
Value Percent:	
Step:	<b>NO</b>
Remarks:	<b>Ins. Comp.</b>
