# Manhole Inspection Report

Date:	04/11/2018	Weather:		Coding:	RZMACP
MH#:	M-809-039	Owner:	NA	Len. Surveyed:	8.6
P.O.#:		Surveyor:	John Kuglmaier	Rim to Invert:	9.1
Customer:		Cert. #:	U-1215-07002349	Wall Material:	Concrete (reinforced)

Street:	Kestrel St. 124' South of Merganser	Project:	Hobart, IN
City:	Hobart, IN	GPS Northing:	2907307.515
Location:		GPS Easting:	2907307.515
Drain Area:	Southwest	GPS Accuracy:	Sub-Meter
Cover Shape:	Circular	Evidence of Surcharge:	No
Cover Size:	22.5	Potential for Runoff:	None
Comments:

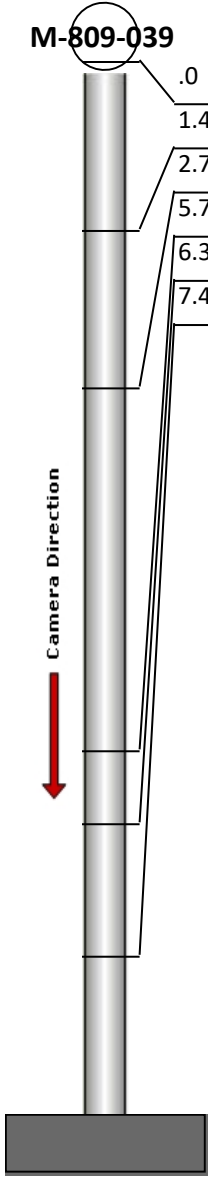
.0	MGP	General Photo	10	NA
	1.4	IS	Infil Stain	25	NA
	2.7	MGP	General Photo	41	NA
	5.7	DSF	Deposits Settled Fine	60	M 2
	6.3	IS	Infil Stain	73	NA
	7.4	MGO	General Observation	87	NA

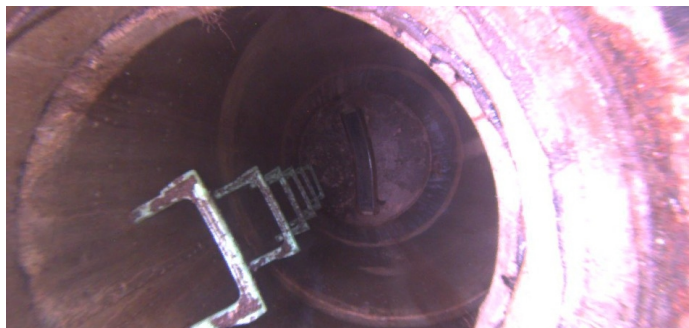
Code: **MGP**  
Description: **General Photo**

Distance (ft): **.0**  
Structural Grade: **0**  
O&M Grade: **0**  
Clock Start/From:  
Clock To:  
1st Value:  
2nd Value:  
Value Percent:  
Step: **NO**  
Remarks:

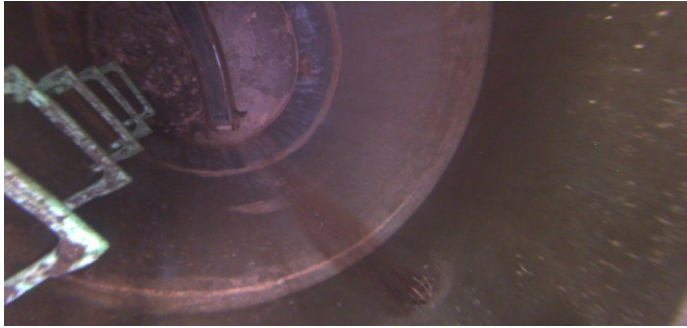
Code: **IS**  
Description: **Infil Stain**

Distance (ft): **1.4**  
Structural Grade: **0**  
O&M Grade: **0**  
Clock Start/From: **5**  
Clock To:  
1st Value:  
2nd Value:  
Value Percent:  
Step: **NO**  
Remarks:

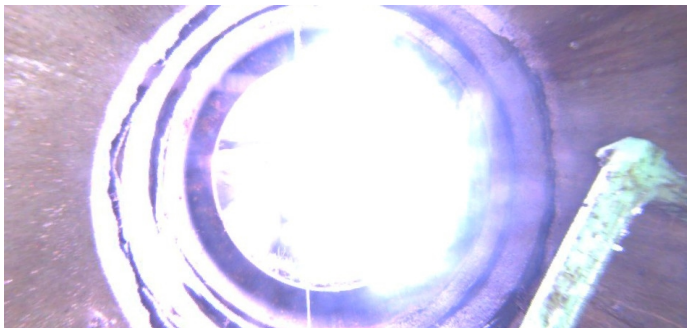
Code: **MGP**  
Description: **General Photo**

Distance (ft): **2.7**  
Structural Grade: **0**  
O&M Grade: **0**  
Clock Start/From:  
Clock To:  
1st Value:  
2nd Value:  
Value Percent:  
Step: **NO**  
Remarks:

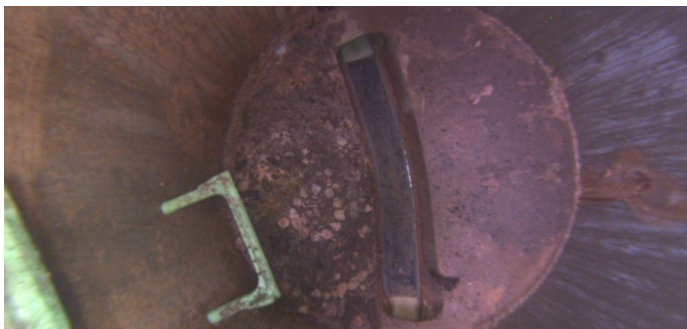
Code: **DSF**  
Description: **Deposits Settled Fine**

Distance (ft): **5.7**  
Structural Grade: **0**  
O&M Grade: **2**  
Clock Start/From: **6**  
Clock To: **11**  
1st Value:  
2nd Value:  
Value Percent: **5.000**  
Step: **NO**  
Remarks:

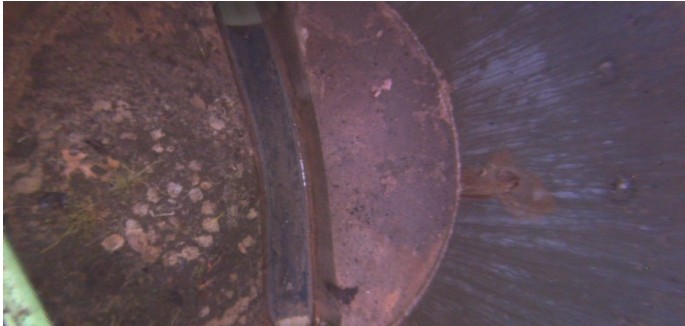
Code:	<b>IS</b>
Description:	<b>Infil Stain</b>

Distance (ft):	<b>6.3</b>
Structural Grade:	<b>0</b>
O&M Grade:	<b>0</b>
Clock Start/From:	<b>3</b>
Clock To:	
1st Value:	
2nd Value:	
Value Percent:	
Step:	<b>NO</b>
Remarks:

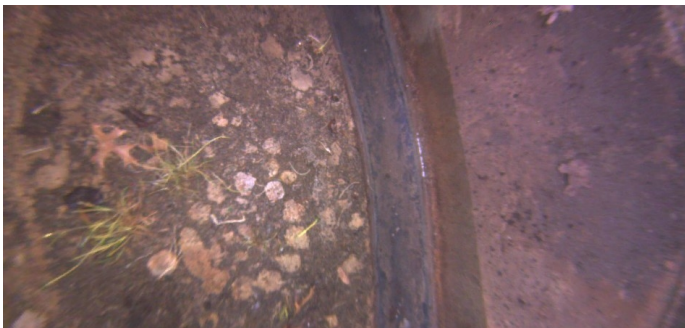
Code:	<b>MGO</b>
Description:	<b>General Observation</b>

Distance (ft):	<b>7.4</b>
Structural Grade:	<b>0</b>
O&M Grade:	<b>0</b>
Clock Start/From:	
Clock To:	
1st Value:	
2nd Value:	
Value Percent:	
Step:	<b>NO</b>
Remarks:	<b>Ins. Comp.</b>
