Manhole Inspection Report

Date:	11/01/2022	Weather:		Coding:	RZMACP
MH#:	M-809-043	Owner:	NA	Len. Surveyed:	7.2
P.O.#:		Surveyor:	Jen Costello	Rim to Invert:	8.2
Customer:		Cert. #:	U-907-5518	Wall Material:	Concrete (non-reinforced)

Street:	Kestrel St. 408' Southeast of Mergan	Project:	502259S9MACP26Jan2023
City:	Hobart, IN	GPS Northing:	2278972.145
Location:		GPS Easting:	2907571.808
Drain Area:	Southwest	GPS Accuracy:	Sub-Meter
Cover Shape:	Circular	Evidence of Surcharge:	No
Cover Size:	24.0	Potential for Runoff:	None
Comments:

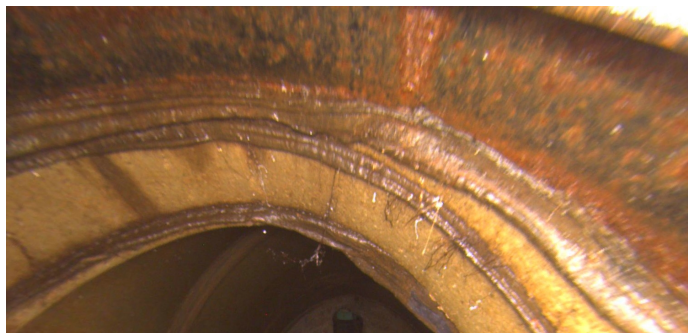
Code: **ISGT**
Description: **Intruding Sealing Grout**

Distance (ft): **.0**
Structural Grade: **0**
O&M Grade: **2**
Clock Start/From: **12**
Clock To: **12**
1st Value:
2nd Value:
Value Percent: **5.000**
Step: **NO**
Remarks:

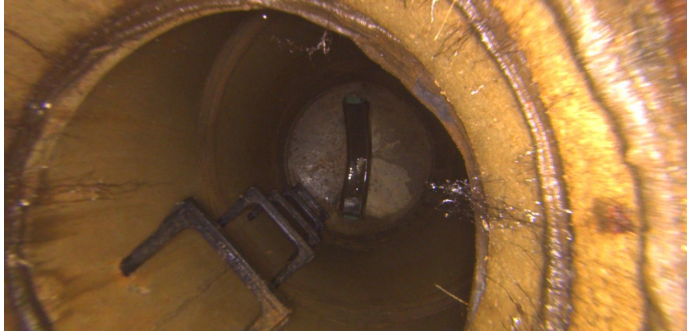
Code:	MGO
Description:	General Observation
Distance (ft):	.0
Structural Grade:	0
O&M Grade:	0
Clock Start/From:	
Clock To:	
1st Value:	
2nd Value:	
Value Percent:	
Step:	NO
Remarks:	access mh

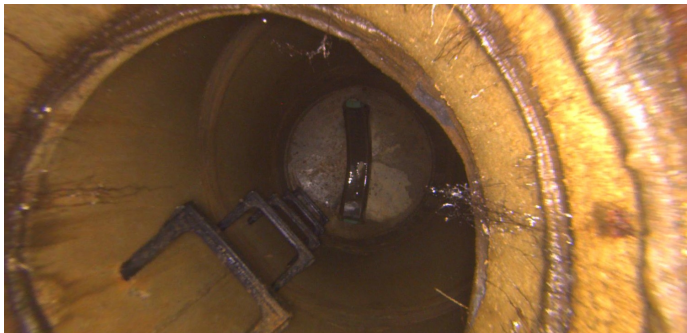
Code:	SRI
Description:	Surface Roughness Increased
Distance (ft):	.0
Structural Grade:	1
O&M Grade:	0
Clock Start/From:	12
Clock To:	12
1st Value:	
2nd Value:	
Value Percent:	
Step:	NO
Remarks:

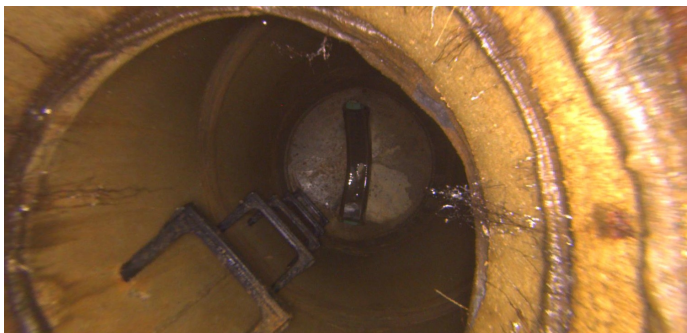
Code:	RFJ
Description:	Roots Fine Joint
Distance (ft):	.0
Structural Grade:	0
O&M Grade:	1
Clock Start/From:	12
Clock To:	12
1st Value:	
2nd Value:	
Value Percent:	
Step:	NO
Remarks:

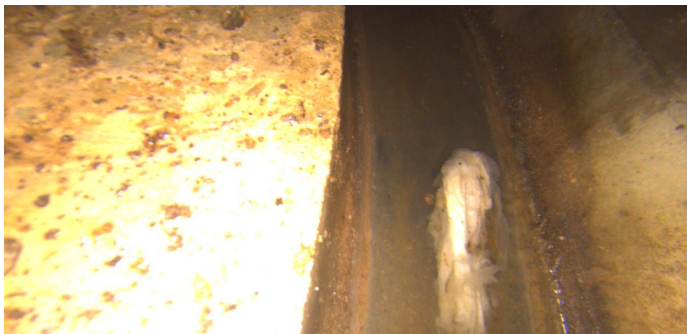
Code: **SRI**
Description: **Surface Roughness Increased**

Distance (ft): **7.2**
Structural Grade: **1**
O&M Grade: **0**
Clock Start/From: **12**
Clock To: **12**
1st Value:
2nd Value:
Value Percent:
Step: **NO**
Remarks:

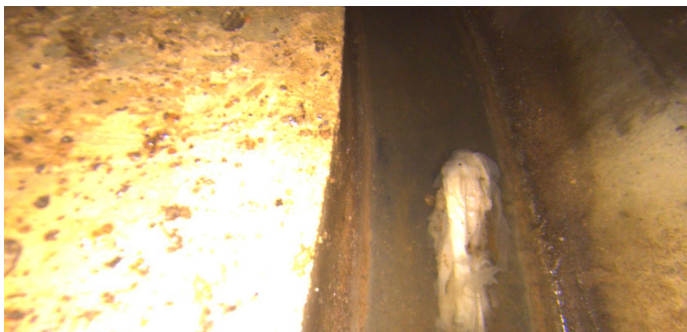
Code: **MGO**
Description: **General Observation**

Distance (ft): **7.2**
Structural Grade: **0**
O&M Grade: **0**
Clock Start/From:
Clock To:
1st Value:
2nd Value:
Value Percent:
Step: **NO**
Remarks: **end of survey**

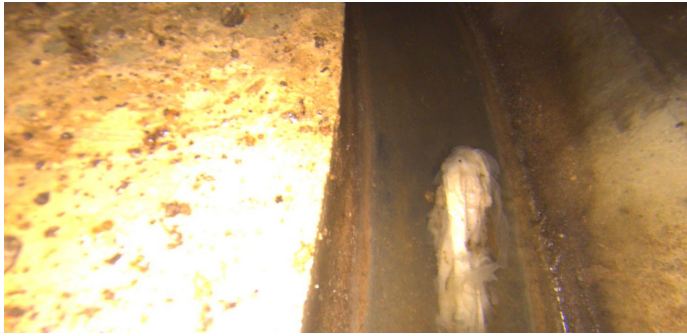
Code: **DSZ**
Description: **Deposits Settled Other**

Distance (ft): **7.2**
Structural Grade: **0**
O&M Grade: **2**
Clock Start/From: **6**
Clock To:
1st Value:
2nd Value:
Value Percent: **5.000**
Step: **NO**
Remarks: **paper products**

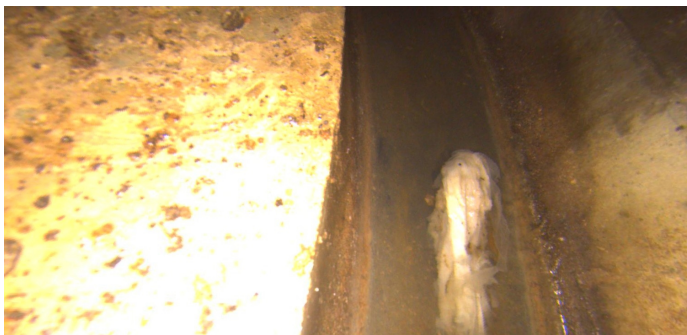
Code: **SRI**
Description: **Surface Roughness Increased**

Distance (ft): **7.2**
Structural Grade: **1**
O&M Grade: **0**
Clock Start/From: **3**
Clock To: **9**
1st Value:
2nd Value:
Value Percent:
Step: **NO**
Remarks:
